## *Air Barrier Commissioning of Large Buildings*

September 2011

Martin Houston, AIA, LEED AP

Walsh Construction Co.

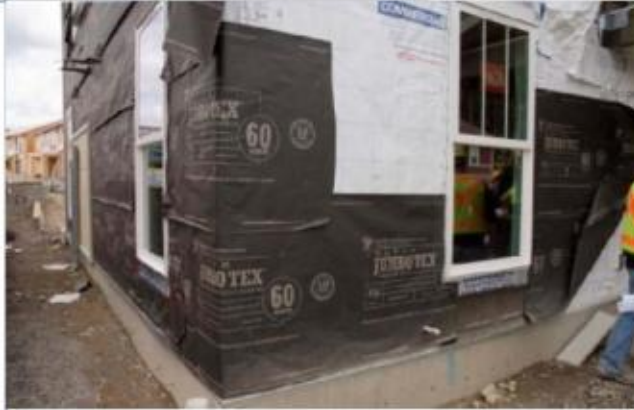
**Photo 15**

A layer of Jumbotex D60 building paper over the Tyvek was installed to prevent direct contact with the back of Fiber Cement siding and to improve drainage.

The long term effects of salts and minerals that leach through the back side of Fiber Cement siding is unknown. This is the second reason for adding the paper layer.

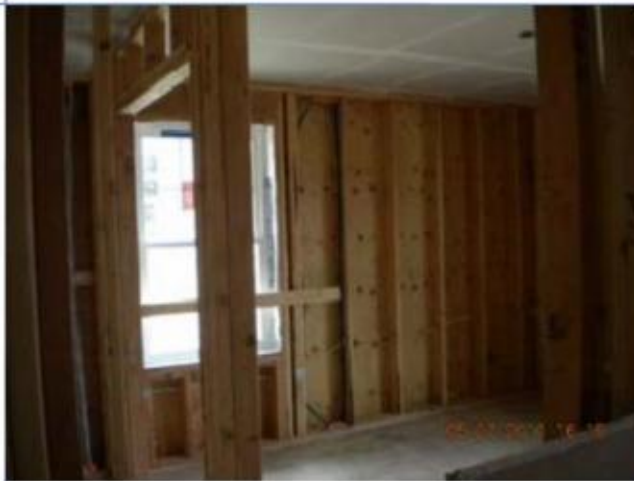
**Photo 16**

The ceiling at the attic is part of the air barrier system for this project. Typically, the drywall contractors come in and do all the drywall work at once.

The ceiling is an "out of sequence" component that has to be scheduled and installed to enable the A.B. testing.

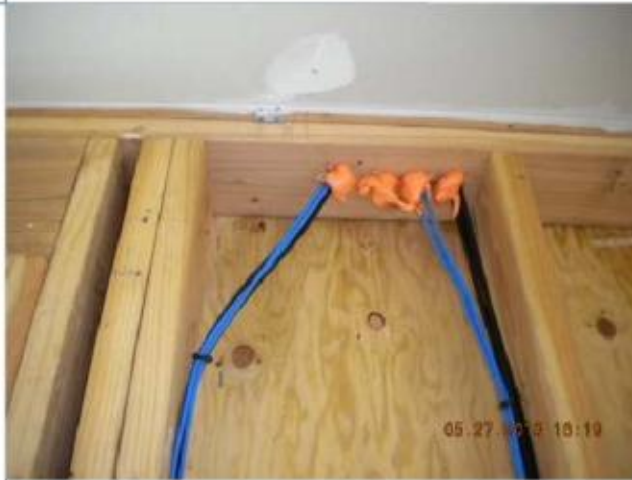
**Photo 17**

Penetrations through the top plate into the attic must be sealed.  
Note the continuous sealant joint at the top plate to GWB ceiling. This is the air seal at this interface, as the top plate needs to bridge the A.B. from ceiling to Tyvek on the exterior wall.

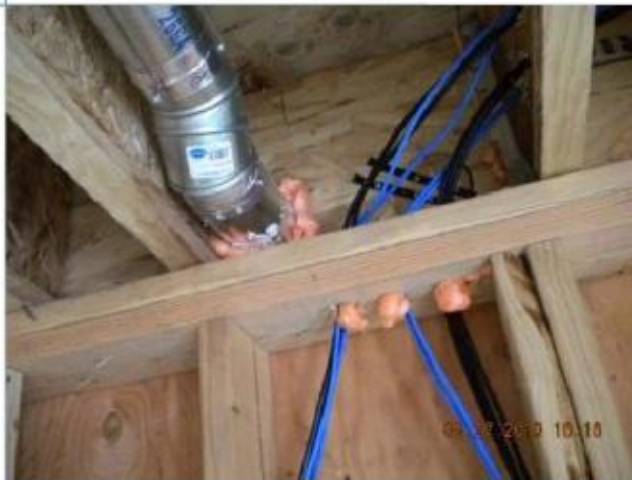
**Photo 18**

Air seal around the exhaust duct will provide some redundancy as it goes through the rim joist to the exterior side.  
It's a redundant measure because the hood is actually sealed to the Tyvek A.B. membrane to provide air seal from the exterior side of the wall.

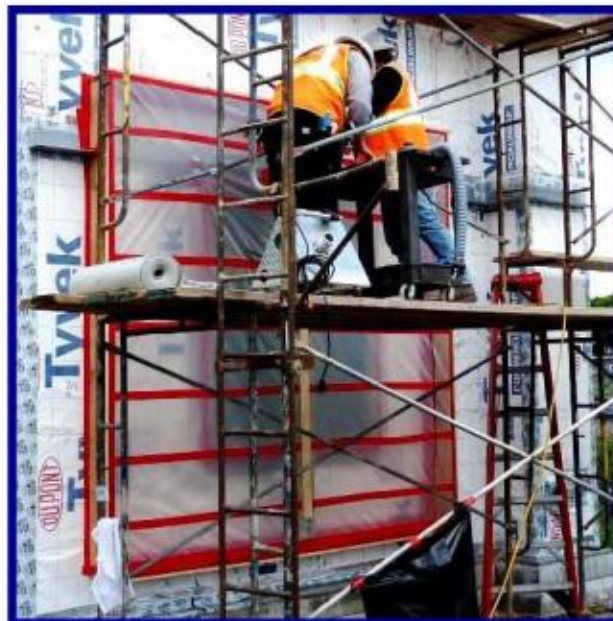
Total square foot of test area = 85.5 square feet.  
 Total square foot of window product = 28.75  
 VPI window measures 57.5" x 72" = 4,130 square inches  
 $4,130 / 144 = 28.75$  square feet

Flow Rate #1 Included: Entire area including window product.  
 Flow Rate Measurement #1: 22.5 scfm

Flow Rate #2 included: Entire area with window MASKED OUT.  
 Flow Rate Measurement #2: 21.5 scfm

Flow rate attributable to VPI window product: 1.0 scfm  
 Corrected Flow Rate:  $1.0\ \text{scfm} / 28.5\ \text{square feet} = \mathbf{0.04\ cfm / ft^2}$   
 R, LC, C product classes have allowable rating of 0.30 cfm / ft<sup>2</sup>

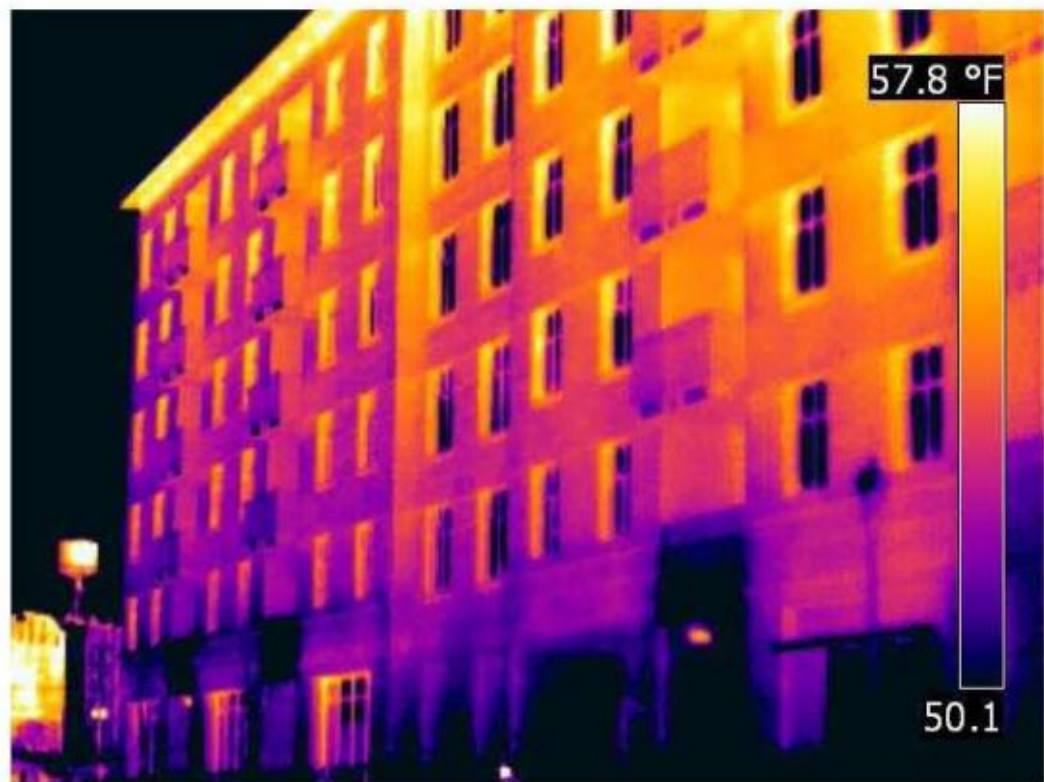
**Friday, March 4<sup>th</sup> 4:20 PM 55 degrees F  
West Elevation**

Thermostats in the units were set to 74F. Visible at the sixth floor deck on the north elevation is the location of one of 10 blower doors installed in the building, seen clearly as a bright area (A). The blower door is turned on and is discharging the heated air from the building, which is clearly heating the window system, the deck soffit and the building overhang. The window head on the fifth floor (B) shows heat transmission through the vinyl frame of the window. This is typical given that the vinyl frame has a lower U value than the glazing or the opaque wall and the vinyl frame acts to conduct the heat to the exterior.

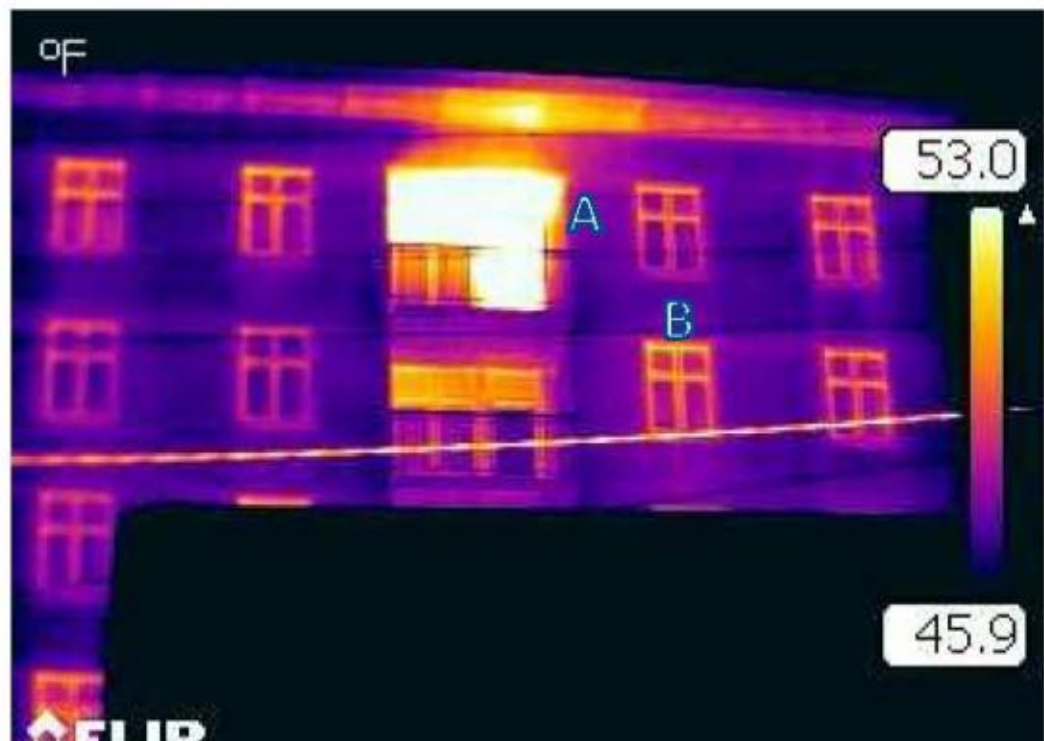
**Friday, March 4<sup>th</sup> 4:20 PM 55 degrees F  
South Wall of Courtyard**

Air leakage is visible at the roof to wall connection (A). It is not unusual to see air leakage at such intersections, especially at inside and outside building corners, as air barrier construction is difficult where the building geometry is complex. The brick ledger (B), is also visible as a clear thermal bridge, conducting heat through the building frame to the exterior. It is typical for brick ledgers to conduct heat unless thermally isolated from the building frame. Note the heat signature at the outside edge of the soffit (C). The roof-to-wall intersection is the likely source of this warm air leakage.
