AIR BARRIERS AND COMMISSIONING

Owner and Developer Perspective

Ed McNamara
Turtle Island Development LLC
Portland, Oregon

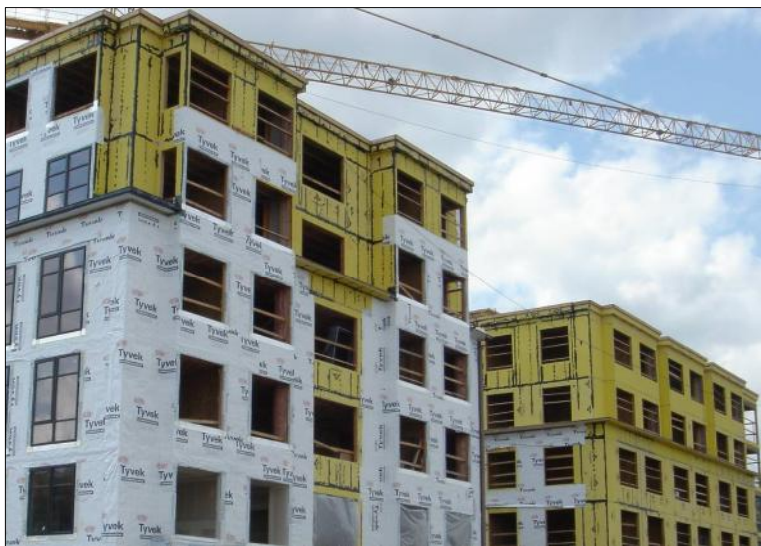
Sitka – Sealed joints on gypsum

- Sitka used sealed joints on exterior gypsum
- Ramona used taped Tyvek
 - Sealed all horizontal joints, assumed vertical joints fell on studs and were relatively tight
 - Framers used pre-fabricated walls,
 - Came out in 12' lengths with sheathing installed
 - Saved costs and time, but
 - Left a large gap every 12' on wall

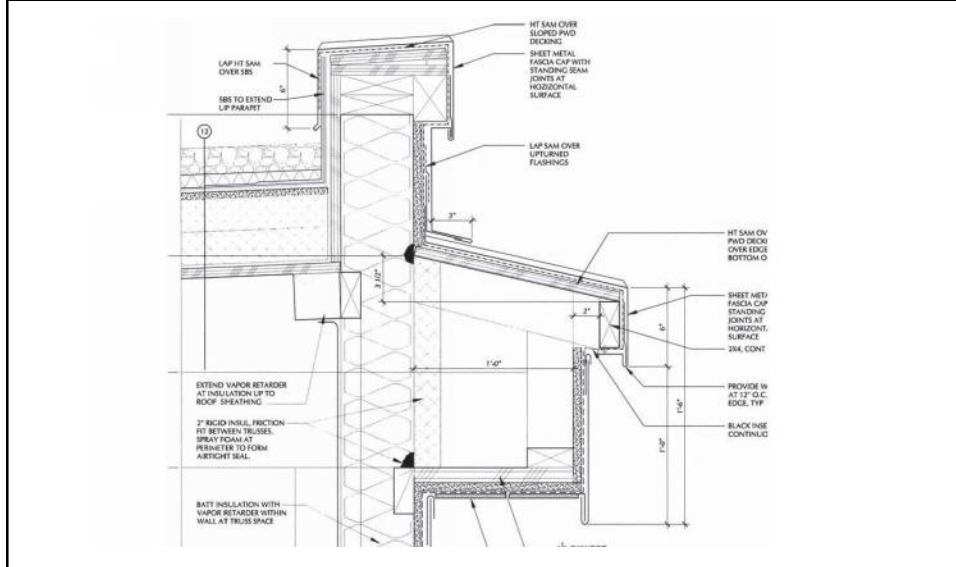
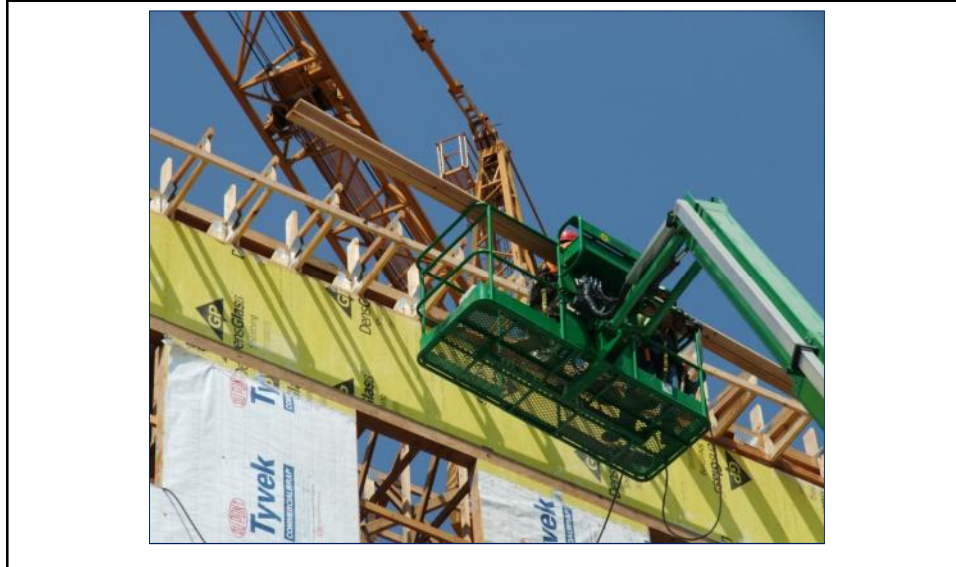
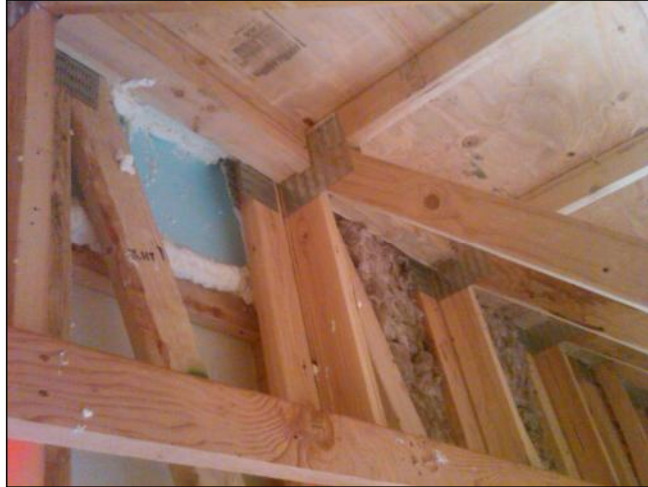
Ramona Cornice

- Ramona cornice construction detail changed by design team
 - Had cornice built as part of roof truss instead of framing it onto wall
 - Improved structural attachment, but
 - Required venting cornice
 - Air barrier had to make transition from outside of sheathing to inside of framing
 - Became impossible to get tight seal

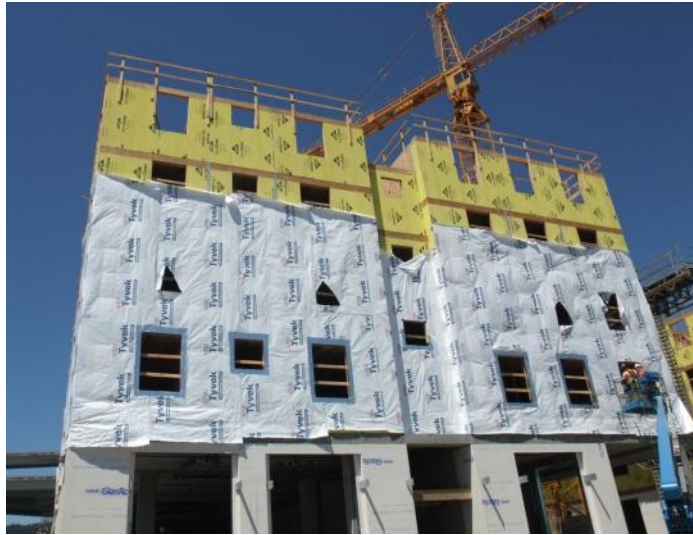
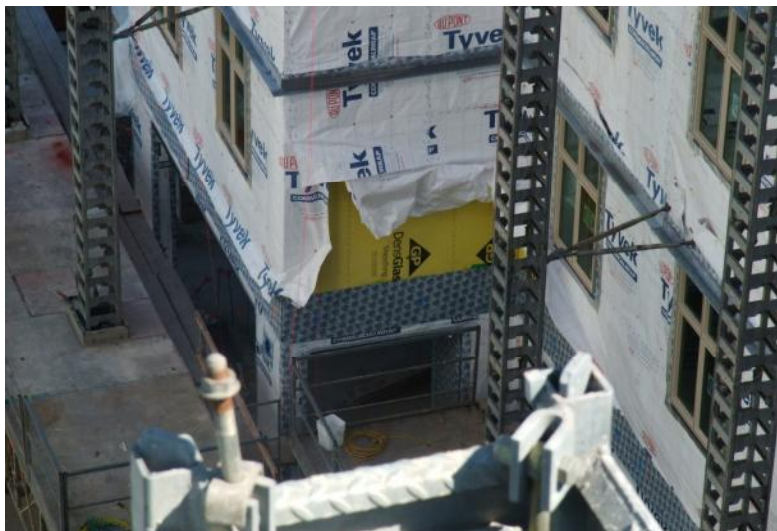
Tyvek Installation

- Ramona air barrier design relied on Tyvek being airtight
 - Installers left loose ends flapping in wind, potentially tearing at staples
 - Masons had to cut Tyvek to install brick ledgers
 - Ledgers didn't arrive
 - Left massive slices in Tyvek in courtyard on windiest day of the year

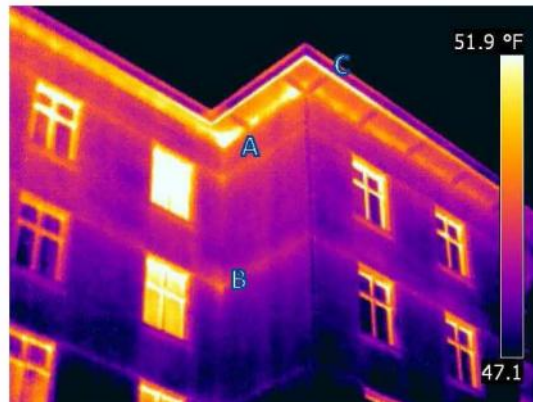
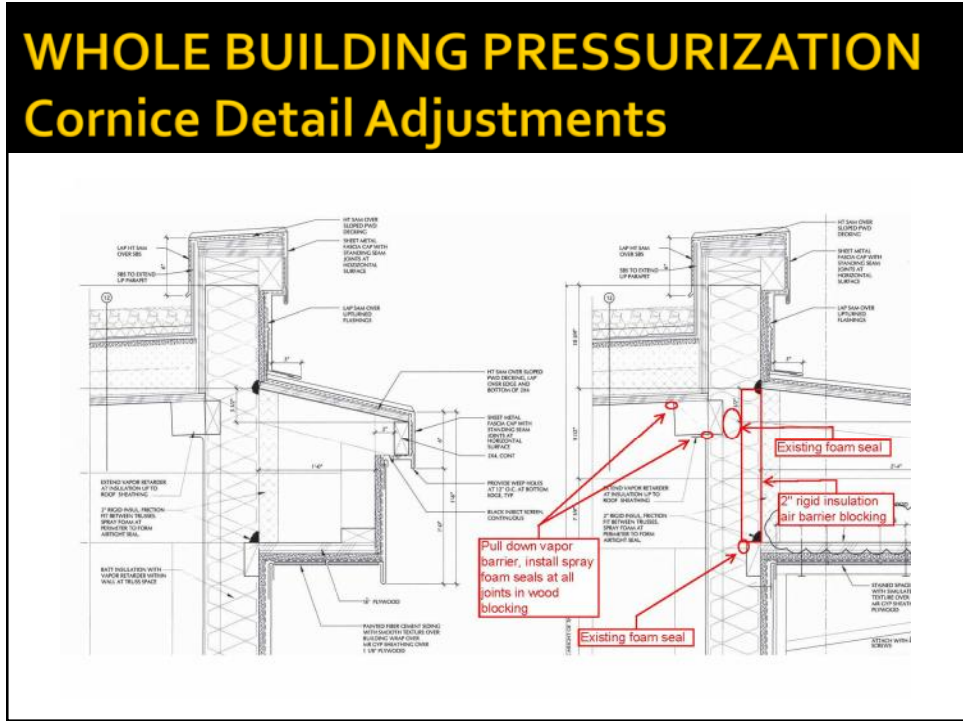
Friday, March 4th 4:20 PM 55 degrees F
South Wall of Courtyard

Air leakage is visible at the roof to wall connection (A). It is not unusual to see air leakage at such intersections, especially at inside and outside building corners, as air barrier construction is difficult where the building geometry is complex. The brick ledge (B), is also visible as a clear thermal bridge, conducting heat through the building frame to the exterior. It is typical for brick ledgers to conduct heat unless themally isolated from the building frame. Note the heat signature at the outside edge of the soffit (C). The roof-to-wall intersection is the likely source of this warm air leakage.

- Thought it would only help for next building
- Pressurization and thermal imaging (building heated to 23° - or 74° - for 2 days)
 - Found and corrected cornice leaks (thermal imaging and smoke pencils)
 - Found casements that needed adjustment
 - Added vestibule at elevator in garage
 - Added weather-stripping to secondary exterior doors (e.g. door from hallway to loading dock)
