On Stucco Cracking

**Pierre-Michel Busque, P.Eng.
Busque Engineering Ltd.**

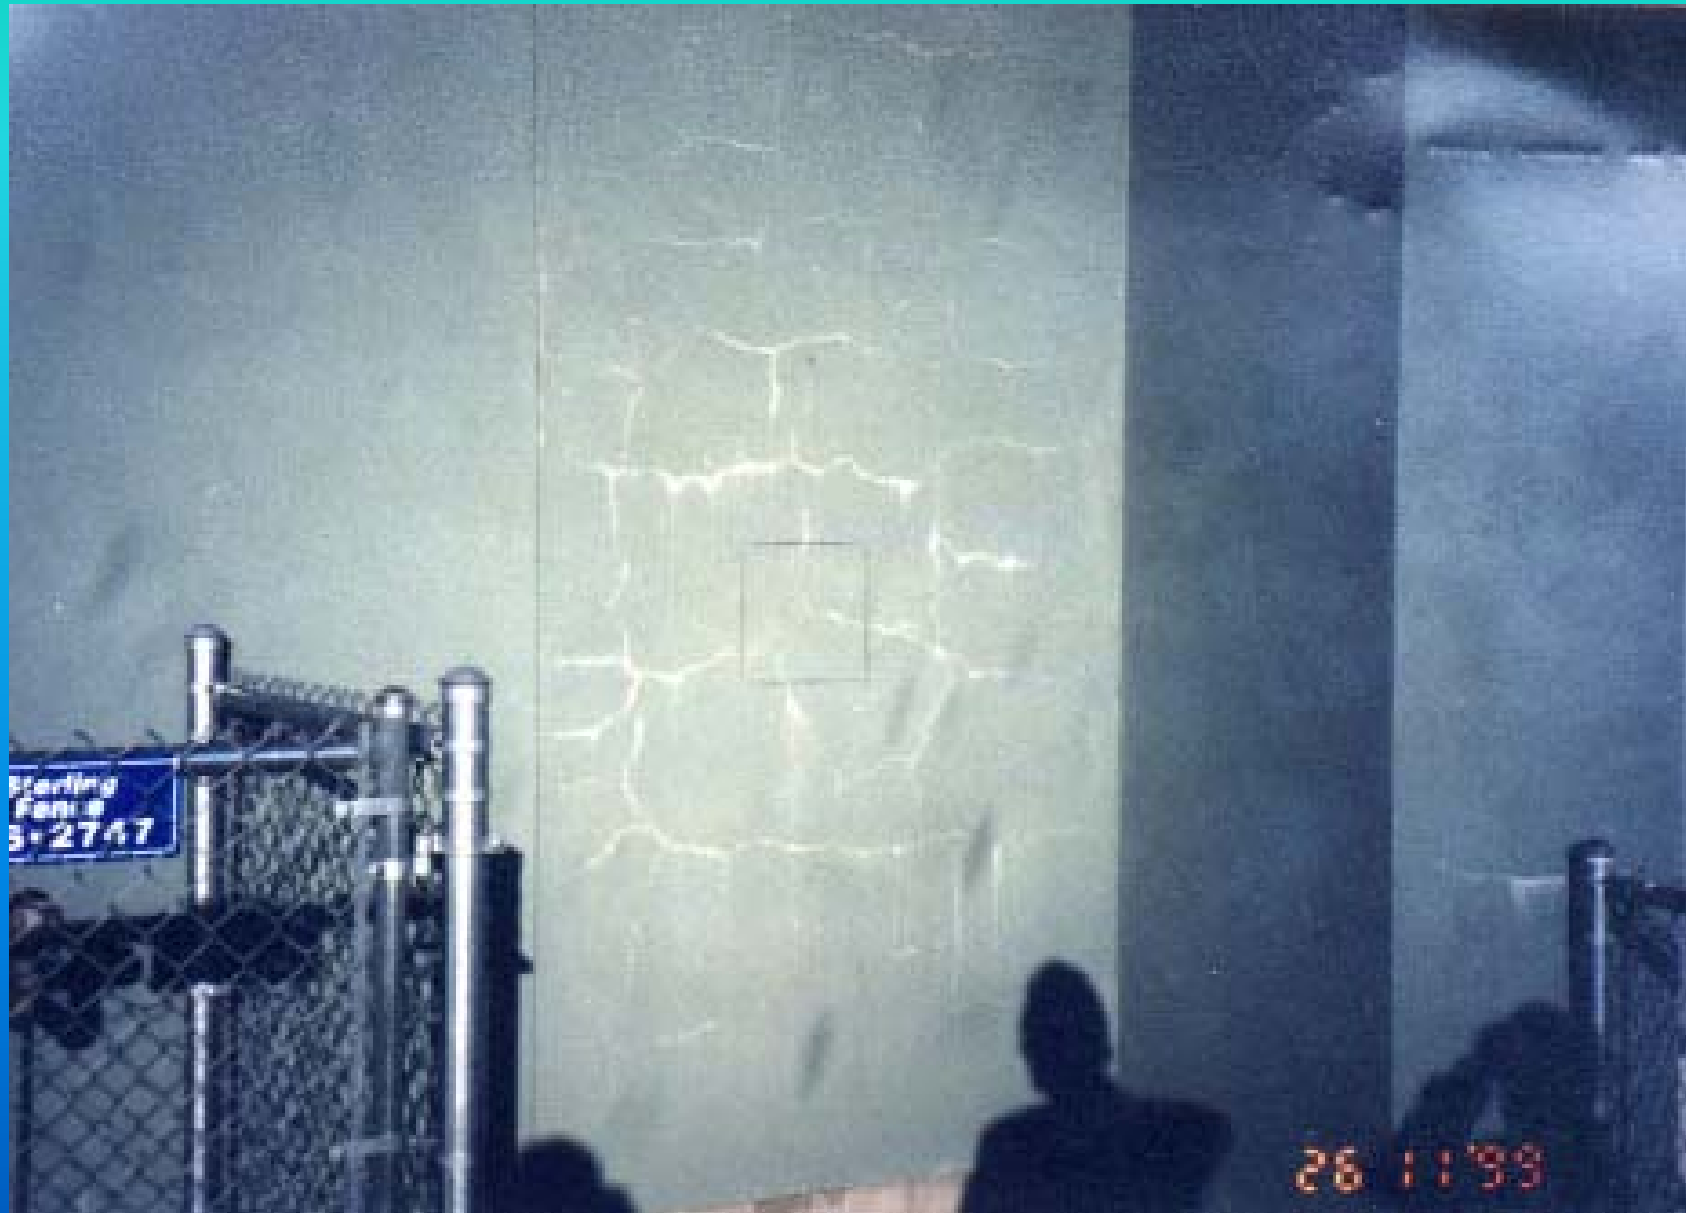
Typical Cracking Patterns-Stucco

- Shrinkage

Open Cracks-Looks Like a Spider Web

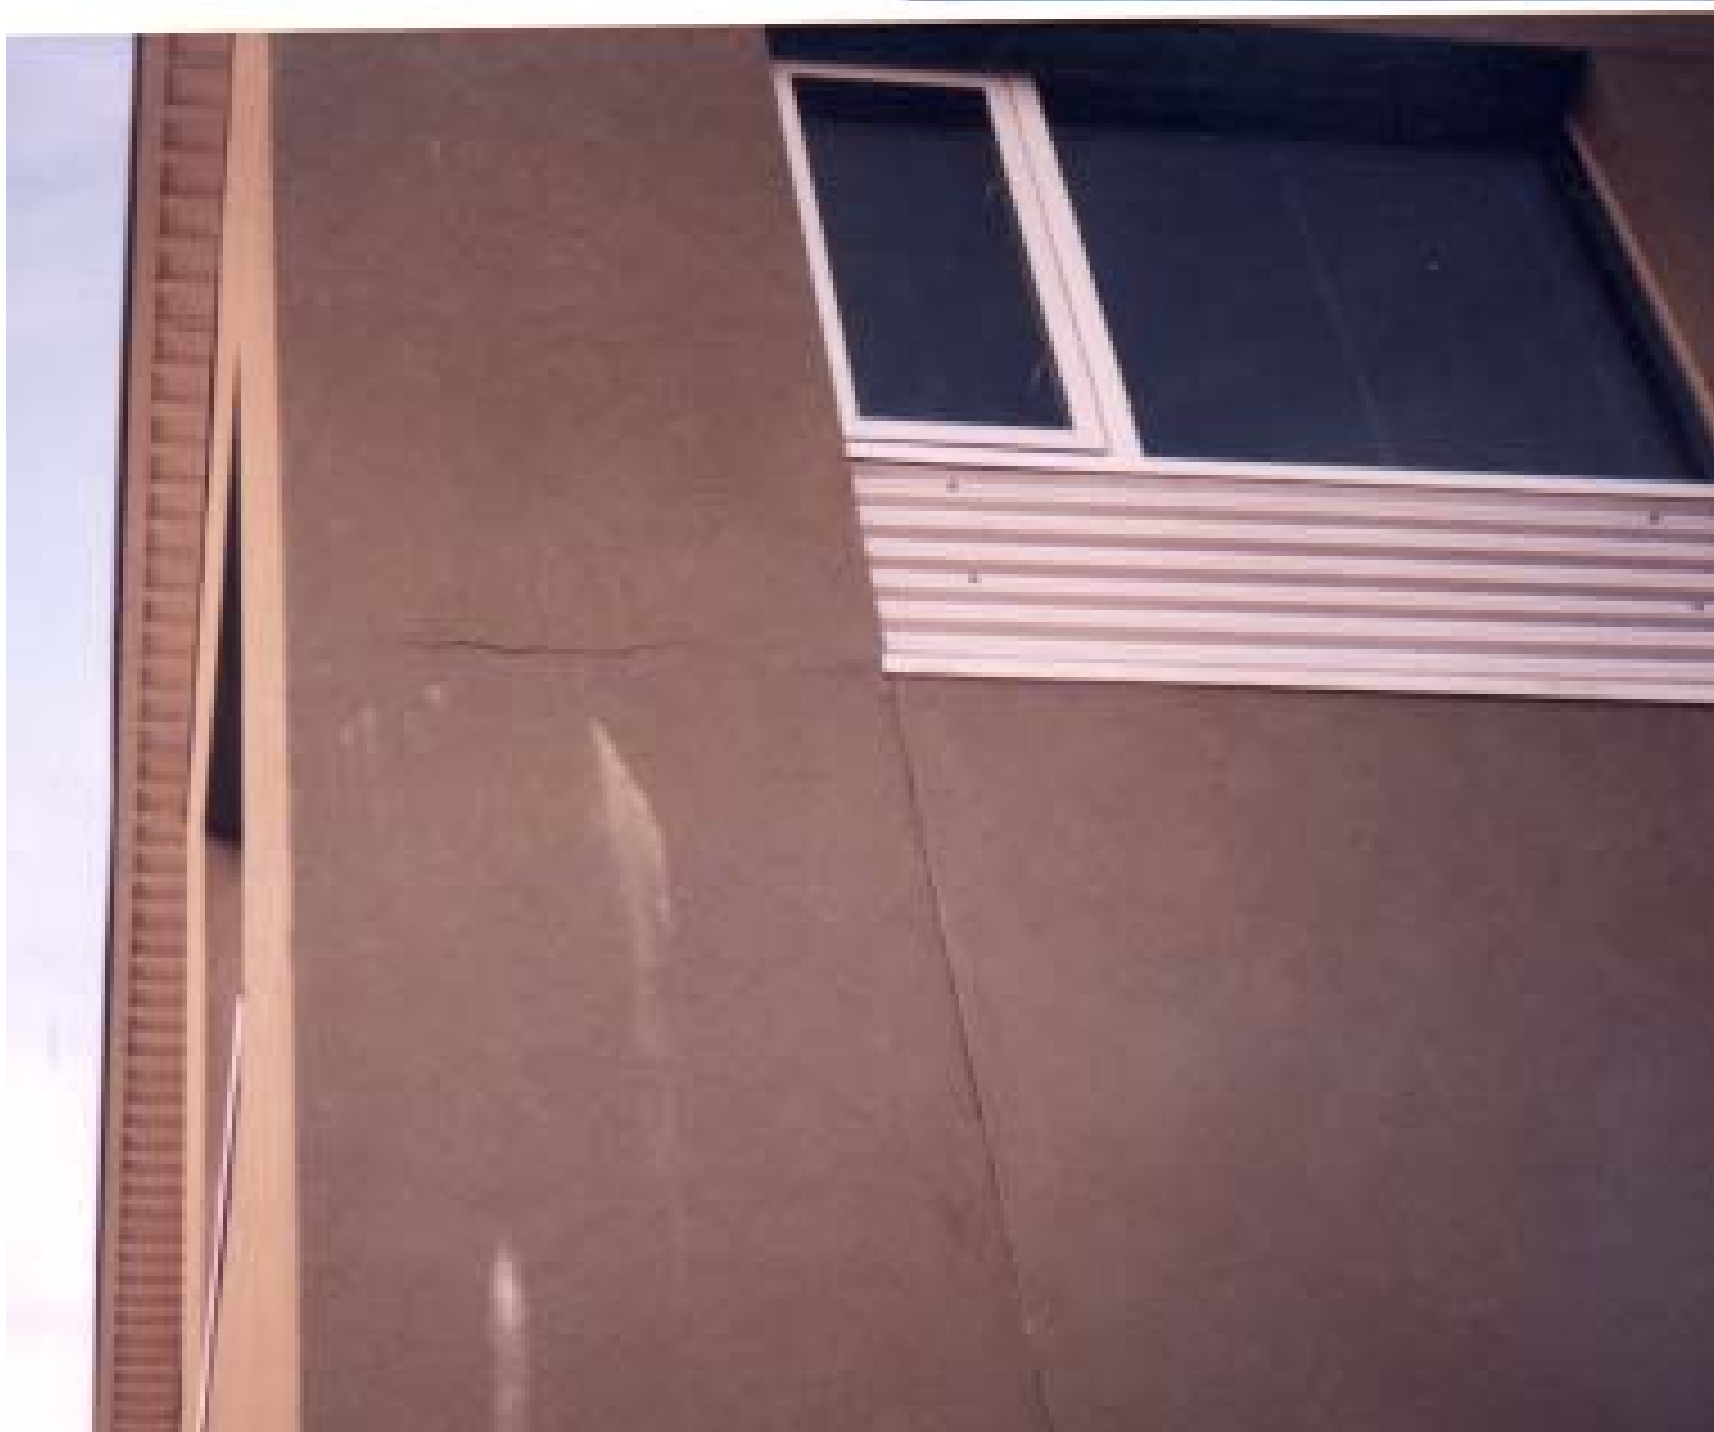
Typical Cracking of Stucco

- Compression of stucco by the structure

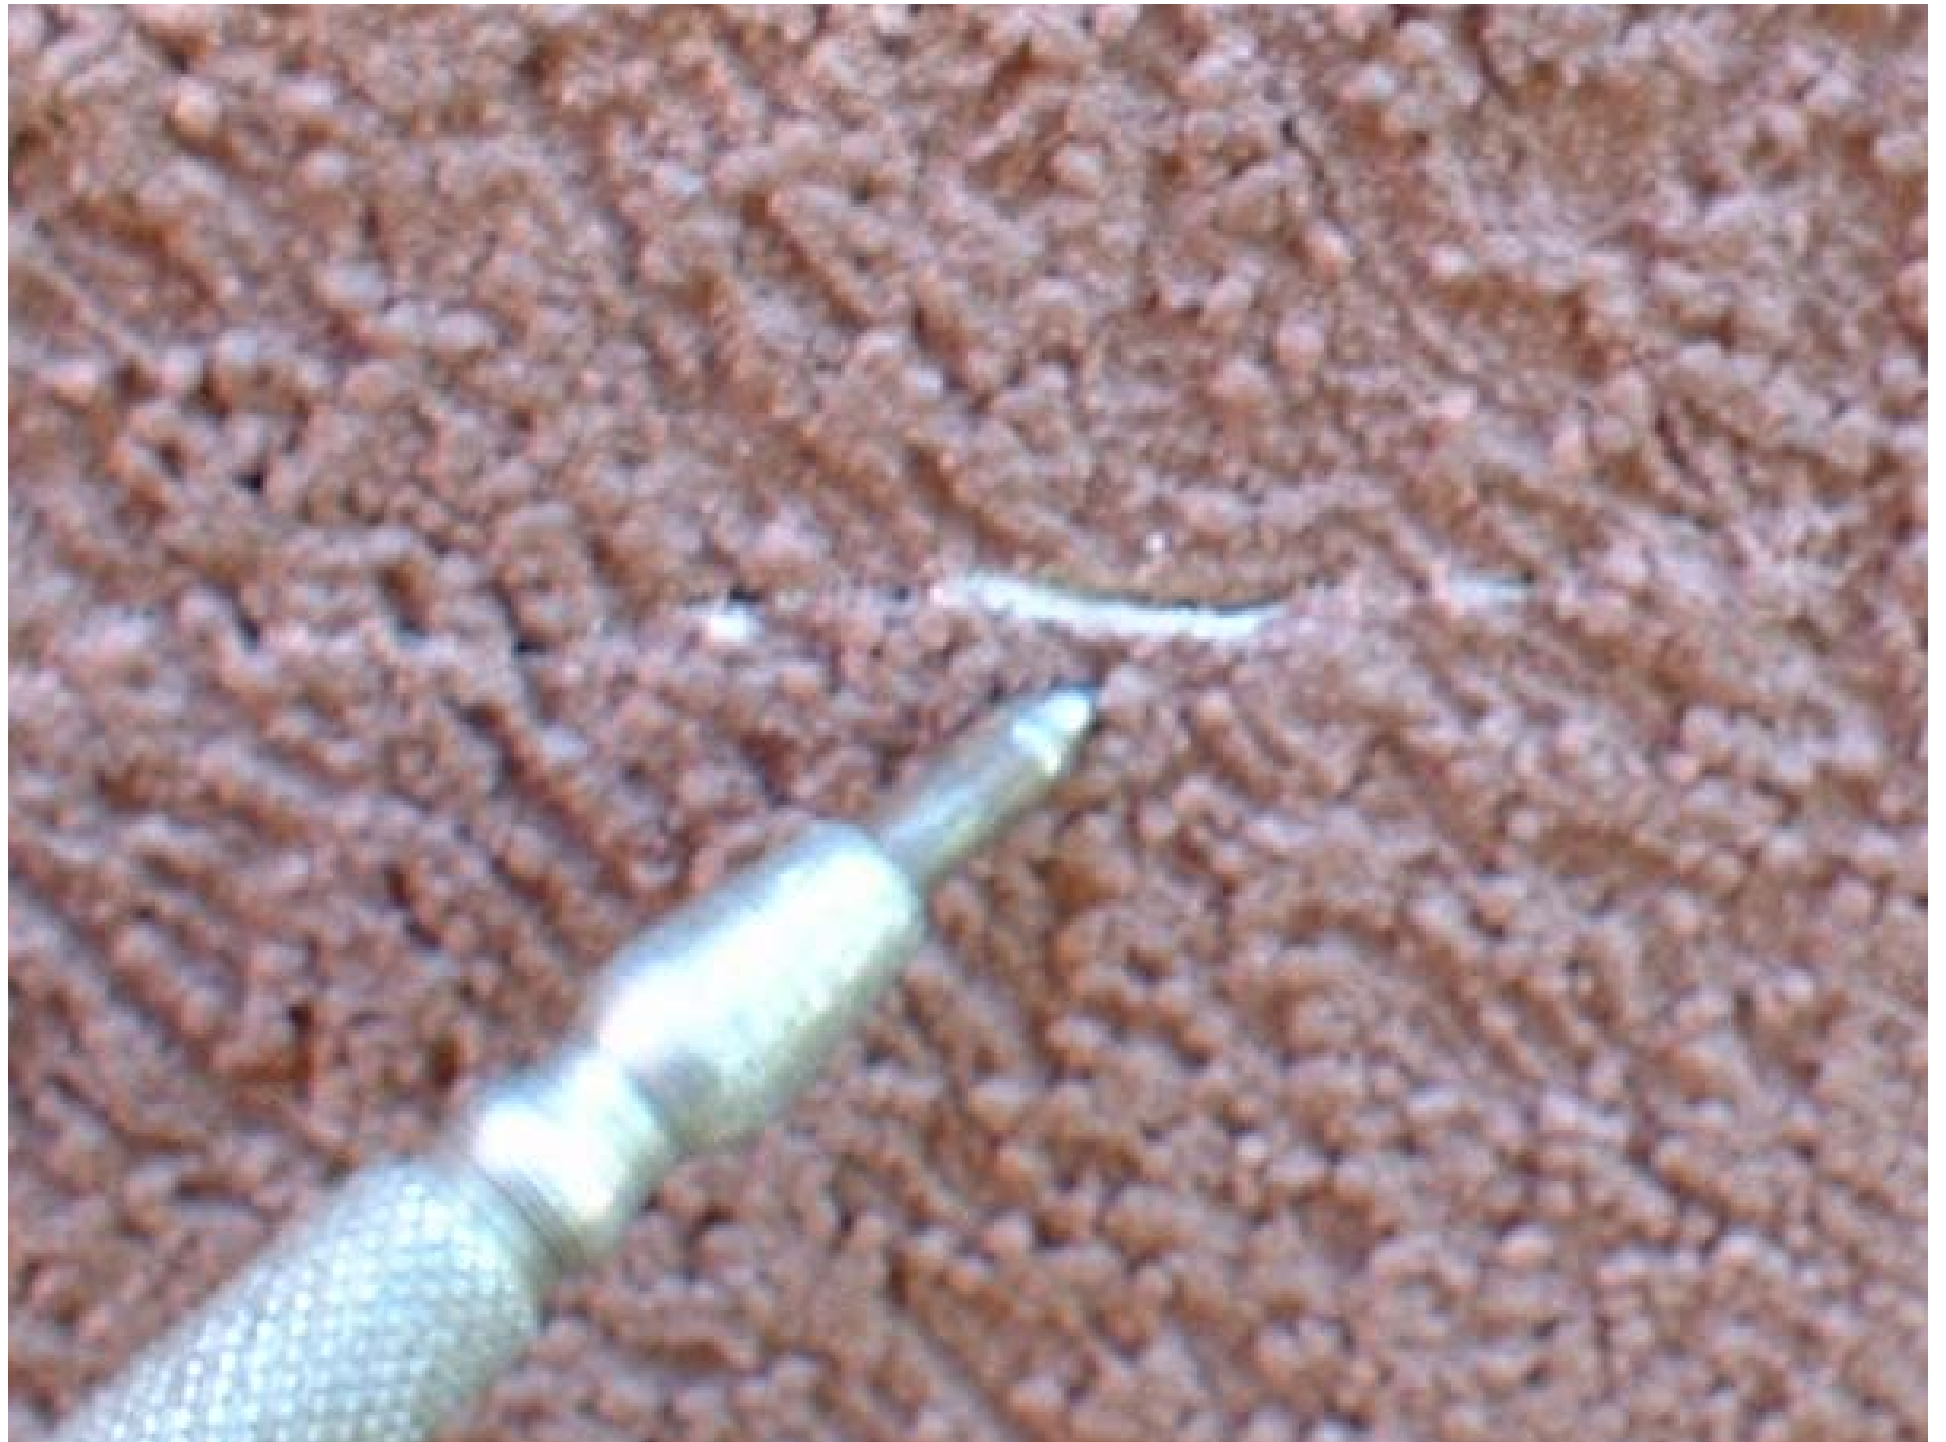
Different Pattern

- Cracks not « open »
- Mid-height of panels
- Mostly on South and East Walls
- Mostly on dark stucco

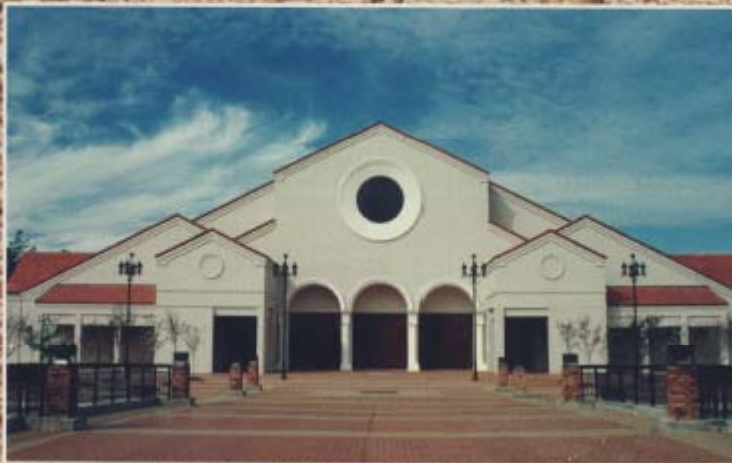
Portland Cement Plaster (Stucco) Manual

17. Horizontal and vertical cracks at metal lath laps.

Improper laps using backed metal lath.

18. Cracking

Poor consolidation

Use lower strength finish coat.

Lap back metal lath with paper to paper and metal over metal.

Correct rodding and floating procedures
