Overseas Curtain Wall: Worth the Trip?

Catherine Lemieux, P.Eng., LEED AP
2010 BCBEC Conference & AGM

- Three projects
 - Jameson House
 - Nassau Airport Expansion
 - Hotel Georgia
- Two Curtain Wall Manufacturers
 - Yuanda Aluminum Industry Engineering Co.
 - Mei Te Curtain Wall System Co.
- Plant Set-Up
- Fabrication Process
- Quality Control
- Mock-Up Testing

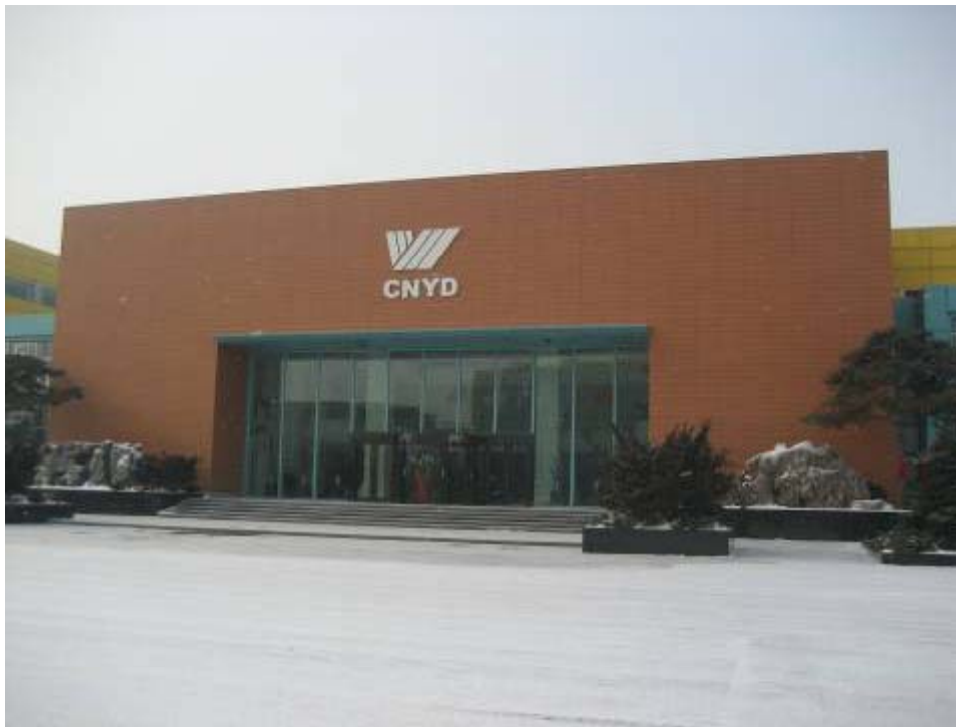
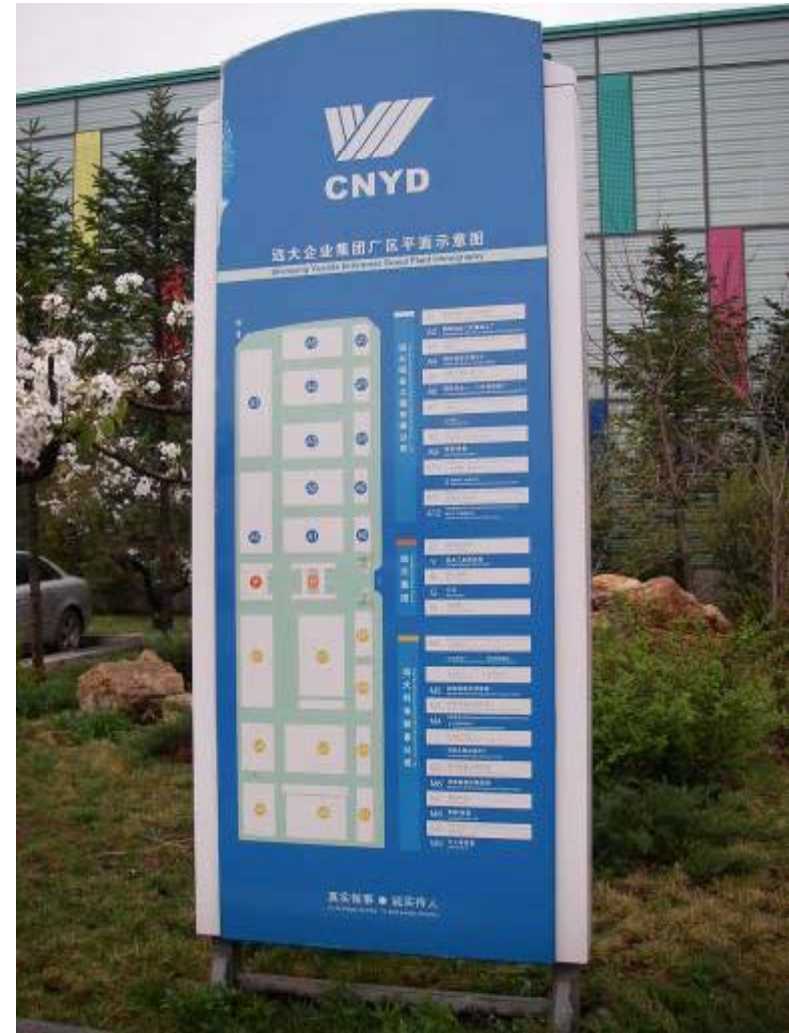
Yuanda's Shenyang Plant

- Many buildings (20 +) make up Shenyang manufacturing base
 - About 80% for CW
 - 20% for other

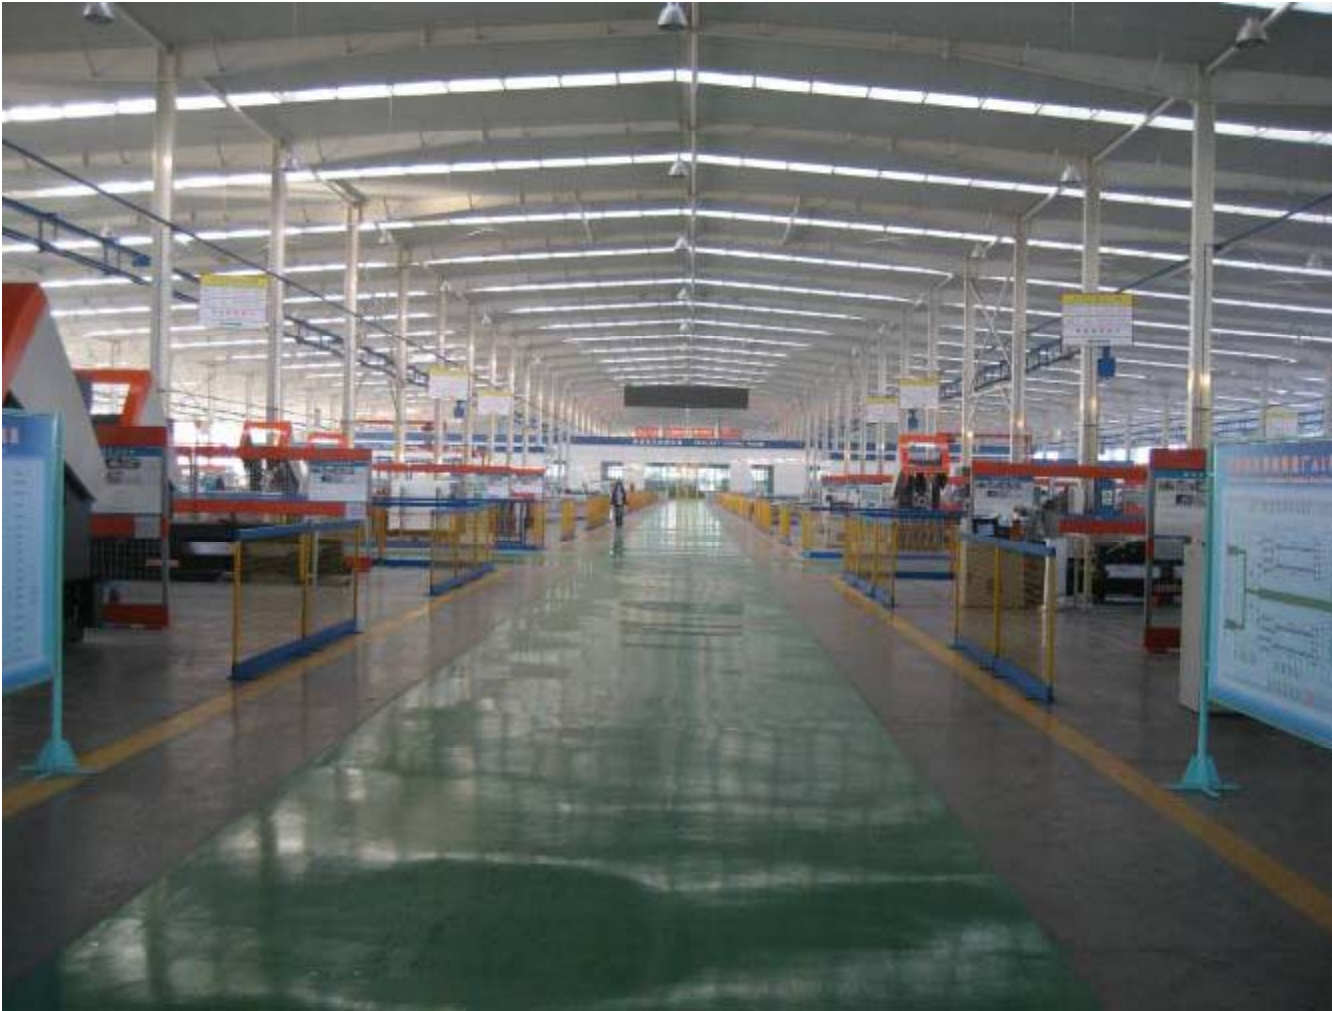
Inside of Yuanda's Plant

- Large, spacious & clean shop
- Organized by project
- Not assembly line
- No overhead equipment

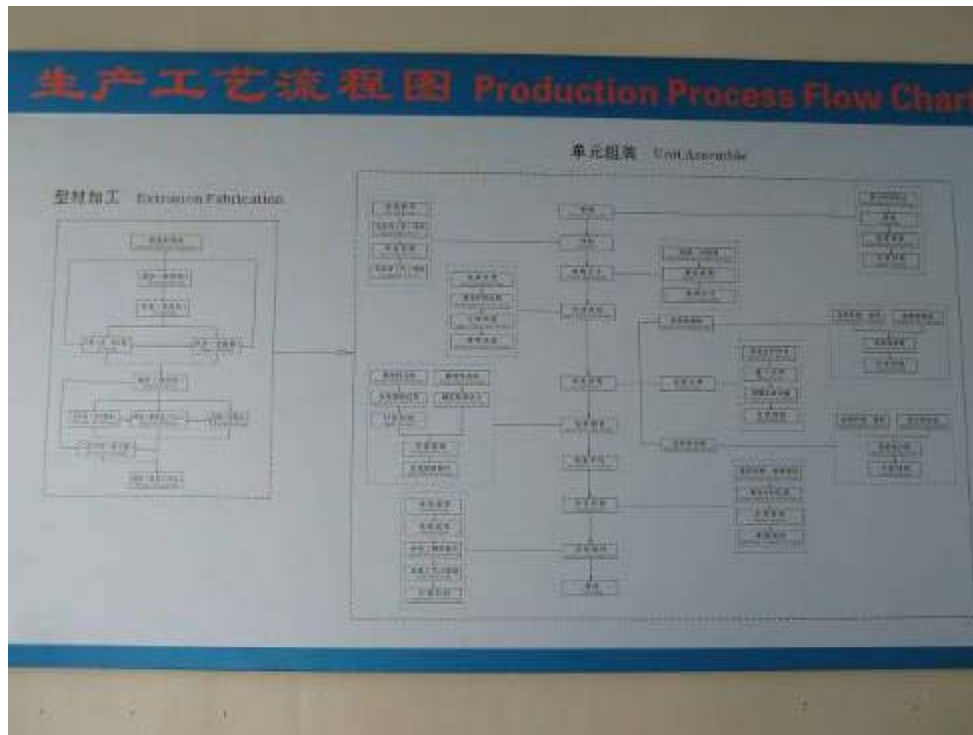
Yuanda's Fabrication Process

- First time design team deals with manufacturer & design engineers → easier to sort out questions / concerns / recommendations in person
- Language barrier is present → alleviated with help of translators & willingness to communicate by all parties
- Units fabricated by drawing → no site measuring

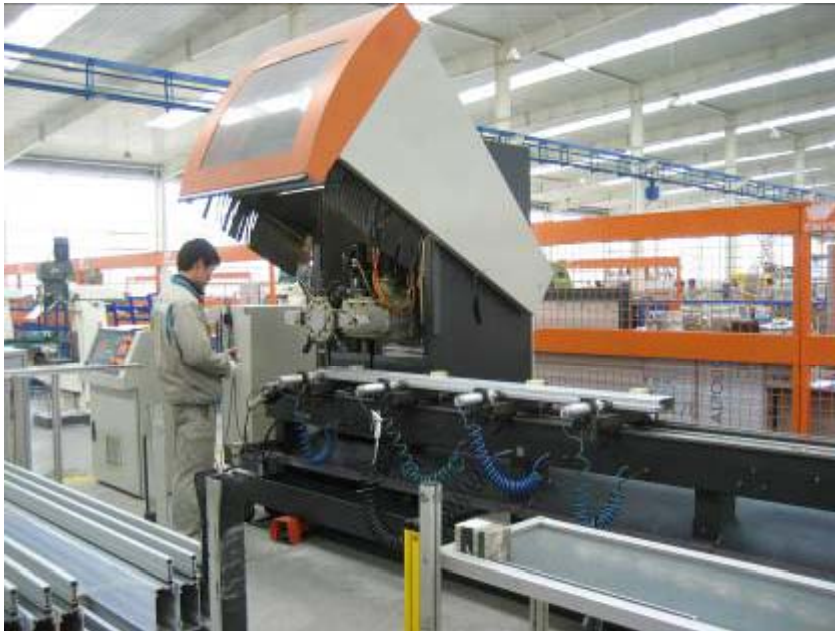
Yuanda's Fabrication Process

- Arrival of extrusions
- Cutting and milling station
 - Separate CNC machines for each task (Germany, Italy, Austria, Netherlands) e.g. → length → corner joinery → weep holes
 - Shop drawing for each step

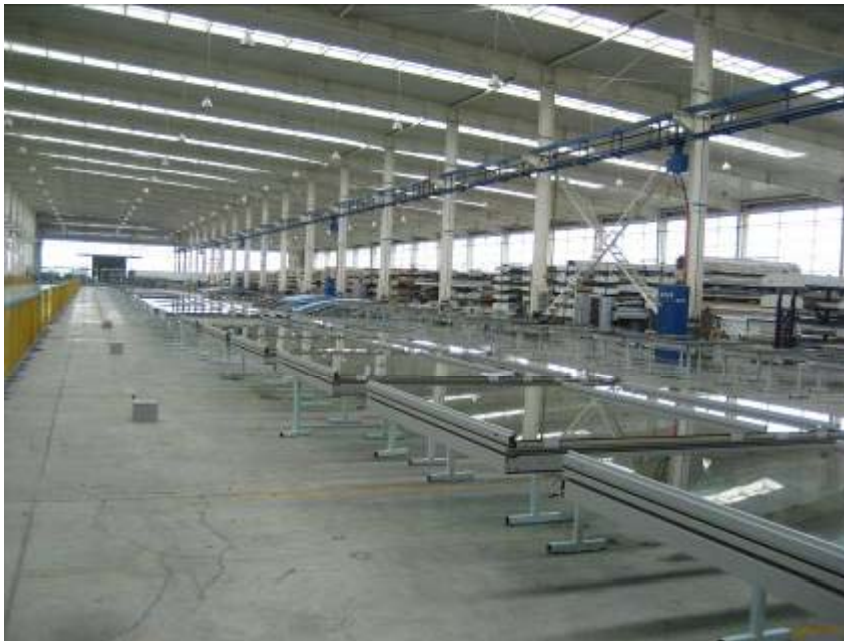
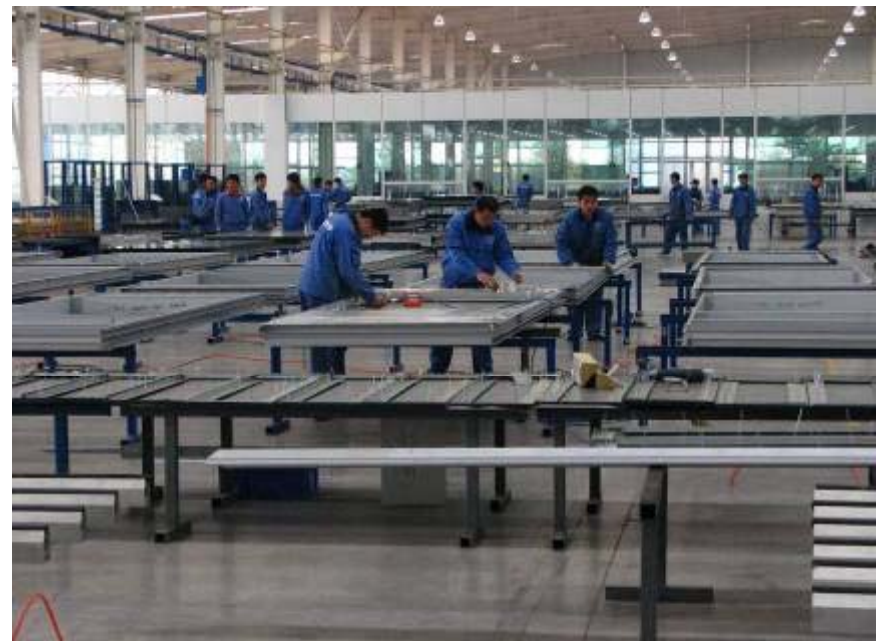
Yuanda's Fabrication Process

- Assembly station
 - Moved by cart
 - Materials brought to each frame
 - More reliance on manual labour, e.g. caulking guns, manual diagonal dimensions vs. jig, IGUs set by hand vs. hoist
 - Labour intensive processes, e.g. masking joints, dots of caulking

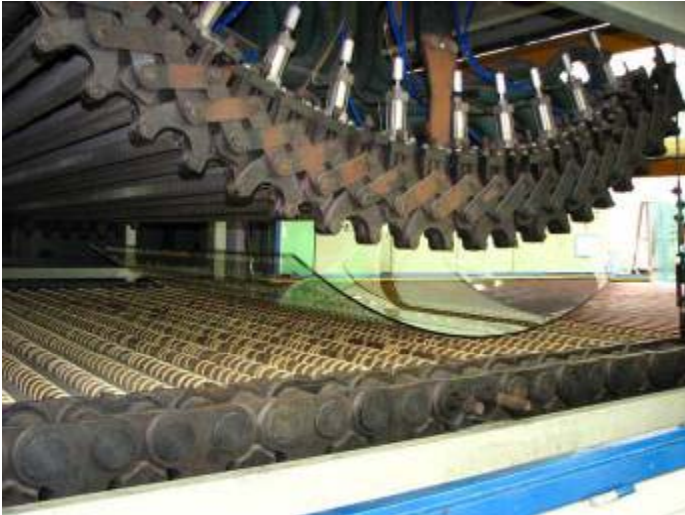
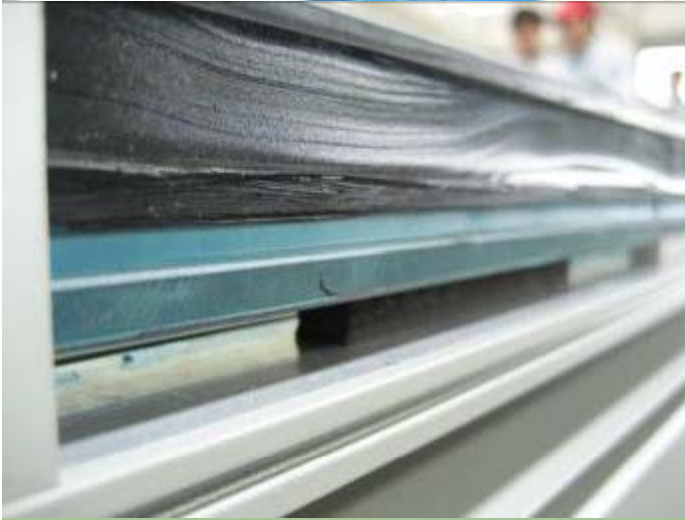
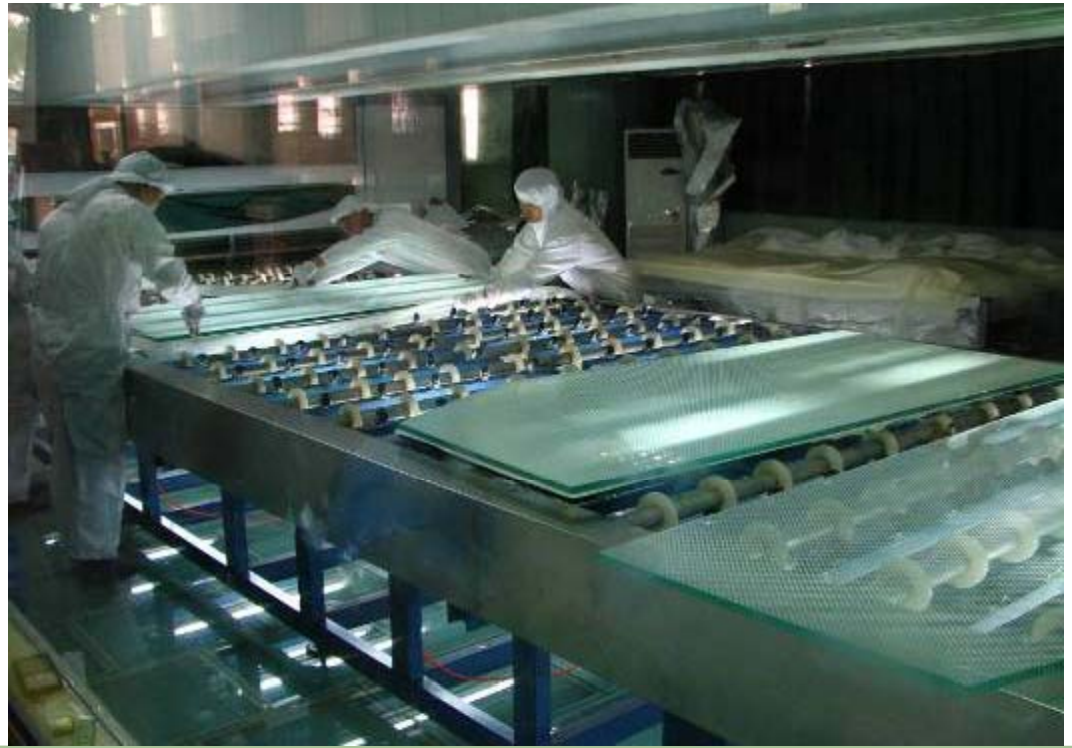
Yuanda's Fabrication Process

- Glass from China
 - Jameson House → Guangdong Golden Glass
 - Nassau Airport → Shanghai Yaohua Pilkington Glass
- Low-e specified is found in North America
- Similar for interlayers

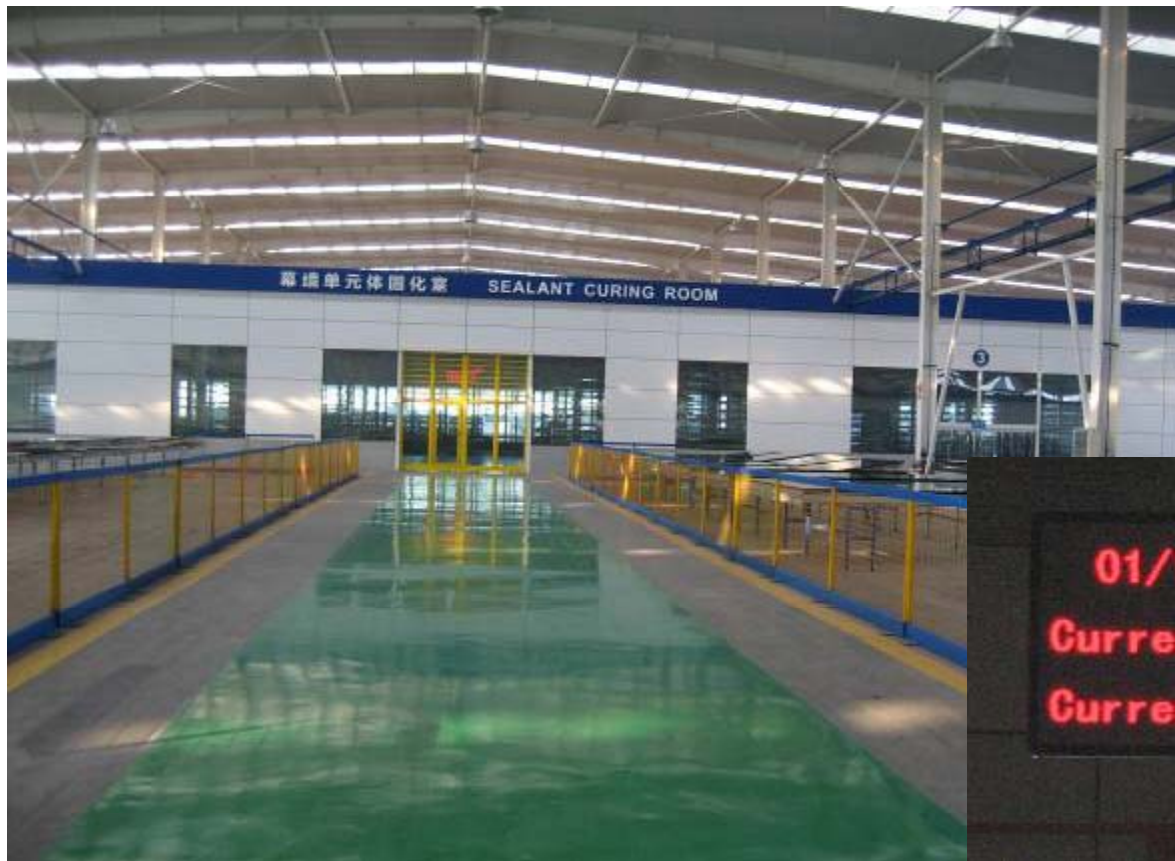
Yuanda's Fabrication Process

- Brand labeled sealants being used
- Sealant Curing Room

01/11/2010 09:48:57
Current Temperatur 18°C
Current Humidity 48%rh

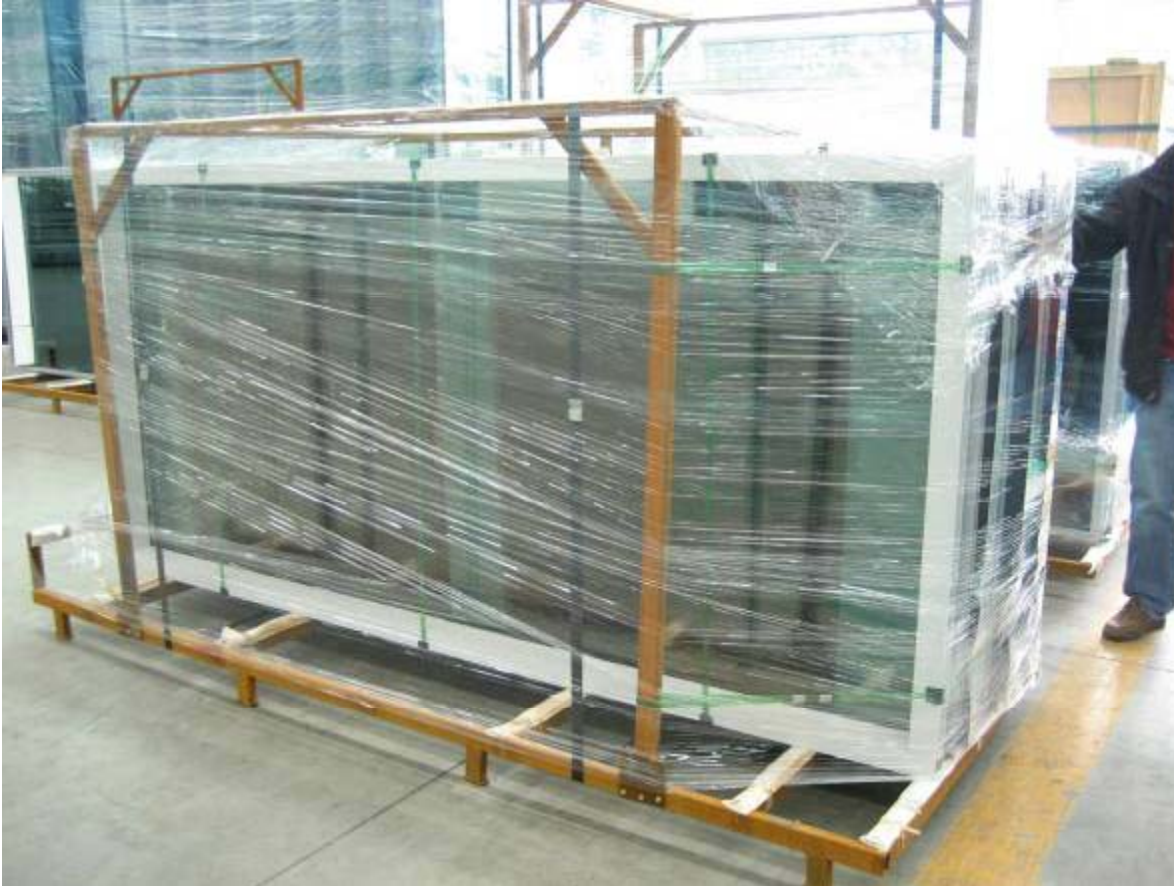
Yuanda's Fabrication Process

- Shipping via container by truck & barge
- Shop drawing of each container and position of each crate
- For Nassau, delivery takes 4 weeks
- Issues with order of arrival

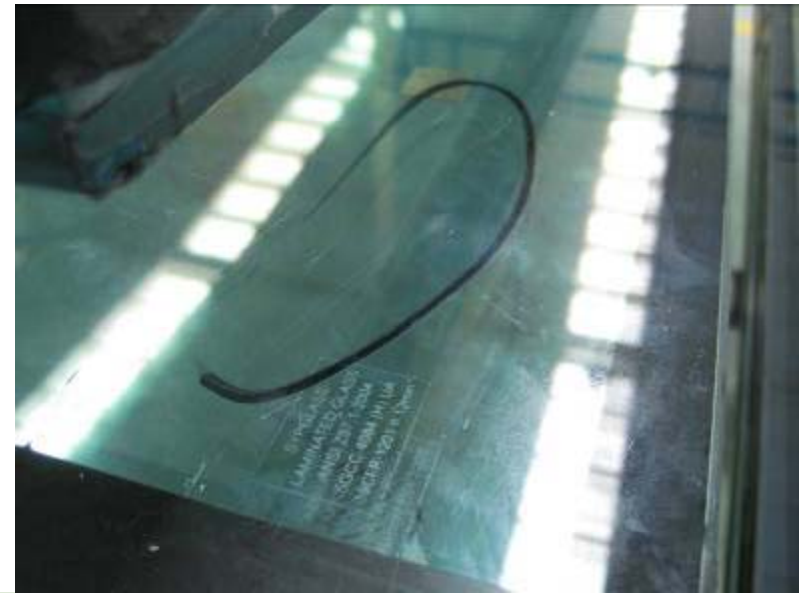
Yuanda's Quality Control

- Extrusion check
 - 10% for dimension, colour, coating, finish, adhesion, uniformity, scratches
- Sealant tests
 - Butterfly & Pull tests at start-up and refill
 - Results documented, photographed, filed for 3 yrs
 - 3 to 5% for SSG adhesion test / deglazing
- IGU check
 - 100% for size tolerance, continuity of perimeter seal, size & location of scratches, presence & location of low-e

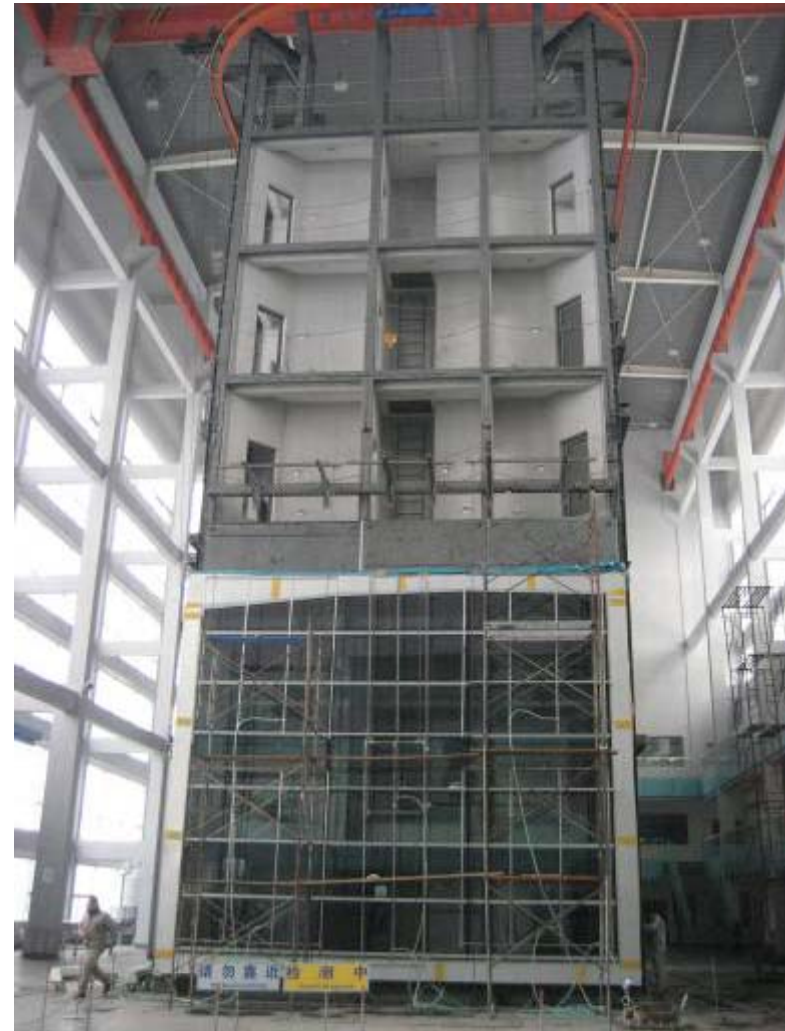
Mock-Up Testing at Yuanda

- Shenyang Kezheng Construction Engineering Testing Co., Ltd. (SKCET)
- Independent lab
- Indoor facility, allowing multiple mock-ups at same time, 5 stories high
- Good knowledge of common ASTM / AAMA
- Not so much for Miami-Dade → 3rd party agency
- Unheated facility – affected some tests

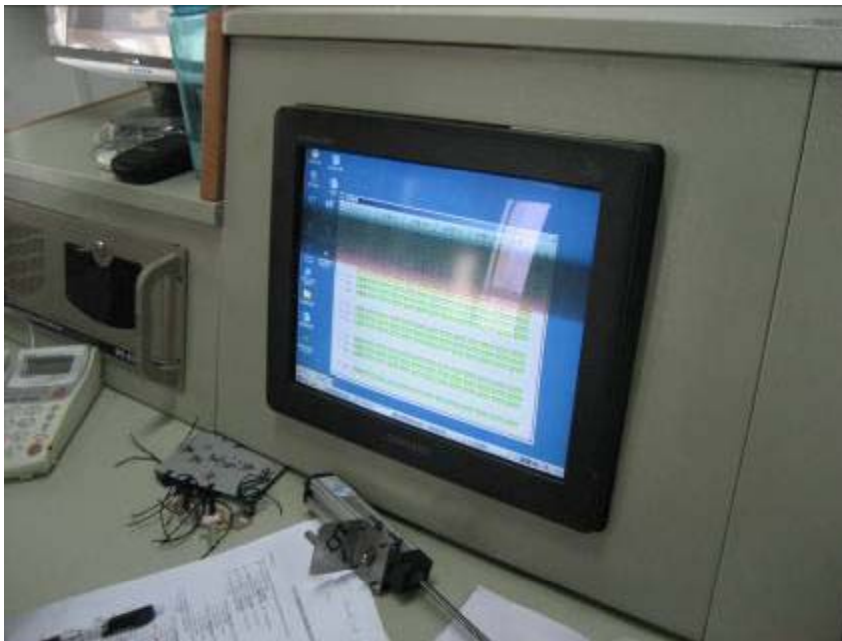
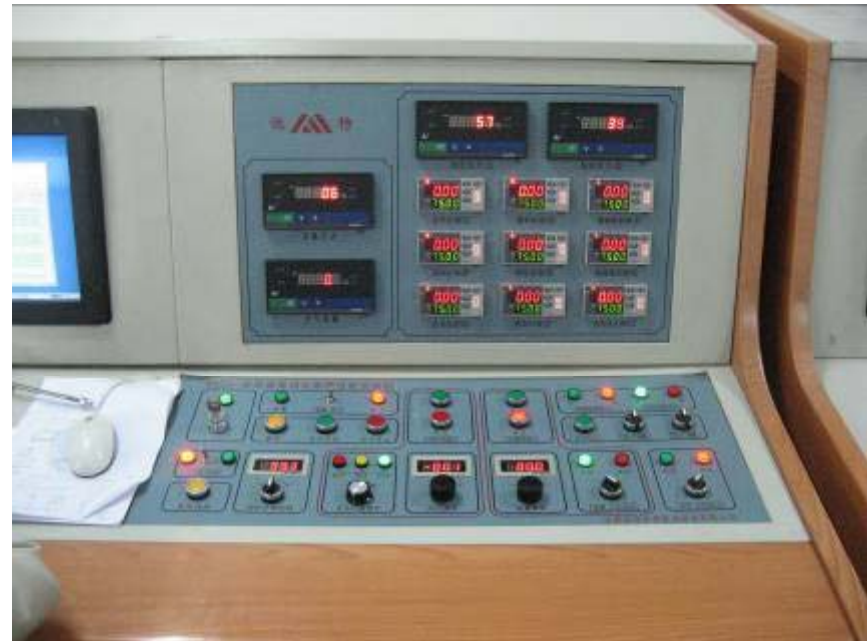
Mock-Up Testing at Yuanda

- System control and measurements centralized in control rooms
 - Pressurization fans
 - Electronic meters for pressure, flow and linear transducers
- Data saved in spreadsheet format
- SKCET issues their own lab report

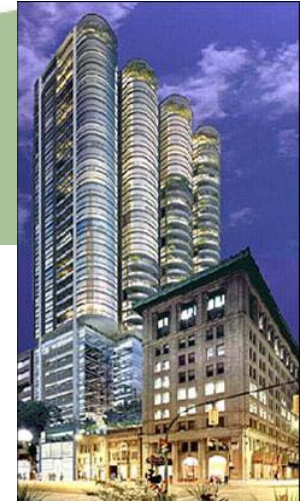
Mock-Up Testing at Yuanda

- Mock-up for Jameson House consisted of:
 - Two stories high
 - Straight and curved sections
 - Deck interface

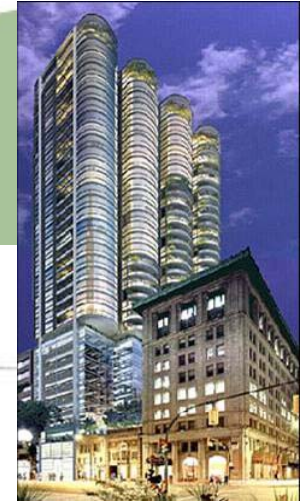
Mock-Up Testing at Yuanda

Deck above

Full glazing below

- Intent was to test 3D deck slab – curtain wall interface
- Issues with mock-up:
 - Missing waterproofing at deck
 - Deck construction was sheet metal welded to top of steel frame
 - Sheet metal inserted after mock-up constructed
- Results:
 - Water leakage at interface of CW outside the slab, of deck junction and inner deck wall
 - Site condition not tested
- Recommendation:
 - Field mock-up to confirm performance of WP transition

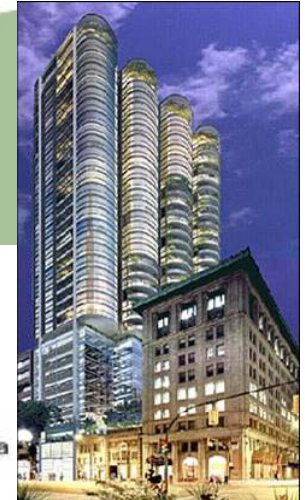
- Testing to ASTM and AAMA standards per projects specs and VBBL
- Results: CW met criteria
- Of note:
 - Water leakage at deck interface and at chamber connection throughout
 - After repeat E330 at 1.5 x design wind pressure, three vertical split mullions had joint widen to 5 mm between floors though transducers said 1 mm

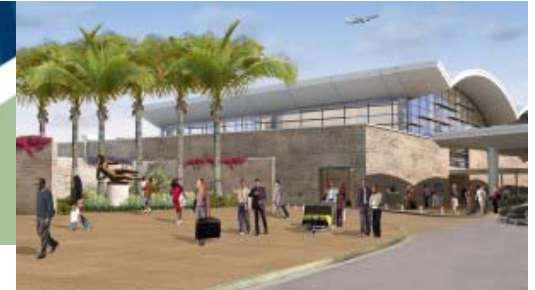
Mock-Up Testing at Yuanda

- Mock-up for Nassau Airport consisted of:
 - Three 8-ft wide panels, with max height of 20 ft
 - No stack joint or operables
 - Selected because tallest span for project

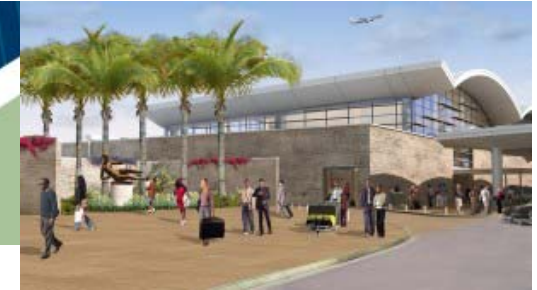
Mock-Up Testing at Yuanda

- Test sequence to meet project specs and Miami-Dad County requirements

- Uniform Static Load Test ASTM E330 was ok until positive proof load (105 psf or 5030 Pa)
 - Structural attachment of sill track to chamber failed
 - Caused CW to buckle in and decouple vertical mullion
 - Investigation: undersized fasteners
- New fasteners and sill track
- Qualify fix with ASTM E331 and Restart ASTM E330

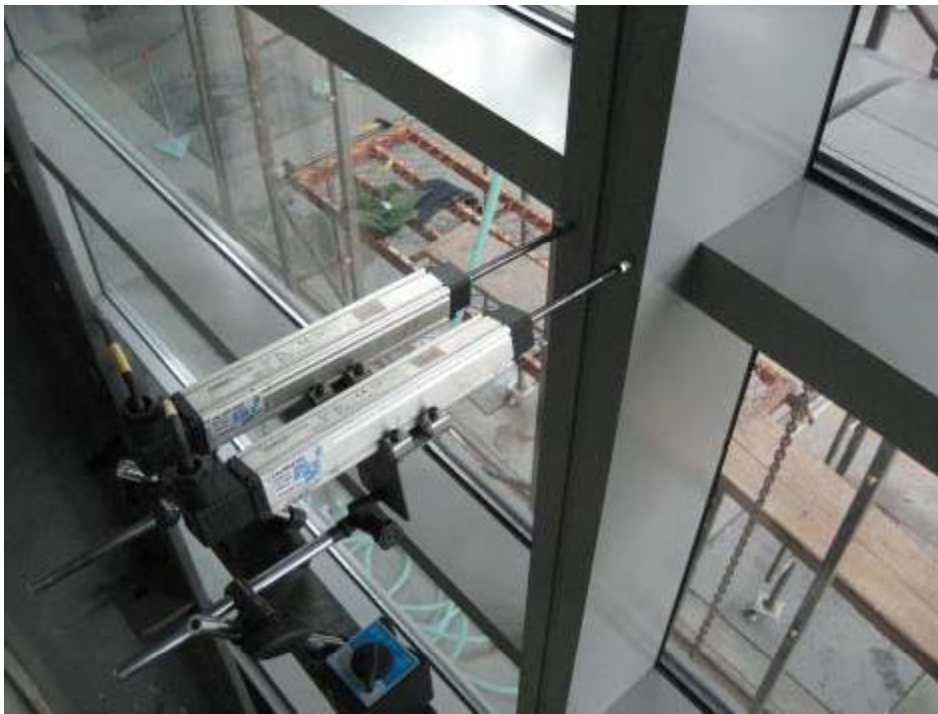
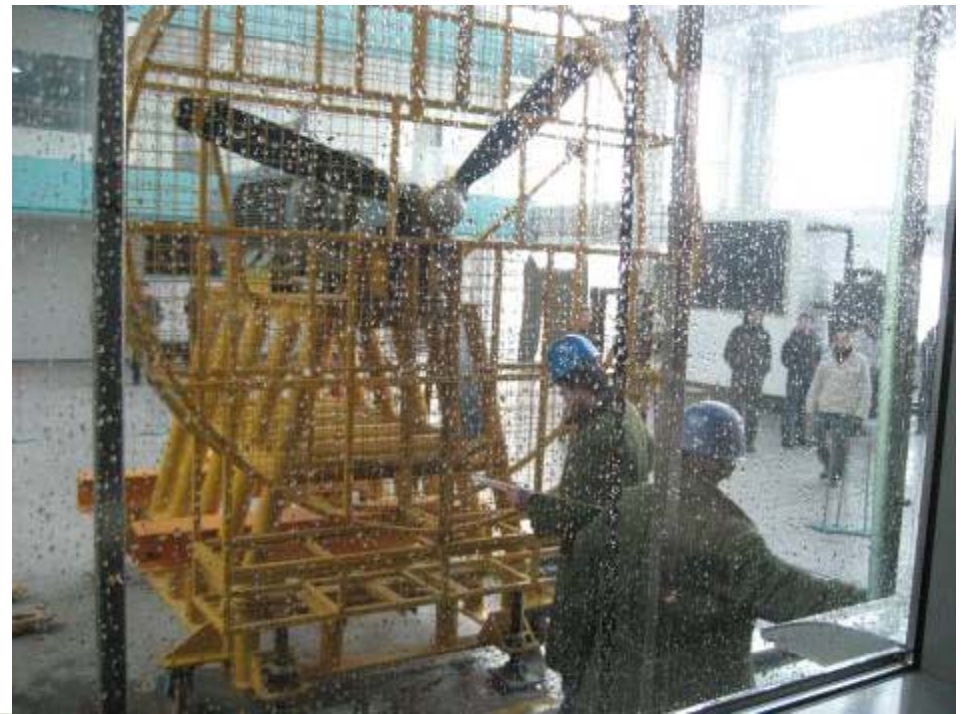
Mock-Up Testing at Yuanda

- SKCET familiar with more standard ASTM / AAMA tests, not so much with Miami-Dade requirements
- Thermal testing and associated air & water tests not done: → 10-day lead time → temperature
- Calibration of fans, transducers, spray racks, etc., all checked before testing
- Water test had leaks at chamber itself and chamber connection throughout test, but not affecting CW

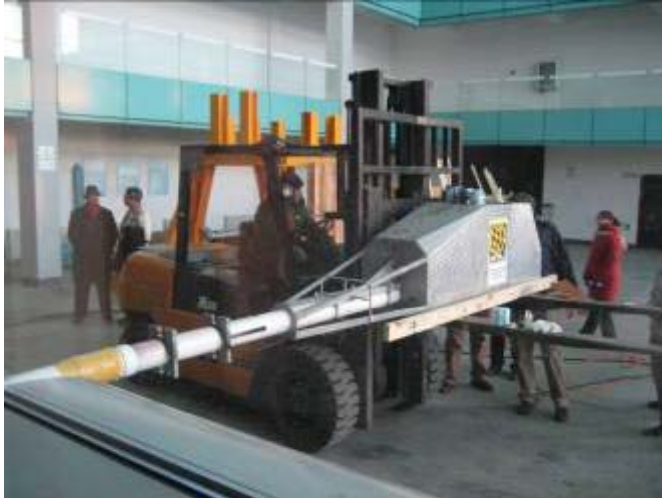
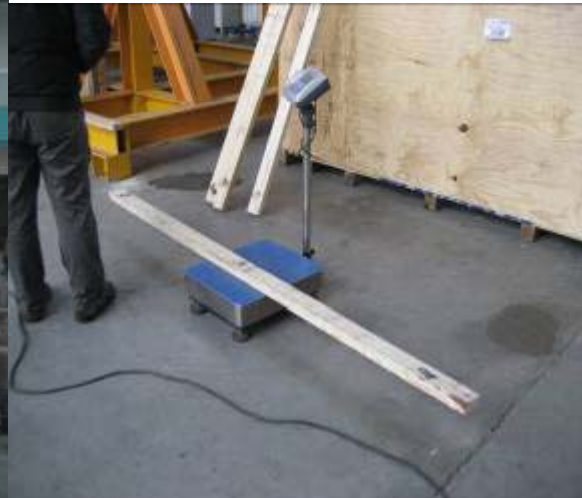
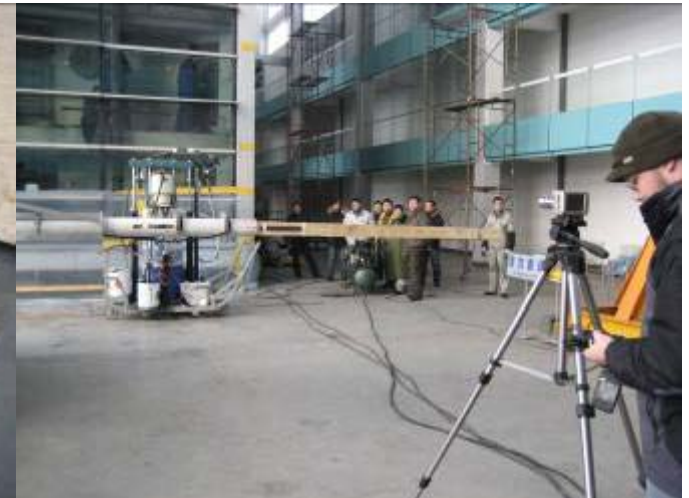
- ASTM E 1886 / E 1996: Performance of Exterior Windows, Curtain Wall, Doors and Impact Protective Systems Impacted by Missile(s) and Exposed to Cyclic Pressure Differential
- Consists of three parts:
 - Small Missile Impact Test
 - Large Missile Impact Test
 - Cyclic Load Test

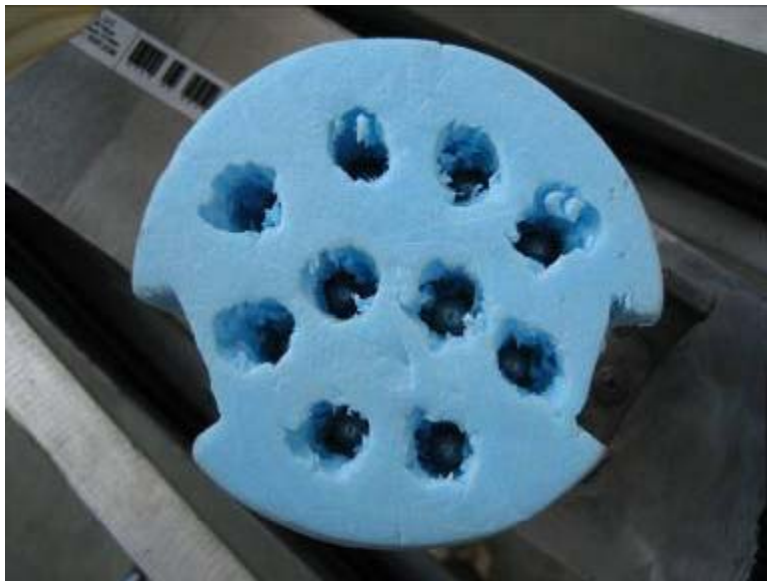
Specimen 3

- Small Missile Impact Test: to test the IGUs with 0.06" thick interlayer (1.28 PVB), for units located at 30 ft and higher above grade

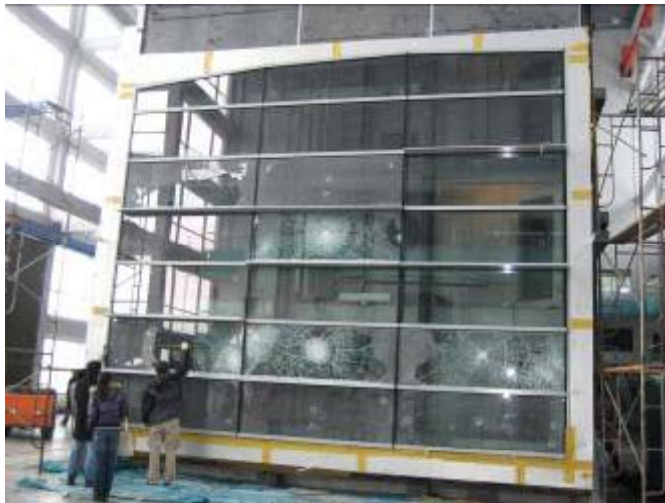
- Cyclic Load Test: to verify that the IGUs withstand cyclical induced positive and negative pressures
- Pass / Fail Criteria: “the test specimen shall resist the large or small missile impacts, or both, with no tear formed longer than 130 mm (5 in.) and wider than 1 mm (1/16 in.) through which air can pass, or with no opening formed through which a 76 mm (3 in.) diameter solid sphere can freely pass when evaluated upon completion of missile impacts and test loading program” (ASTM E 1996 – 09)
- Results: Mock-up met criteria

A screenshot of a computer screen displaying test results for Program #1. The screen shows a table with columns for Stage #, Cycles, Cycles, Min, and Max. The data is as follows:

Stage #	Cycles	Cycles	Min	Max
1	2500	85	14,000	35,000
2	300		0,000	42,000
3	600		35,000	56,000
4	100		21,000	70,000
5	50		18,000	60,000
6	1050		20,000	48,000
7	50		0,000	36,000
8	1350		12,000	30,000

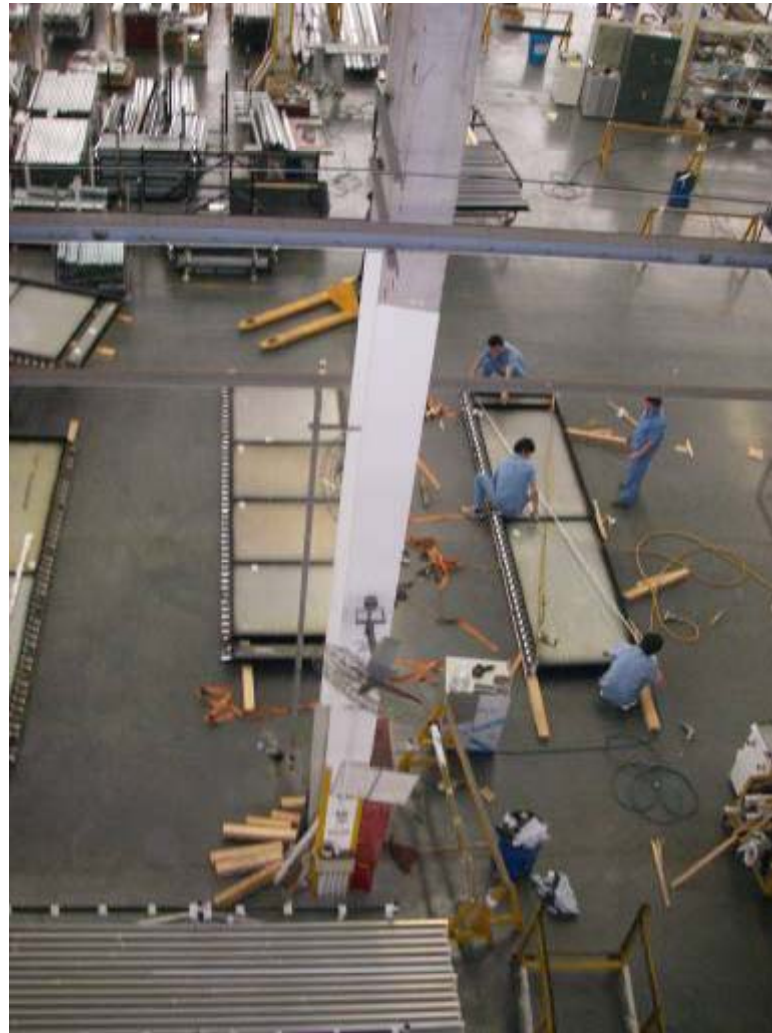
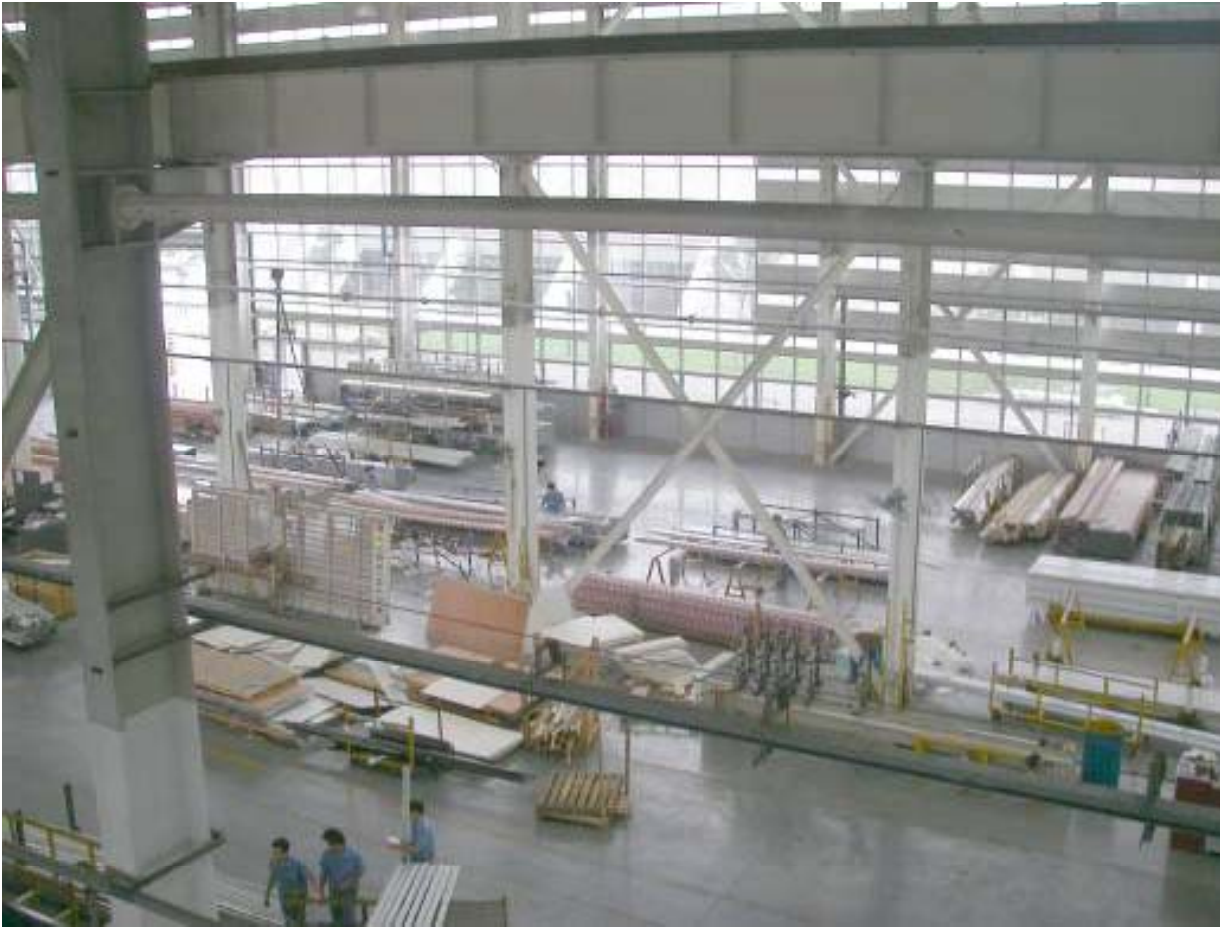
Inside of Mei Te's Plant

- One shop for all projects
- Divided by work station rather than assembly line
- All projects go through same stations
- Different standards for different projects in same space – potentially causes some issues with fabrication requirements
- More used to building CW for warm climate – design considerations needed to be discussed

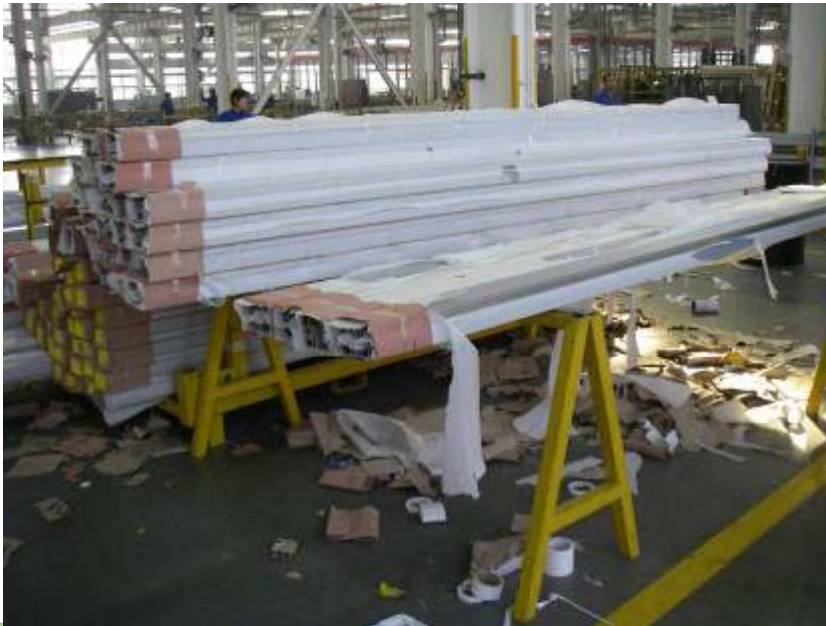
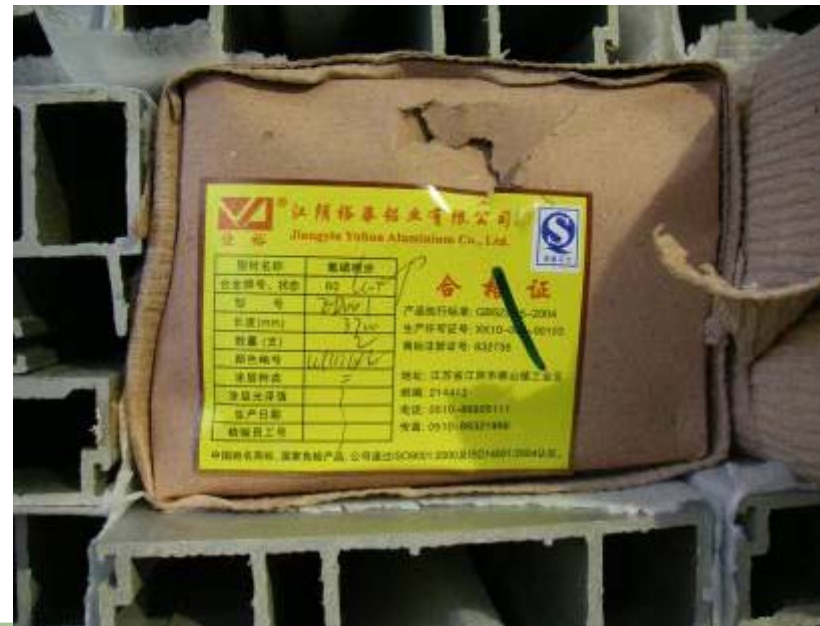
Mei Te's Fabrication Process

- Arrival of extrusions
 - Mei Te removes protective covering to inspect extrusions and then recovers them
 - Due to issues with unacceptable extrusions and finishes in the past
- Cutting and milling station
 - Modern CNC machines, from Europe

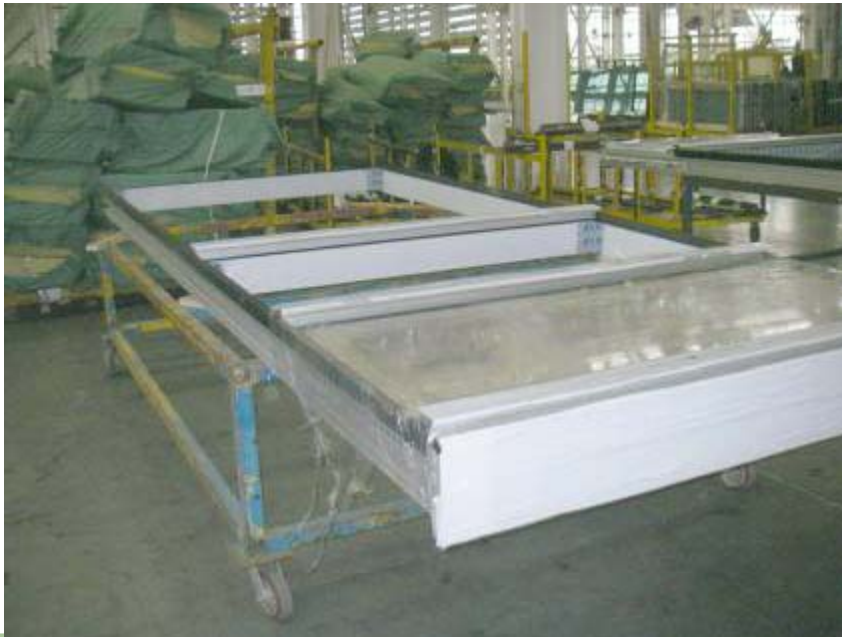
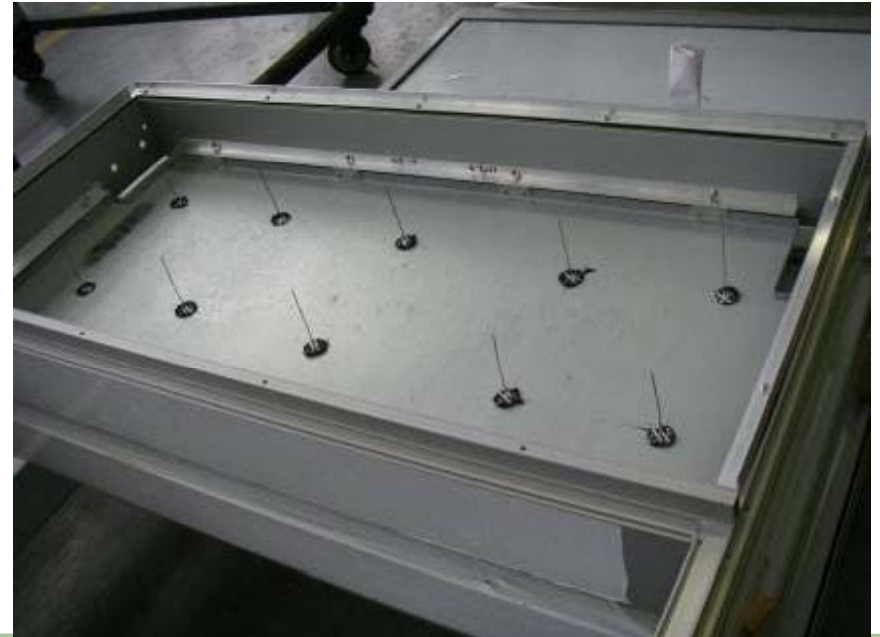
Mei Te's Fabrication Process

- Assembly station
 - Frames fabricated at work station
 - Moved by cart to next station for insulation and backpan
 - Also more reliance on manual labour, e.g. caulking guns, manual diagonal dimensions vs. jig, etc.

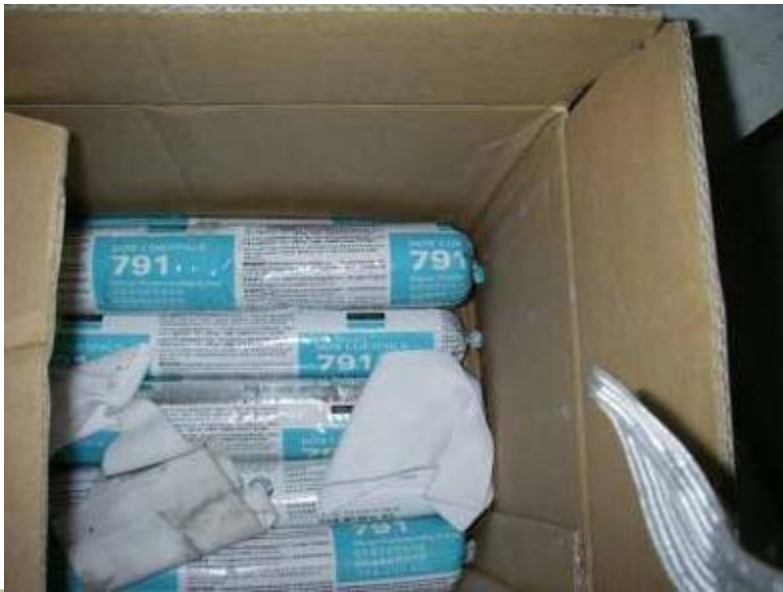
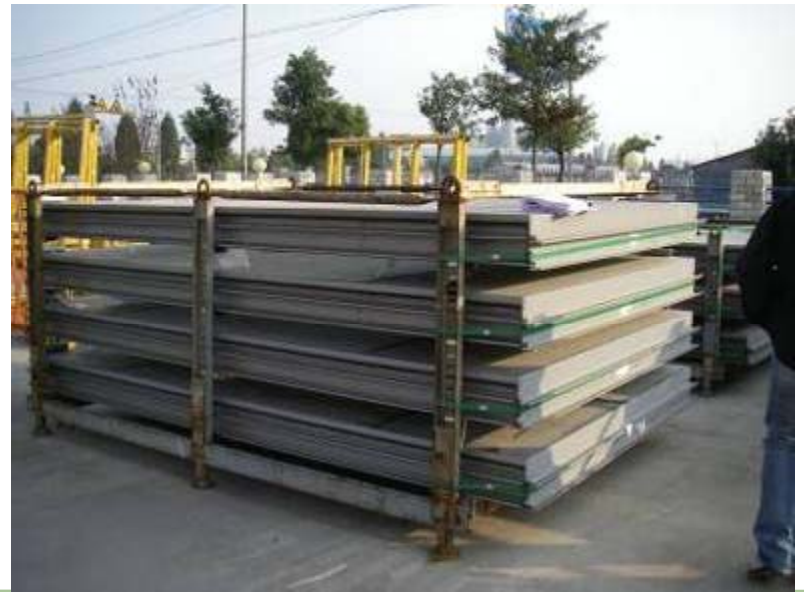
Mei Te's Fabrication Process

- Sealant:
 - Brand labeled sealants being used (QC)
 - Sealant applied in a climate controlled chamber, but curing is in uncontrolled plant
- Packaging:
 - Schedule too tight – IGUs will be done in Vancouver
 - Shrink wrap is installed over backpan insulation where spandrel glass is missing.
 - Units crated horizontally, separated by an air gap
 - Miscellaneous parts temporarily attached for shipping wherever possible
