Overseas Curtain Wall: Worth the Trip?

Catherine Lemieux, P.Eng., LEED AP
2010 BCBEC Conference & AGM

- Three projects
 - Jameson House
 - Nassau Airport Expansion
 - Hotel Georgia
- Two Curtain Wall Manufacturers
 - Yuanda Aluminum Industry Engineering Co.
 - Mei Te Curtain Wall System Co.
- Plant Set-Up
- Fabrication Process
- Quality Control
- Mock-Up Testing

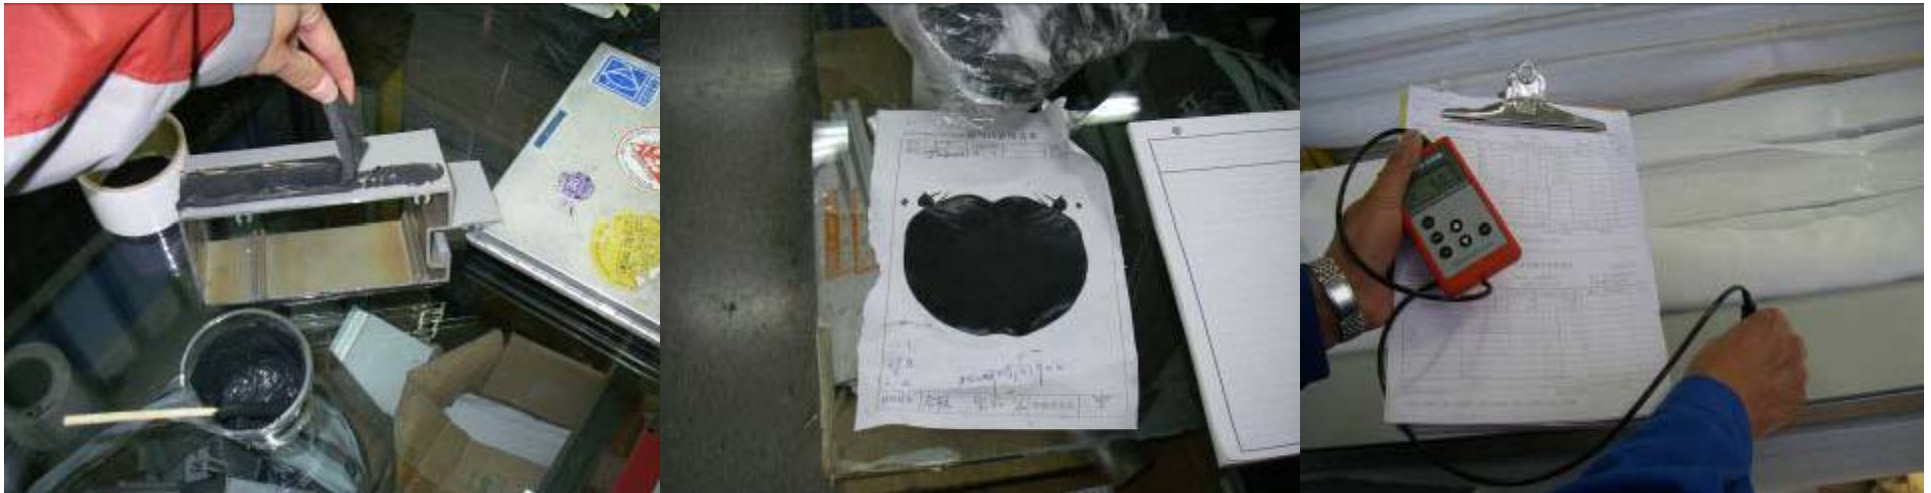
Mei Te's Quality Control

- **Extrusion check**
 - Every extrusion visually checked
 - 2% for coating thickness measurement
 - 5% for coating adhesion tests
 - Extrusion inspection report includes: surface hardness, visual defects, extrusion thickness, straightness and twist
- **Sealant tests**
 - Butterfly, Pull & Adhesion peel tests at start-up and refill
 - No deglazing was being done
- **Glass check**
 - 100% for chips, spalls and continuity of perimeter seal
 - 2 to 3% for size, roller wave, distortion, etc.
 - Results written on inspection form
