## 2014 BCBEC Conference & AGM

# “Wetting and Drying of Exterior Insulated Walls”

## The Coquitlam Test Hut

### A Building Enclosure Research Facility

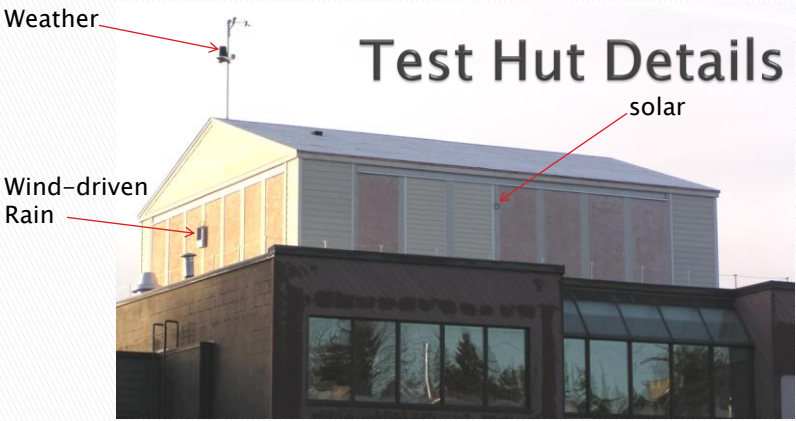
## Test Hut Details

- ▶ 7 Wall assemblies each orientation (x4)
- ▶ 3 Roof assemblies each orientation (x2)
- ▶ Full weather station

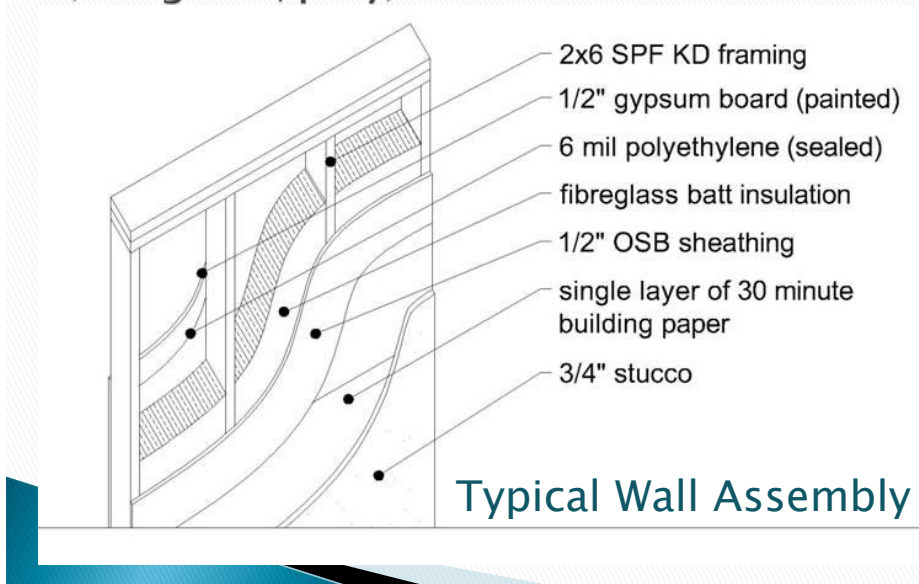
### 1980s Energy Efficient 2x6 (airtight w/poly)

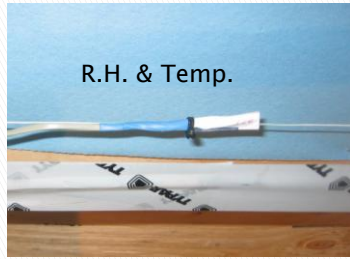
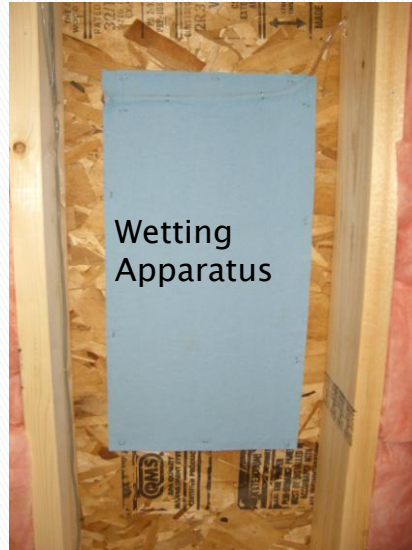
# Sensors & Wetting Systems

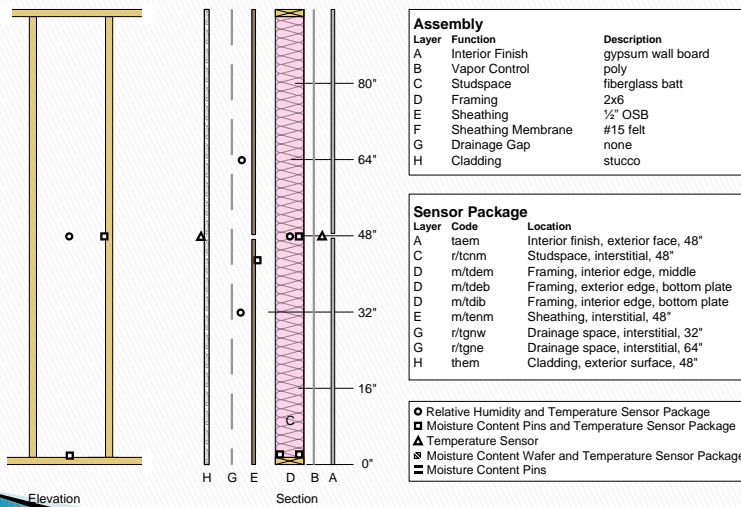
# Typical Sensor Layout

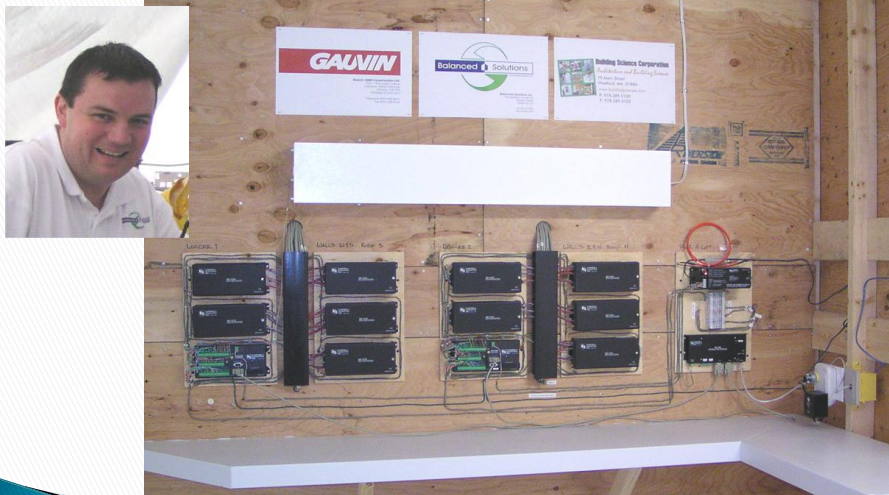
## Data Collection

Design by Chris Schumacher, Bldg Science Labs

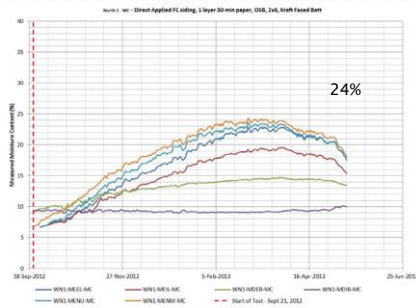
## OSB Sheathing Moisture Content Phase 4 – Indoor at 50% RH, 21° C.

Wall 1 – North  
Control (no exterior insulation)

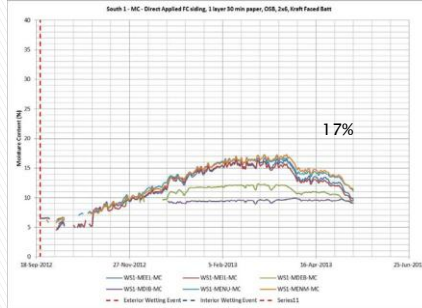
Wall 1 – South  
Control (no exterior insulation)

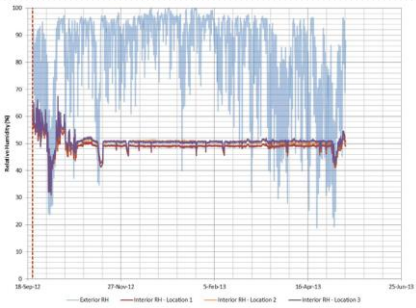
Interior RH at 50%  
Ambient RH (blue)

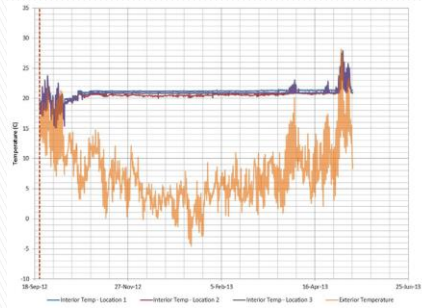
Interior Temp. at 21° C.  
Ambient Temp. (orange)

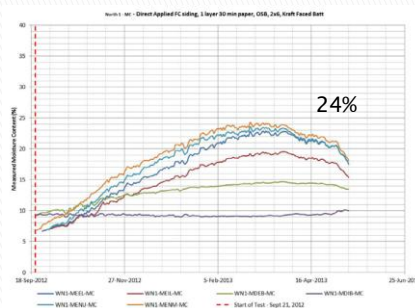
## OSB Sheathing Moisture Content Phase 4 – Indoor at 50% RH, 21° C.

Wall 1 North  
Control (no exterior insulation)

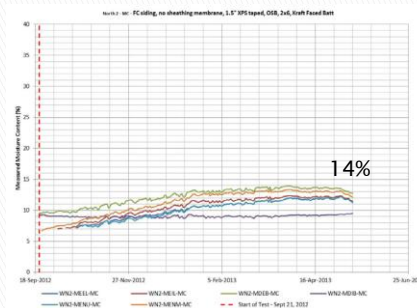
Wall 2 North  
1½” XPS Foam to exterior

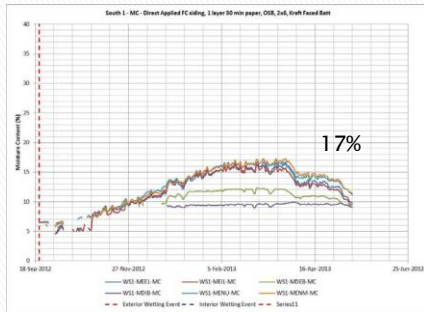
Wall 1 South  
Control (no exterior insulation)

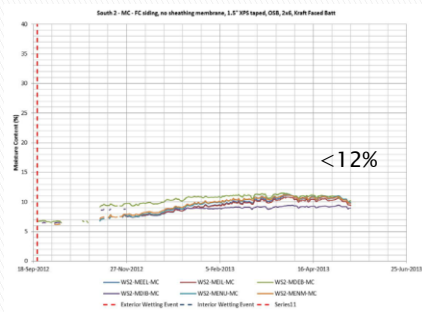
Wall 2 South  
1 1/2" XPS Foam to exterior

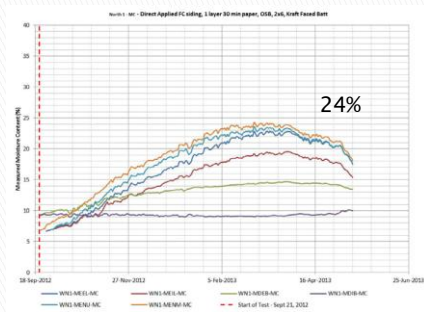
Wall 1 North  
Control (no exterior insulation)

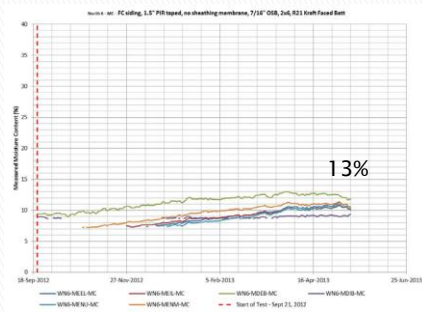
Wall 6 North  
1 1/2" F.F. Polyiso Foam to exterior

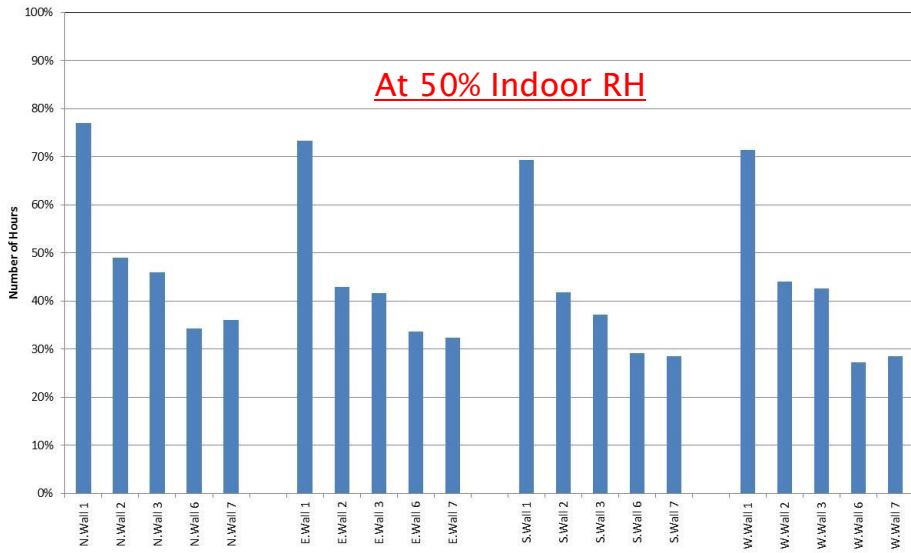
**Potential Air Leakage Condensation Oct 1, 2012 - May 1, 2013 - 5087 hours**  
 (measured sheathing temperature and measured interior dew point, 50% interior RH)

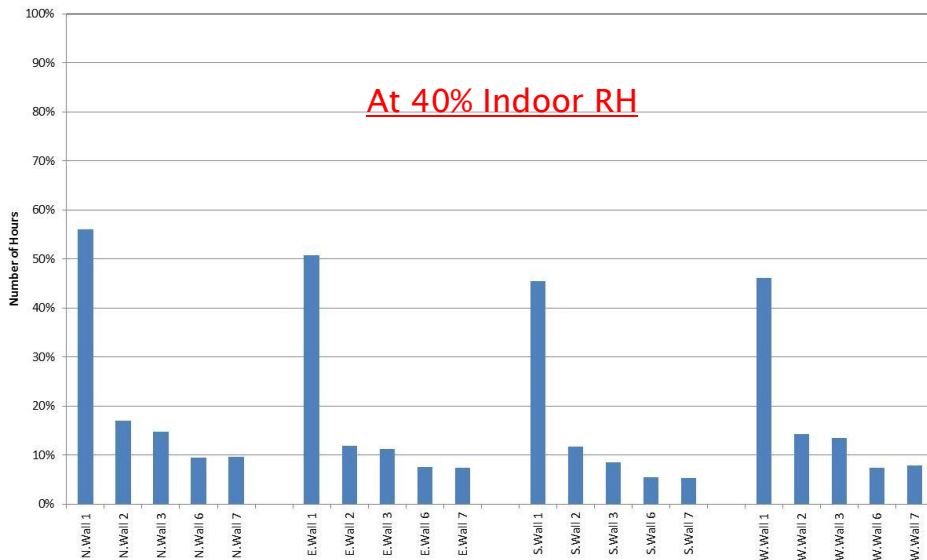
**Potential Air Leakage Condensation Oct 1, 2013 - May 1, 2014 - 5087 hours**  
 (measured sheathing temperature and measured interior dew point, 40% interior RH)

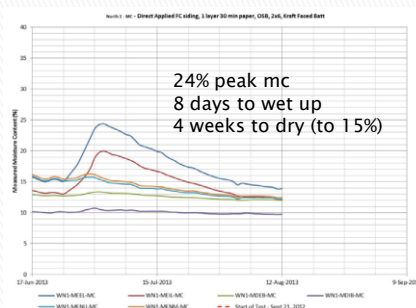
### 1<sup>st</sup> Wetting June 24, 2013

1½ oz. water twice per day x 5 days

Wall 1 North  
Control (no exterior insulation)

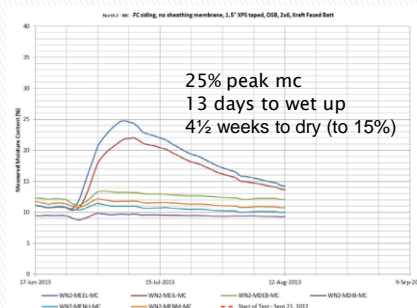
Wall 2 North  
1½" XPS foam to exterior

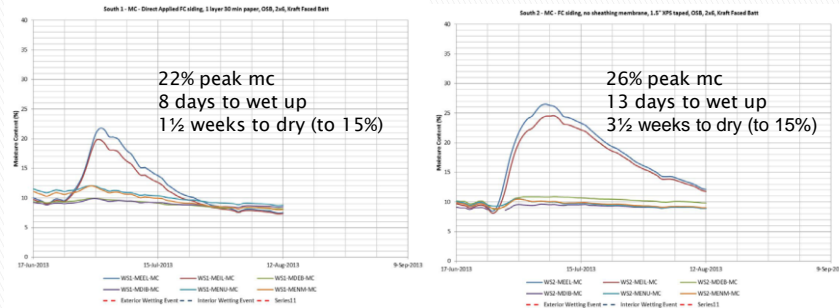
# 1<sup>st</sup> Wetting June 24, 2013

## 1 1/2 oz. water twice per day x 5 days

**Wall 1 South**  
Control (no exterior insulation)

**Wall 2 South**  
1 1/2" XPS foam to exterior
