Curtain Wall Failures & Methods of Retrofit

Rob Wood, P.Eng.

**C3 POLYMERIC**
curtain wall retrofits

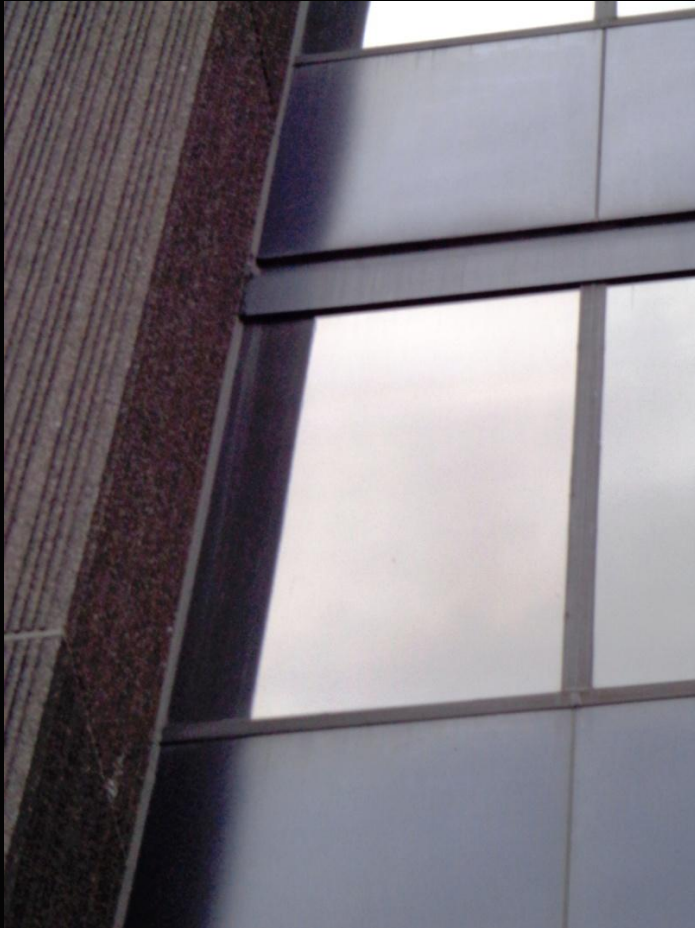
Tower

1. Single, interior glazed vision units
2. Unitized system
3. Installed prior to precast
4. Spandrel areas designed to be drained / vented
5. Face sealed post construction
6. Window film on interior

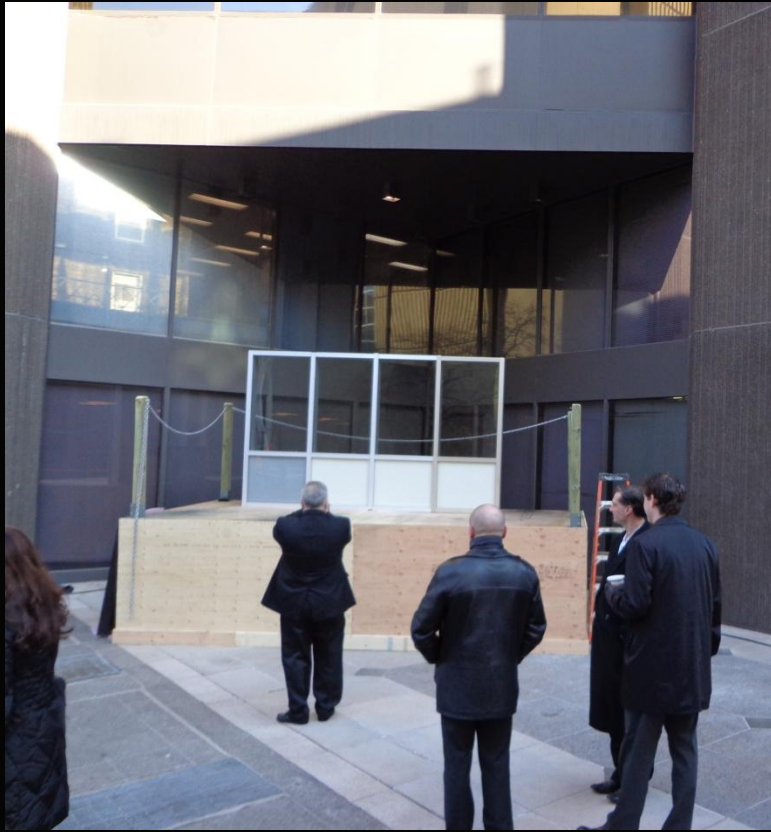
Mockups, Dec-2012

1. 4 types of IGU, spandrel glass, snap cap

IGUs:	Bronze HS, Clear Solarban 60 (3) Temp
Spandrels:	Signal Grey
Caps:	Champagne

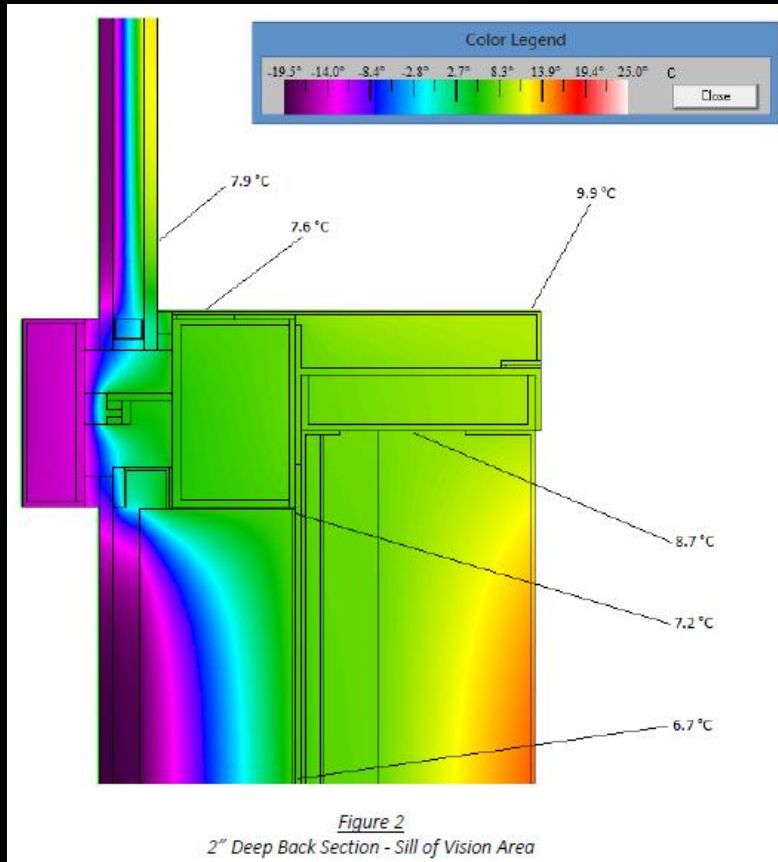
Thermal Analysis #02: 10-Jun-2013

2" Deep Back Section	3" Deep Back Section
Minimum interior surface temperature	6.7°C	8.1°C
Maximum interior relative humidity without formation of condensation	31%	35%
U-Value (Btu/h-ft ² -F)	0.2623	0.2615
Impact on budget	2 %	5%
