Studio Bell, Home of the National Music Centre A Building Envelope Case Study

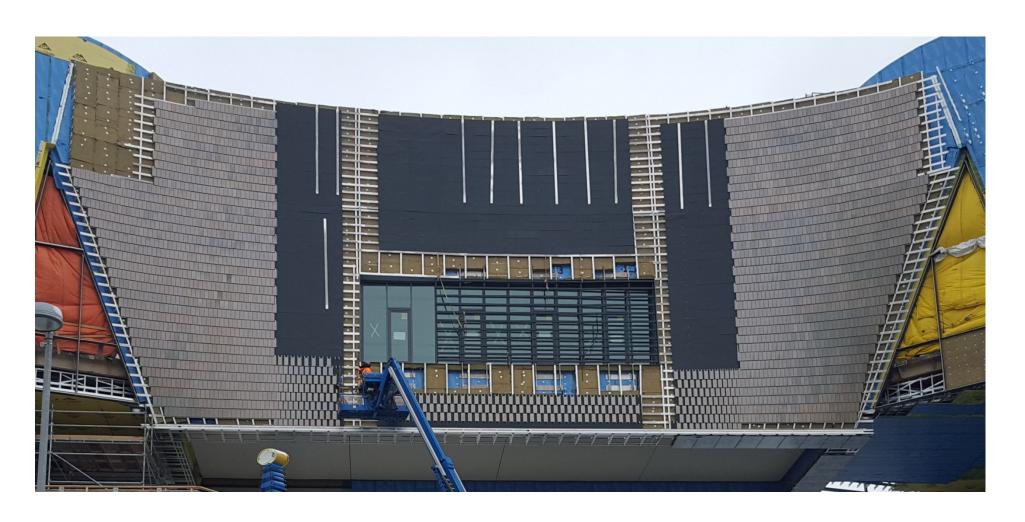
→ Solid Walls – Horizontally extruded terra cotta tiles

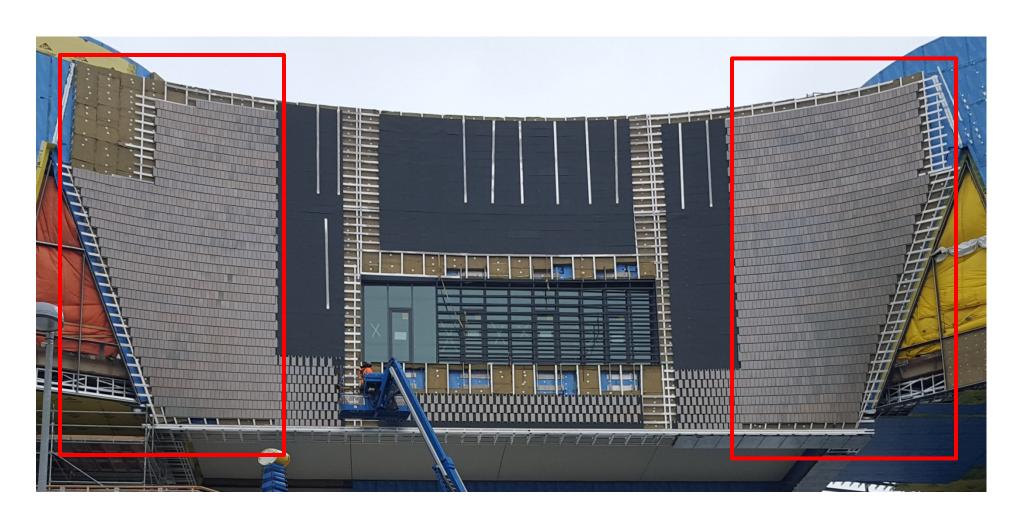
→ Solid Walls – Horizontally extruded terra cotta tiles
