Controlling Mold Growth in Ventilated Wood-Frame Attics in BC's Cool Marine Climate

September 24, 2014

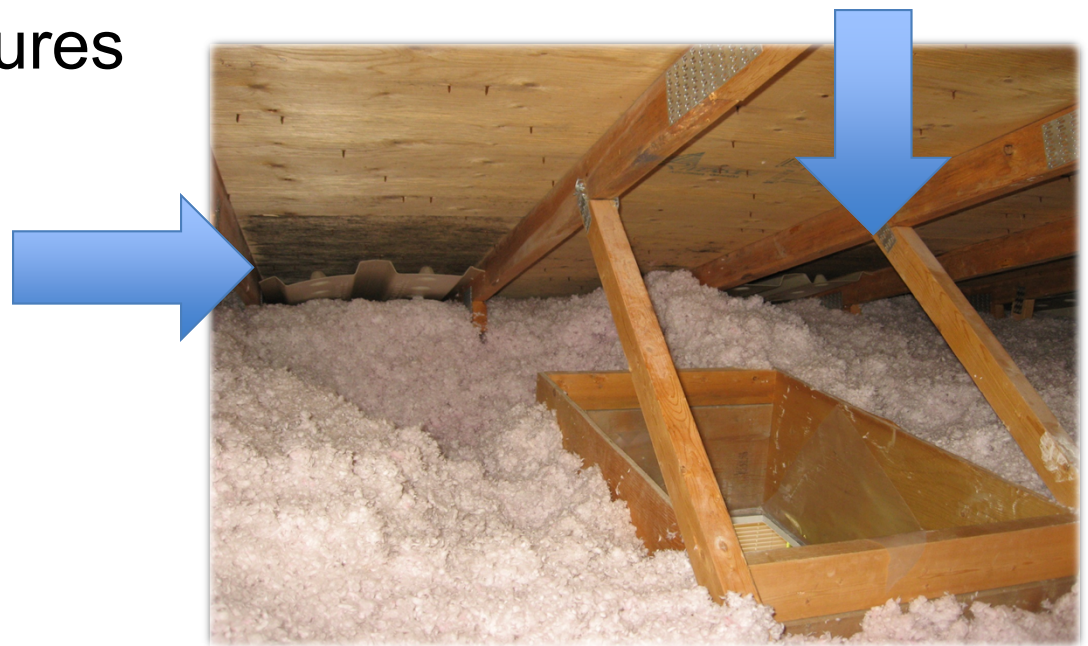
Staining at the location where the ventilation rate should be the highest?

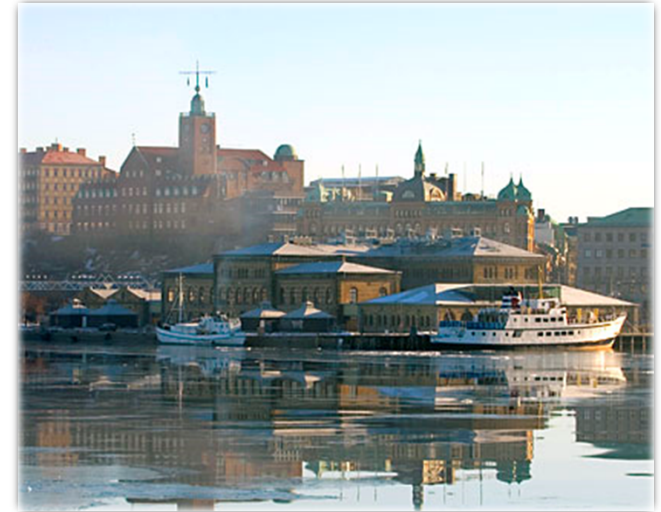
Europe – Gothenburg, Sweden (Present)

- Recent survey indicates that as many as 60% to 80% of existing buildings around Gothenburg have mold in the attics

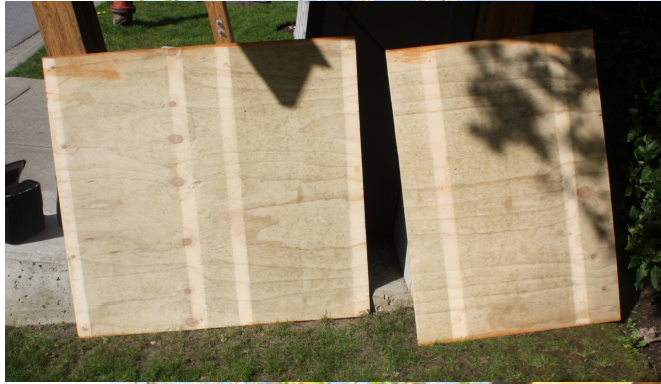
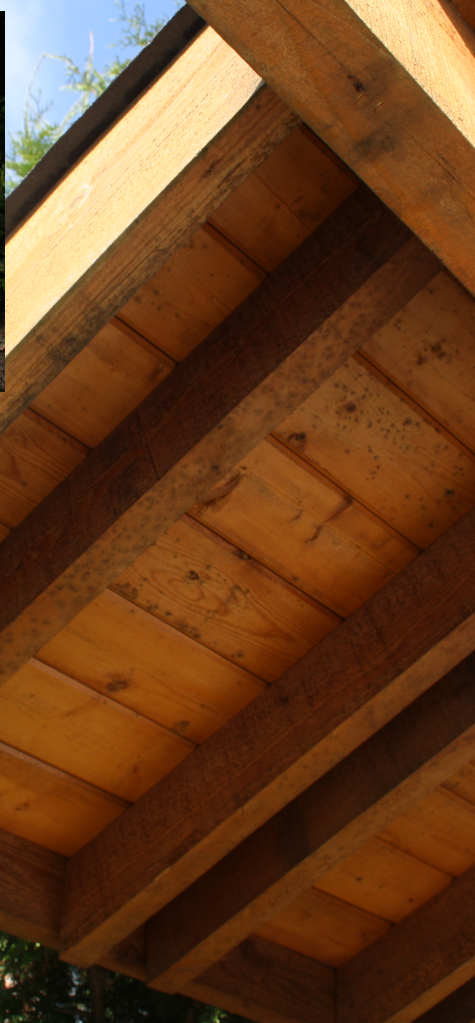
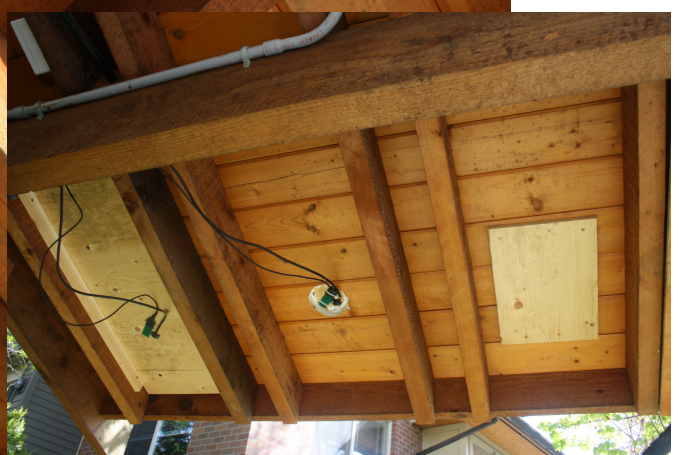
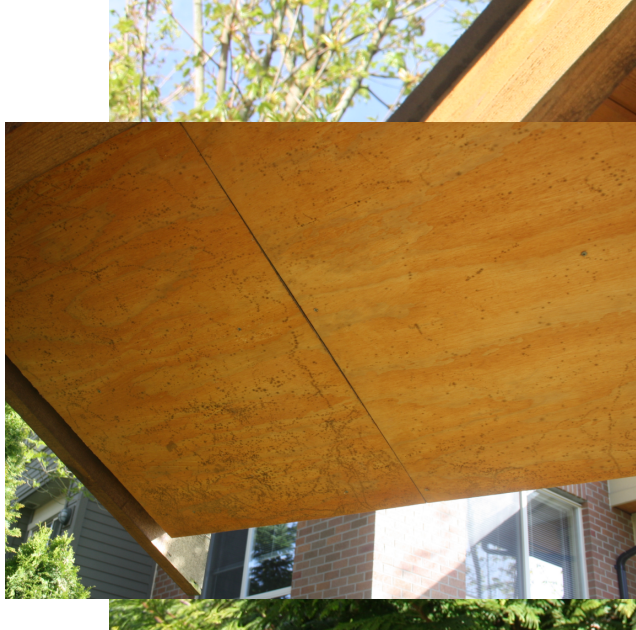
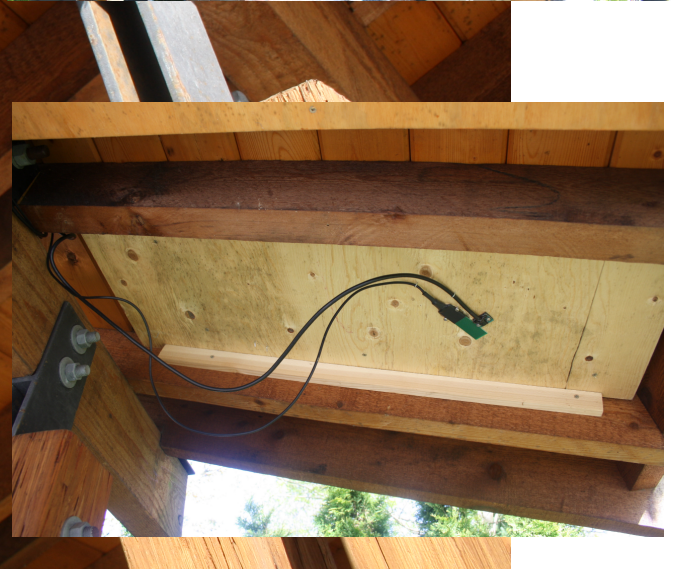
This is not from leaky shingles!

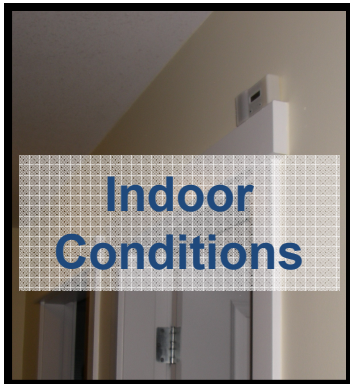
The indoor moisture was low to moderate

- Many previous Canadian studies indicated that moisture problems in attics were generally not evident without high indoor RH
- The units in this study do not follow this trend

Unit	Average Temperature (°C)	Average RH (%)	95% Percentile Dewpoint Temperature (°C)	Average DVP (Pa)	95% Percentile DVP (Pa)	99% Percentile DVP (Pa)
Outdoors	6.9	84.4	8.5	N/A	N/A	N/A
1	24.1	30.7	9.3	250	600	750
2	22.1	40.7	10.7	250	450	550
3	19.1	37.5	7.1	0	200	300
4	23.3	32.8	9.0	100	300	500

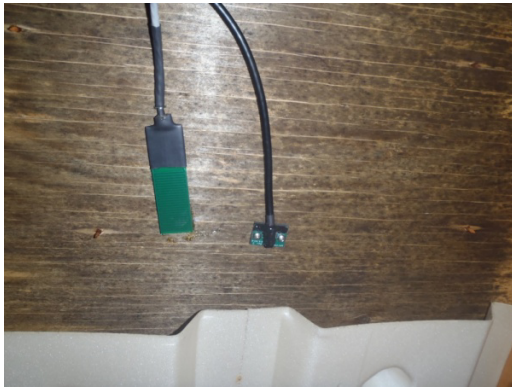
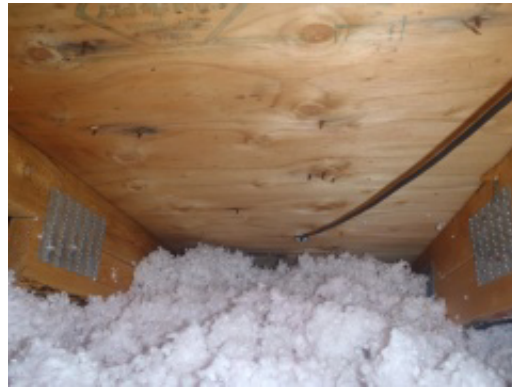
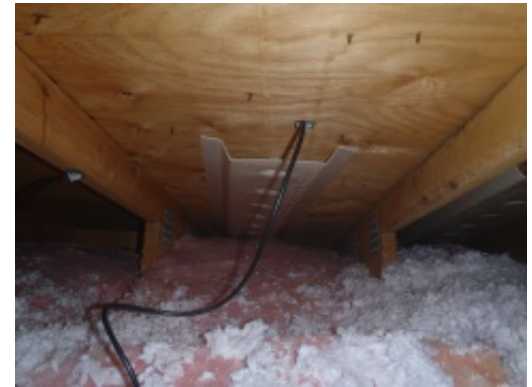
Plywood Sheathing Staining

Unit	Moderate to Heavy – Field Area Spotty or Covered	Light – localized at Fasteners	No visible Staining
1	East: baffle	East: non-baffle, West: baffle & non-baffle	East: truss West: truss
2	East: baffle	East: non-baffle West: baffle & non-baffle	East: truss West: truss
3	West: baffle	East: baffle & non-baffle West: non-baffle	East: truss West: truss
4	North: non-baffle	North: baffle	South: baffle & non-baffle South: truss

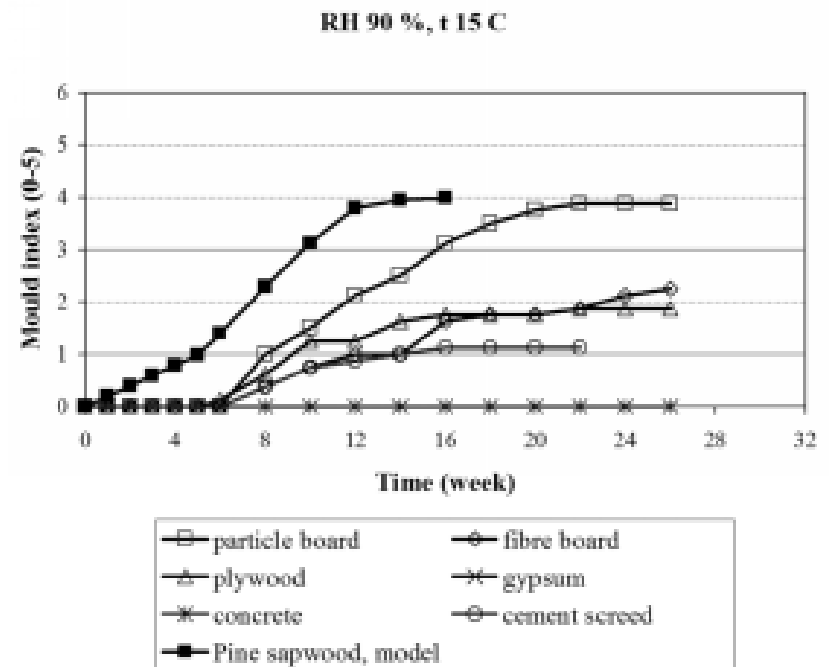
Mold Index

- In concept, accounts for exposure time, temperature, and RH concurrently
- Single indicator for evaluating mold risk
- Can not predict absolute mold growth with the given unknowns
- **A good yardstick**

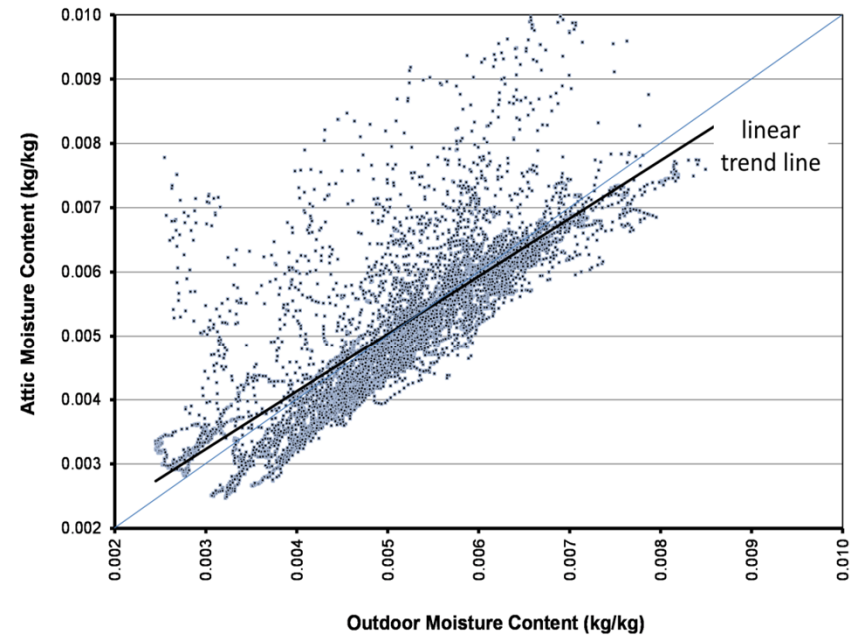
Monitoring Results Long-Term Trends

Decreasing moisture levels in the sheathing and elevated temperatures

Outdoor air is the principal moisture source

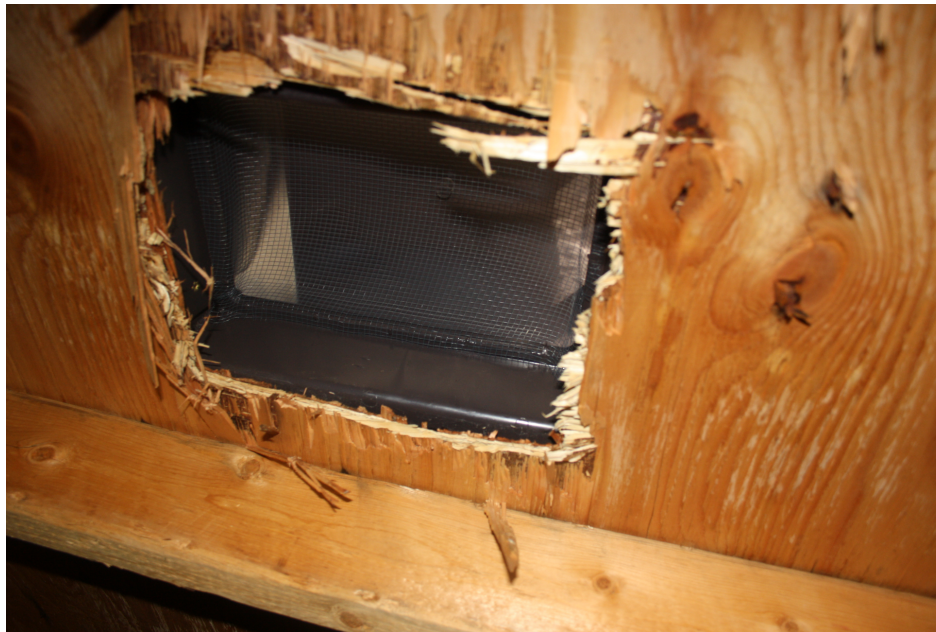
Cancel the Roof Hacking

- There was no real benefit in terms of the mold index
- The risk of mold did not appear to be reduced

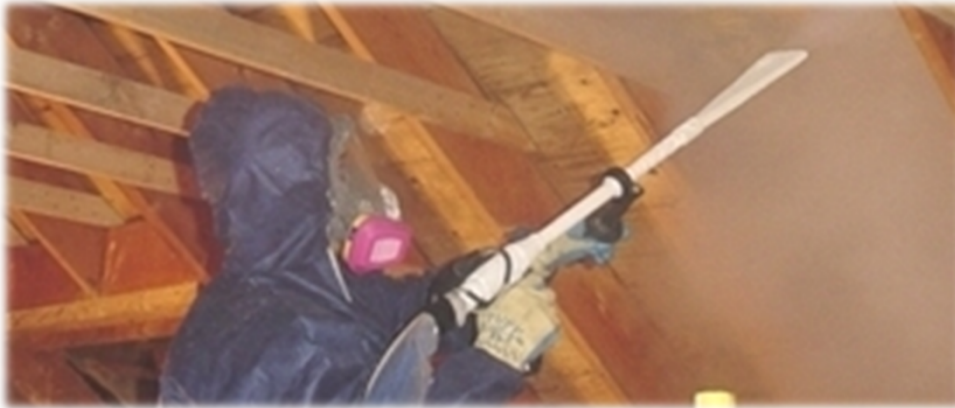
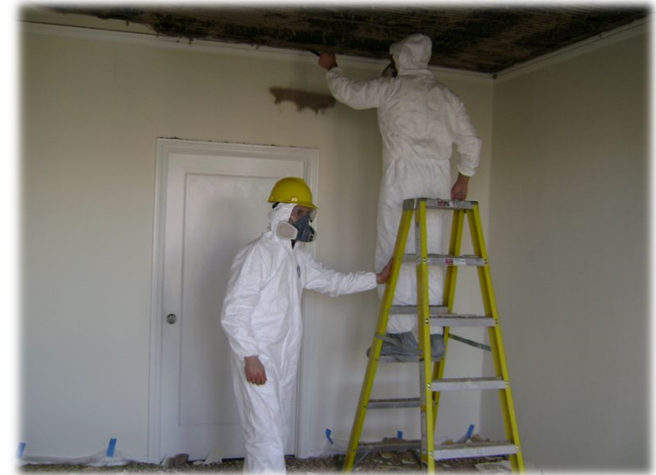
- Soap, water, and scrubbing is problematic in attics with low slopes near the soffit area (though we know of abatement companies recommending removing the ceiling to do this)
- Dry-ice blasting, or other media blasting, is an option. However, this is more costly, cleaning up is problematic, and proper clean-up requires temporary removal of the insulation
