HISTORICAL BUILDING RESTORATION

Pierre-Michel Busque, P.Eng

Case Studies

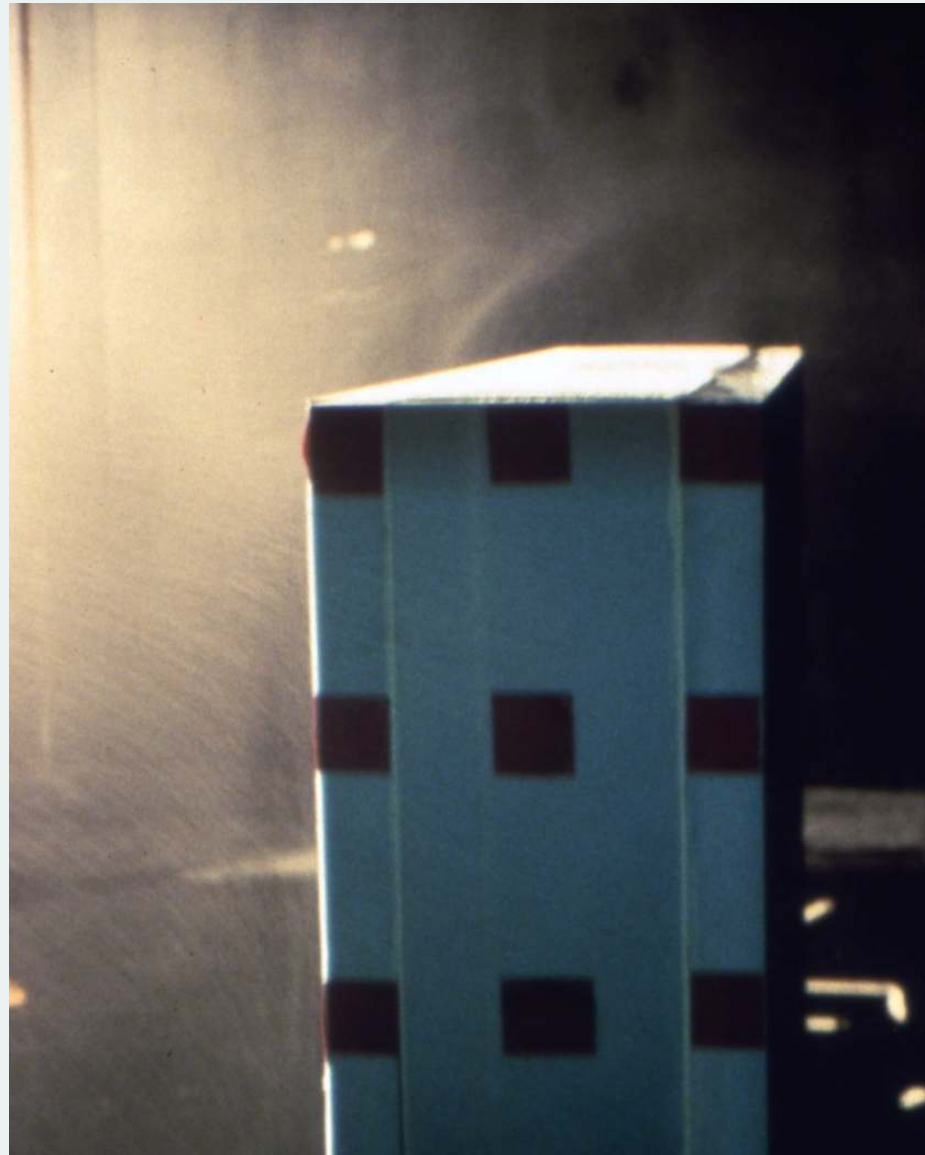
CMHC Wind Driven Rain
Study 1994

Wind tunnel testing

Modeled the wetting patterns of a building.

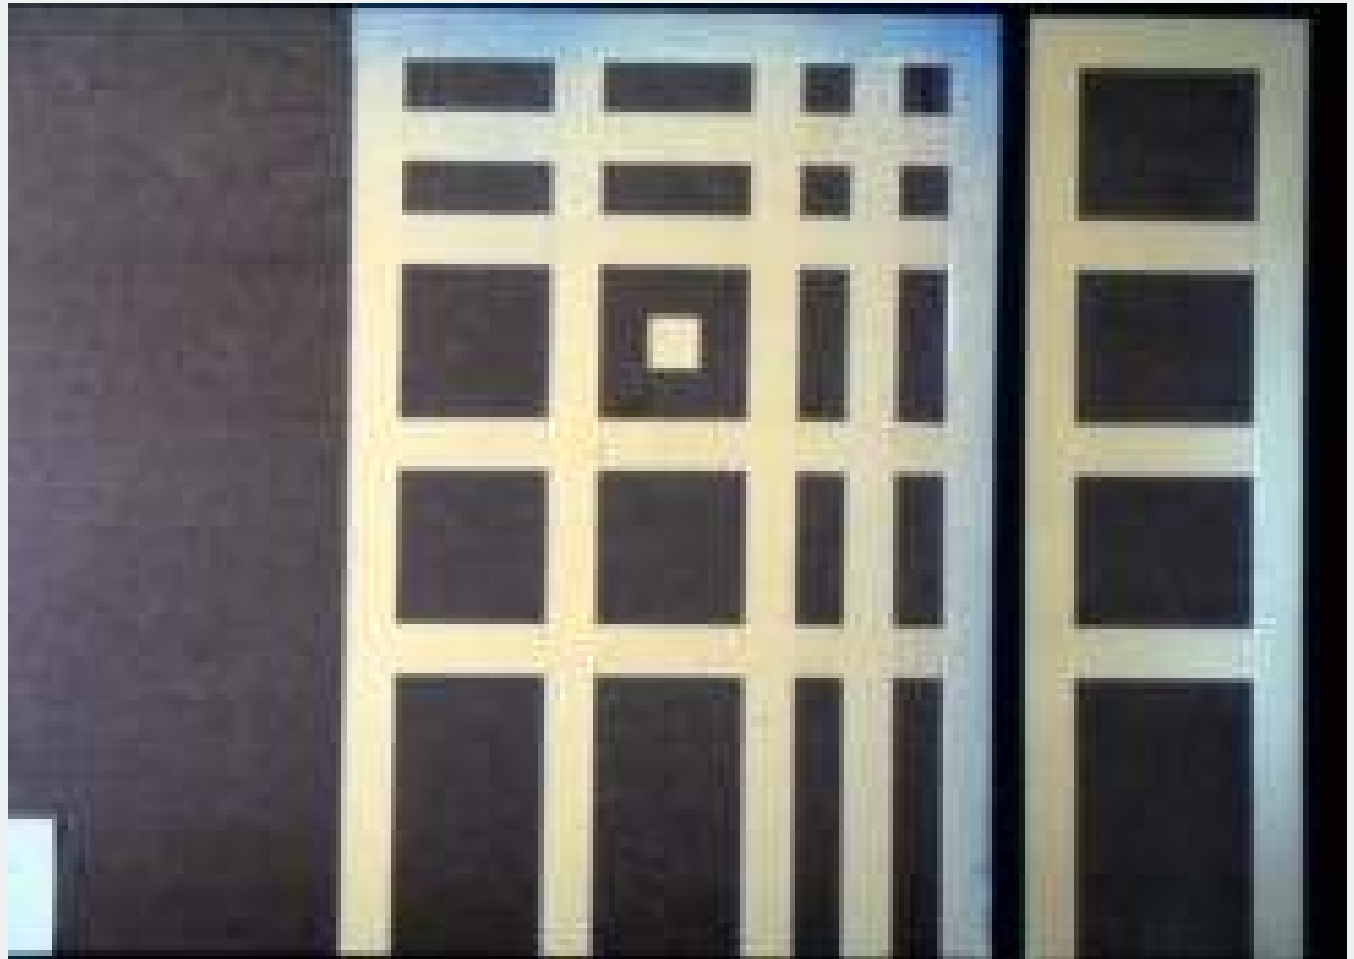
Wind tunnel testing

Wetting pattern is
distinct

Dark areas are saturated

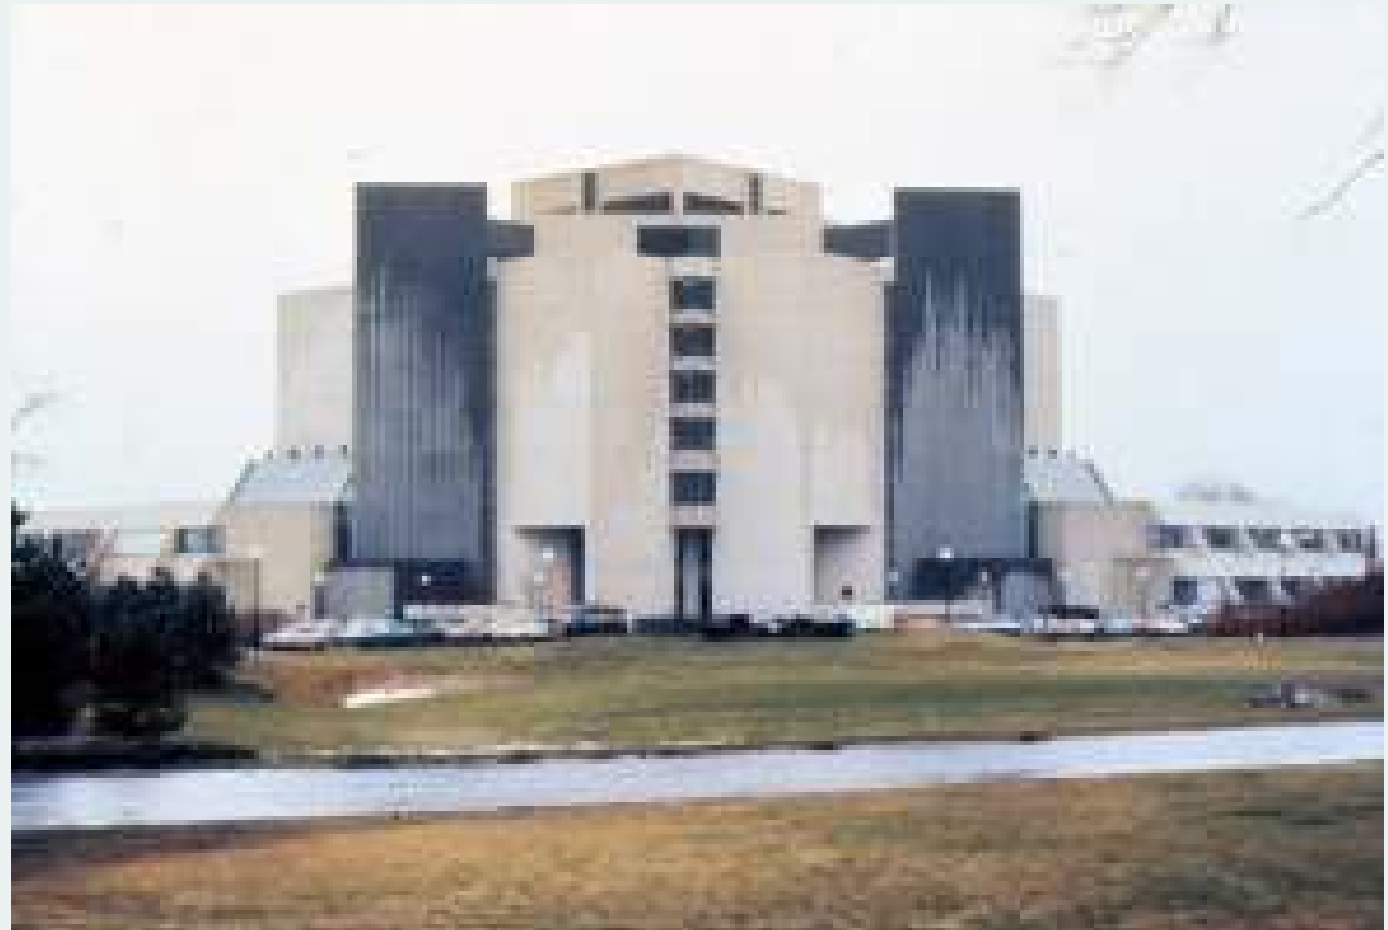
National Research Council Library Ottawa

Architectural features were for more than just looks.

These helped the façade to shed water

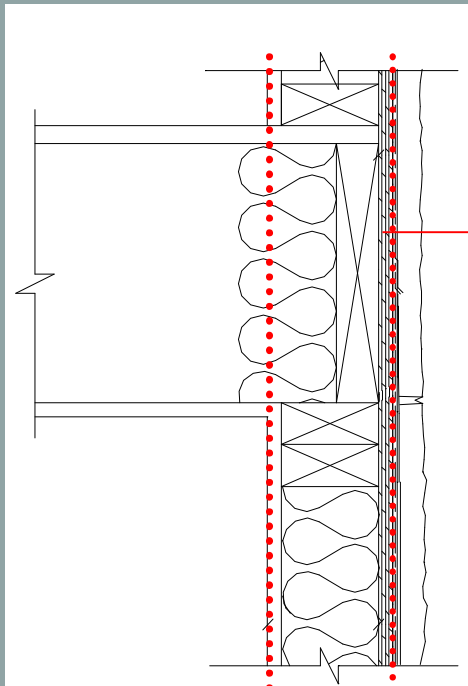
Accumulators: failures tend to be more drastic

**Accumulator:
water enters
more easily
than it can
escape**

VB VB

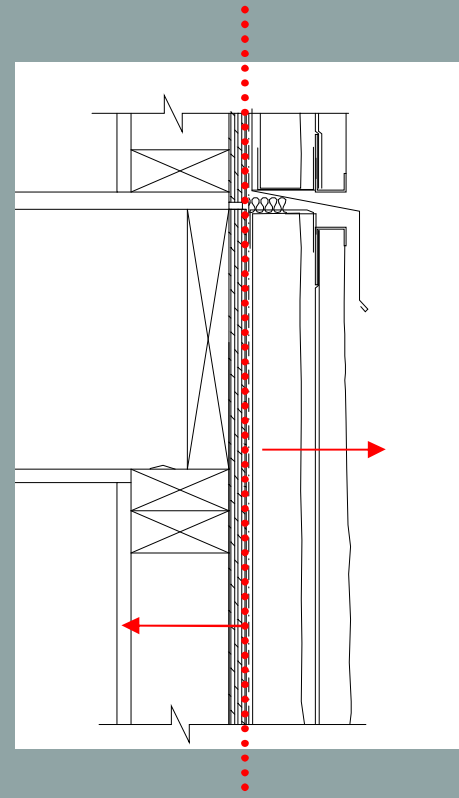
Dissipaters: failures tend to be more localized

**Dissipater:
water is not
stored easily
in the
assembly**

VB

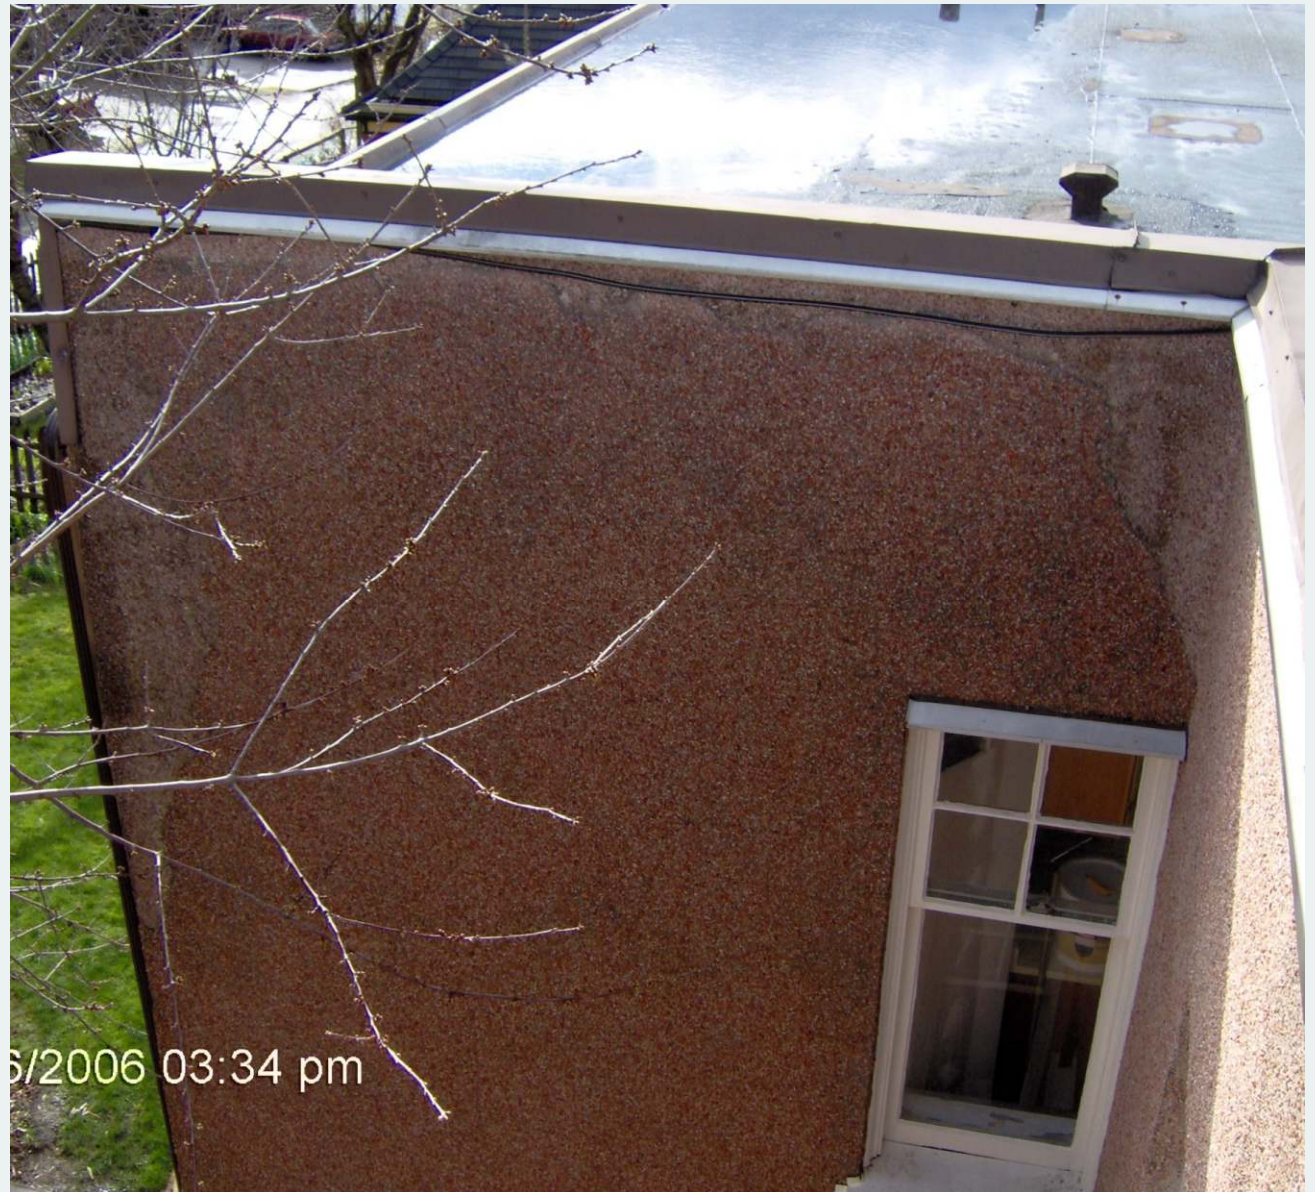
What We Did

1" EPS insulation,
applied to brick

Paperless gypsum
board

No complaints after
8 years

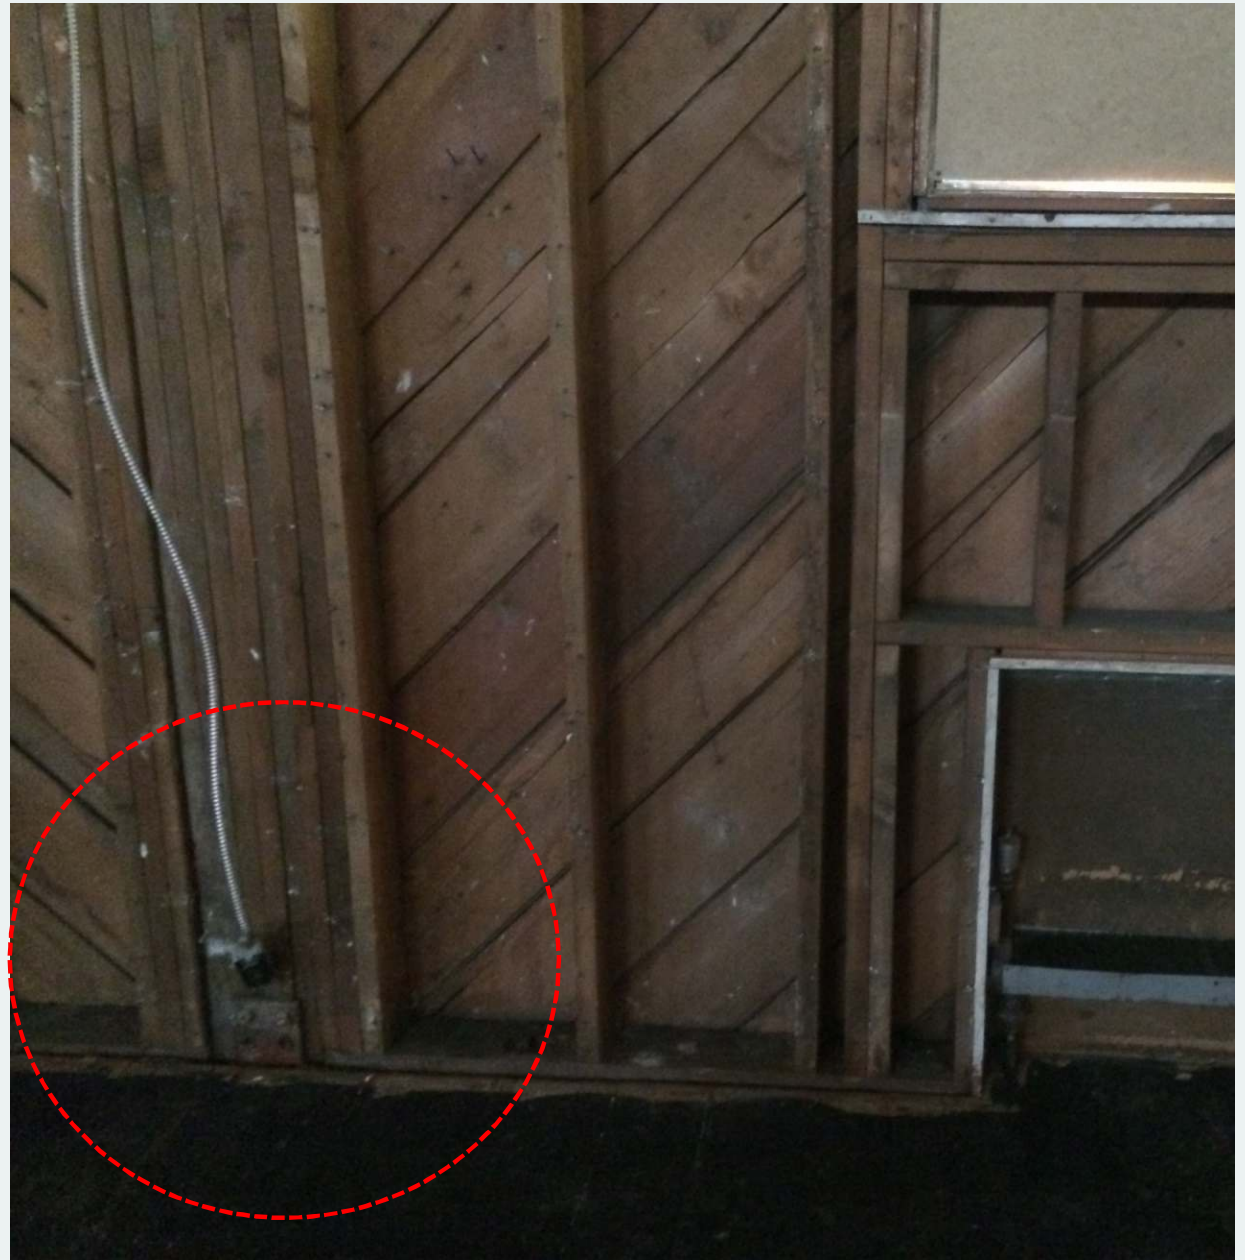
Our Response

Leakage too severe to insulate.

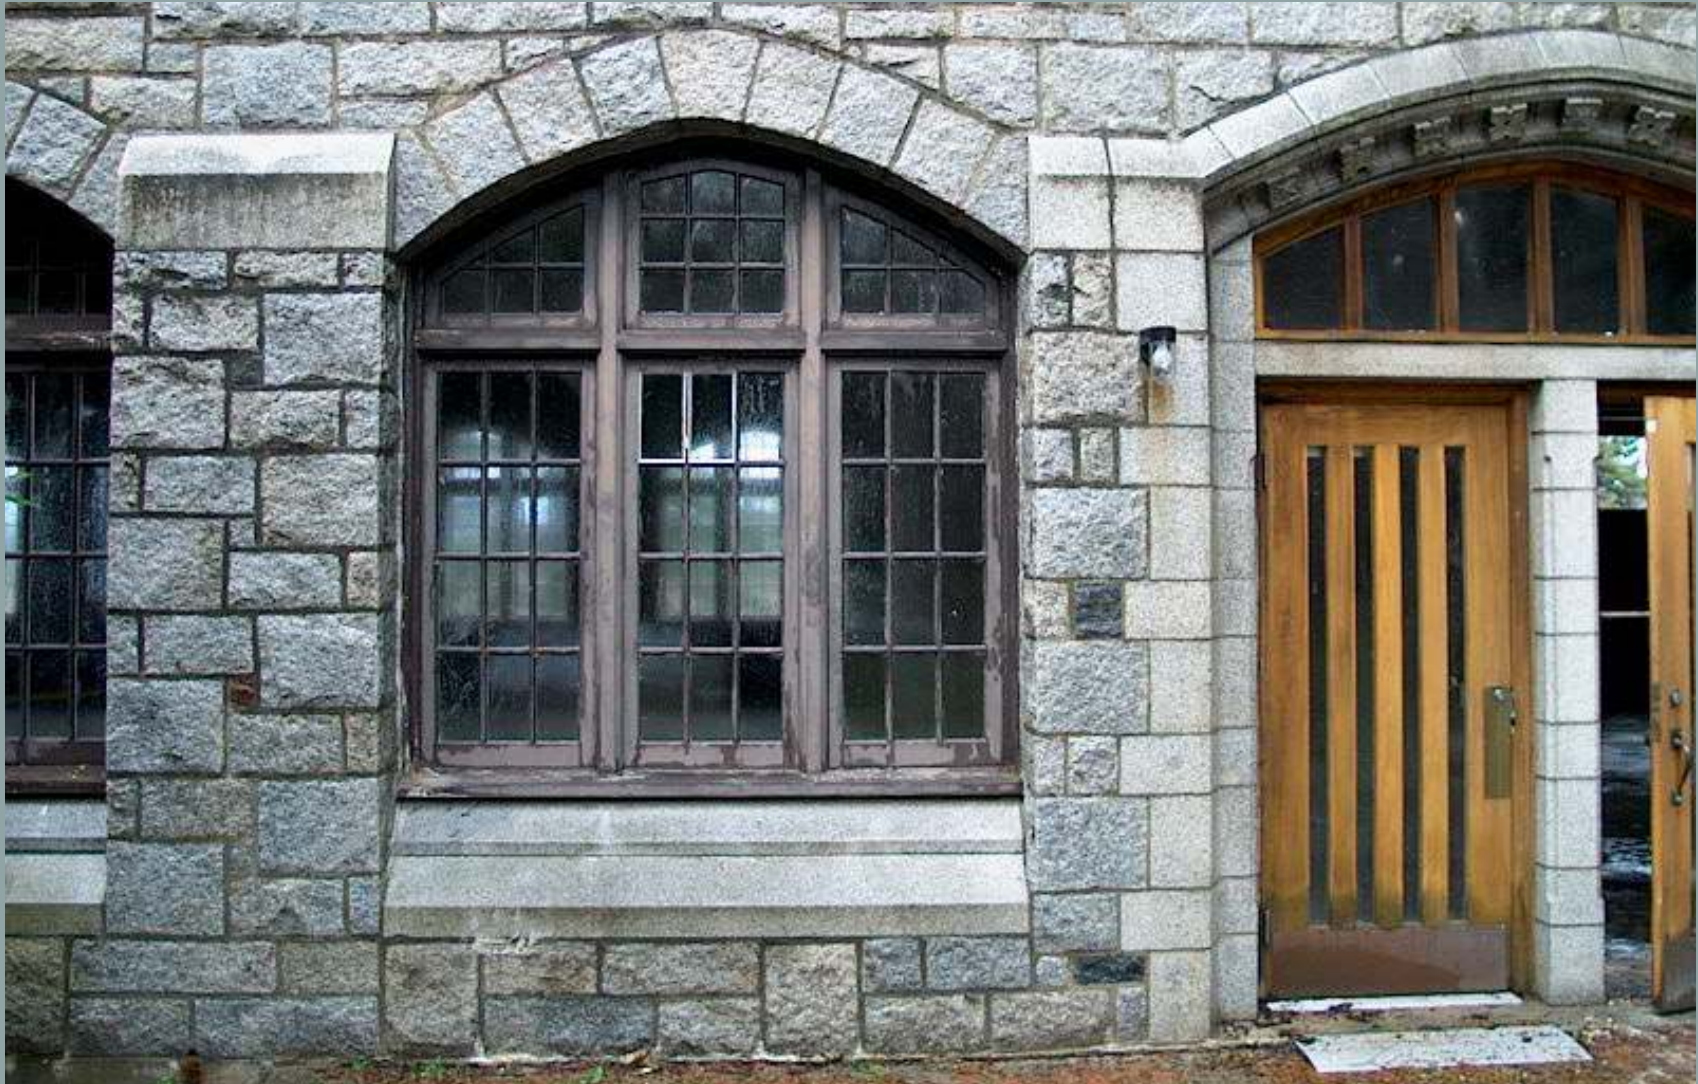
Windows had a waterproofing liner below them.

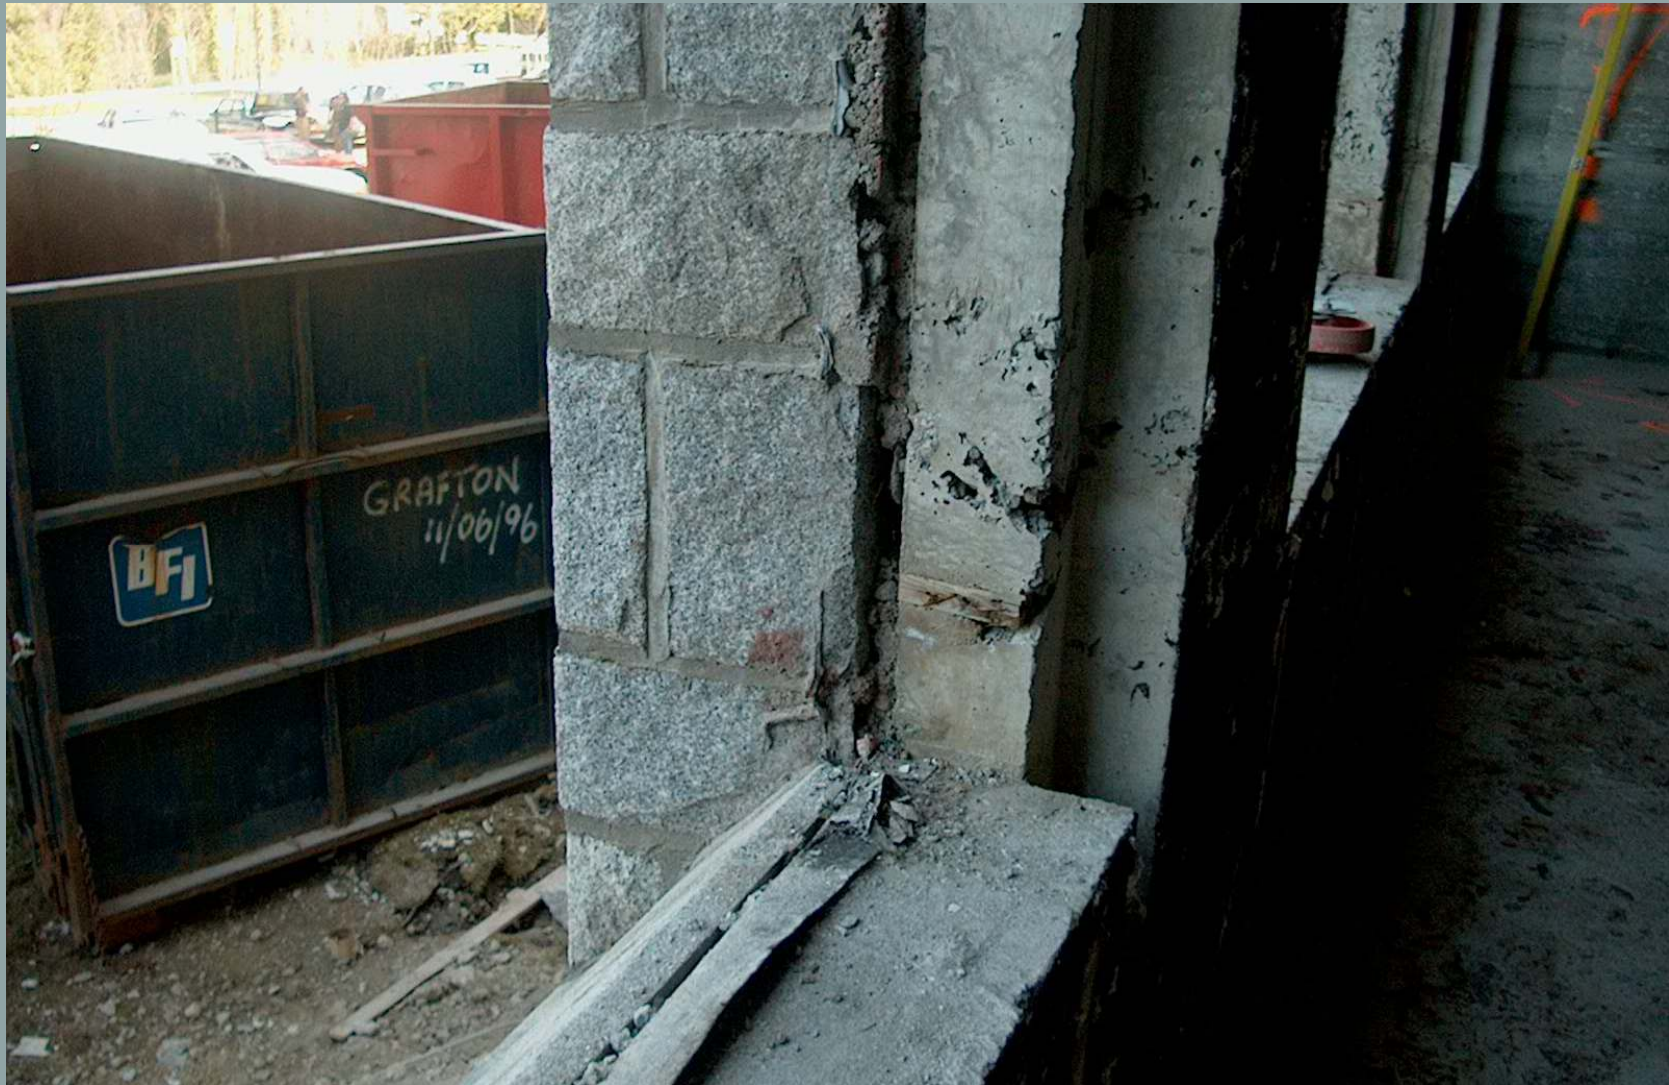
Windows (had a waterproofing liner below)

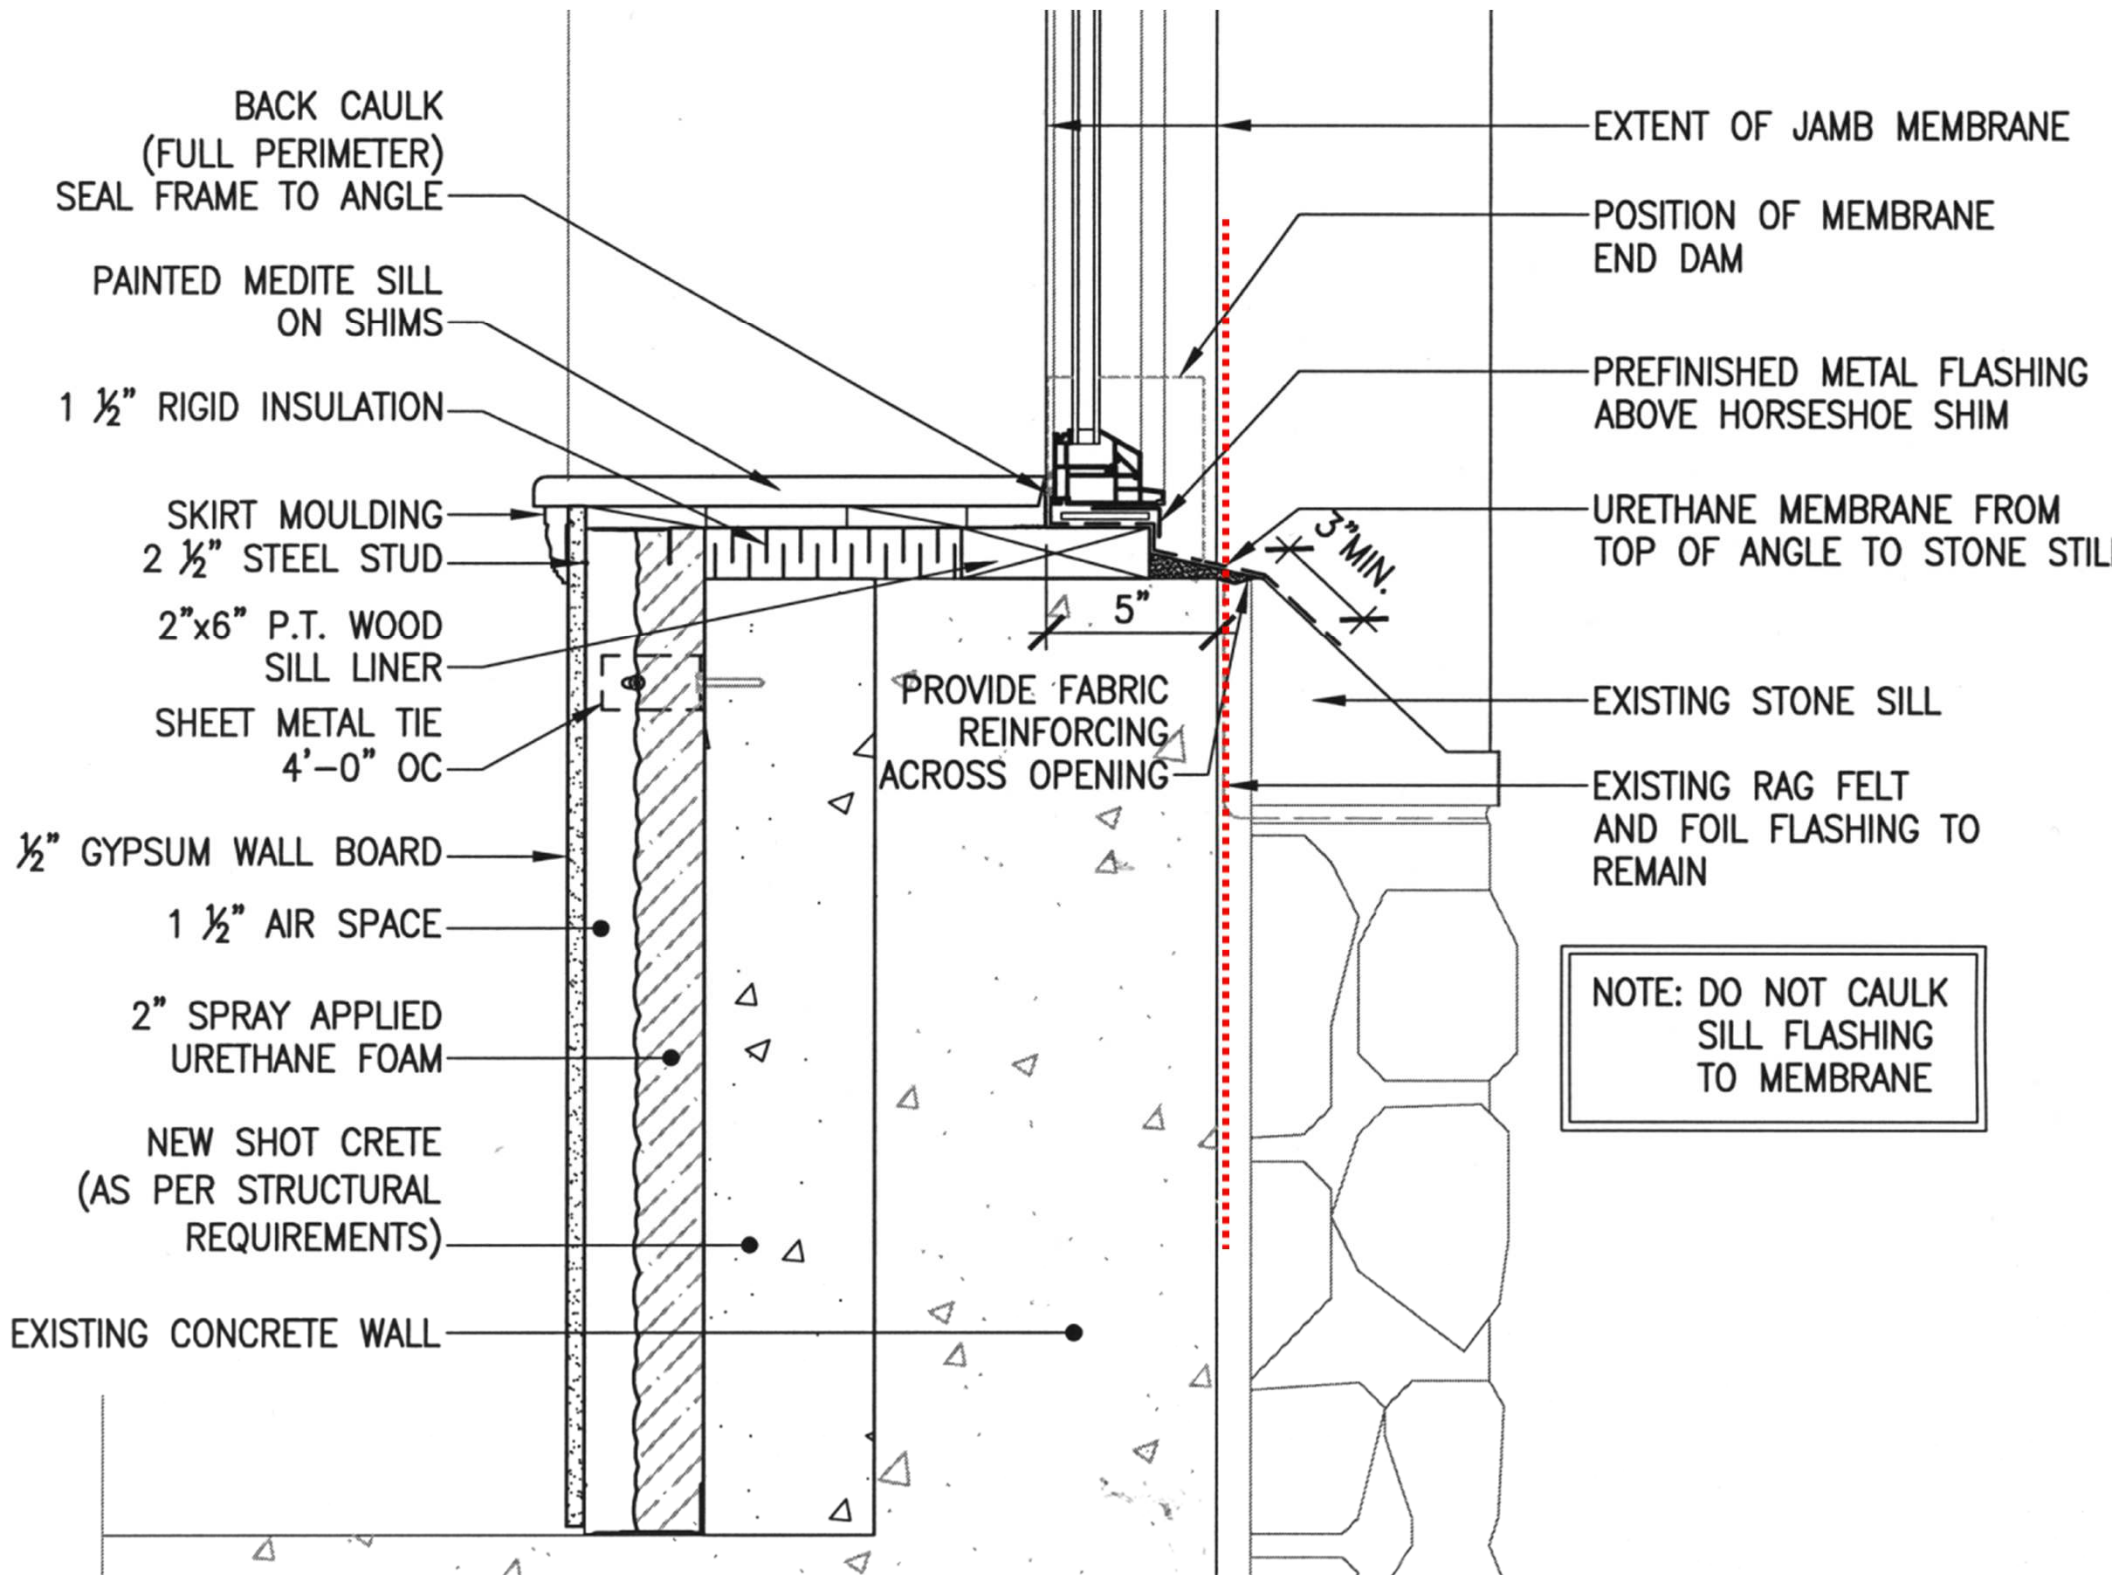
80 year old school

BACK CAULK
(FULL PERIMETER)
SEAL FRAME TO ANGLE

PAINTED MEDITE SILL
ON SHIMS

1 1/2" RIGID INSULATION

2 1/2" STEEL STUD

2"x6" P.T. WOOD
SILL LINER

2" SPRAY APPLIED
URETHANE FOAM

NEW SHOT CRETE
(AS PER STRUCTURAL
REQUIREMENTS)

EXISTING CONCRETE WALL

PREFINISHED METAL FLASHING
ABOVE HORSESHOE SHIM

URETHANE MEMBRANE FROM
TOP OF ANGLE TO STONE SILL

EXISTING RAG FELT
AND FOIL FLASHING TO
REMAIN

NOTE: DO NOT CAULK
SILL FLASHING
TO MEMBRANE

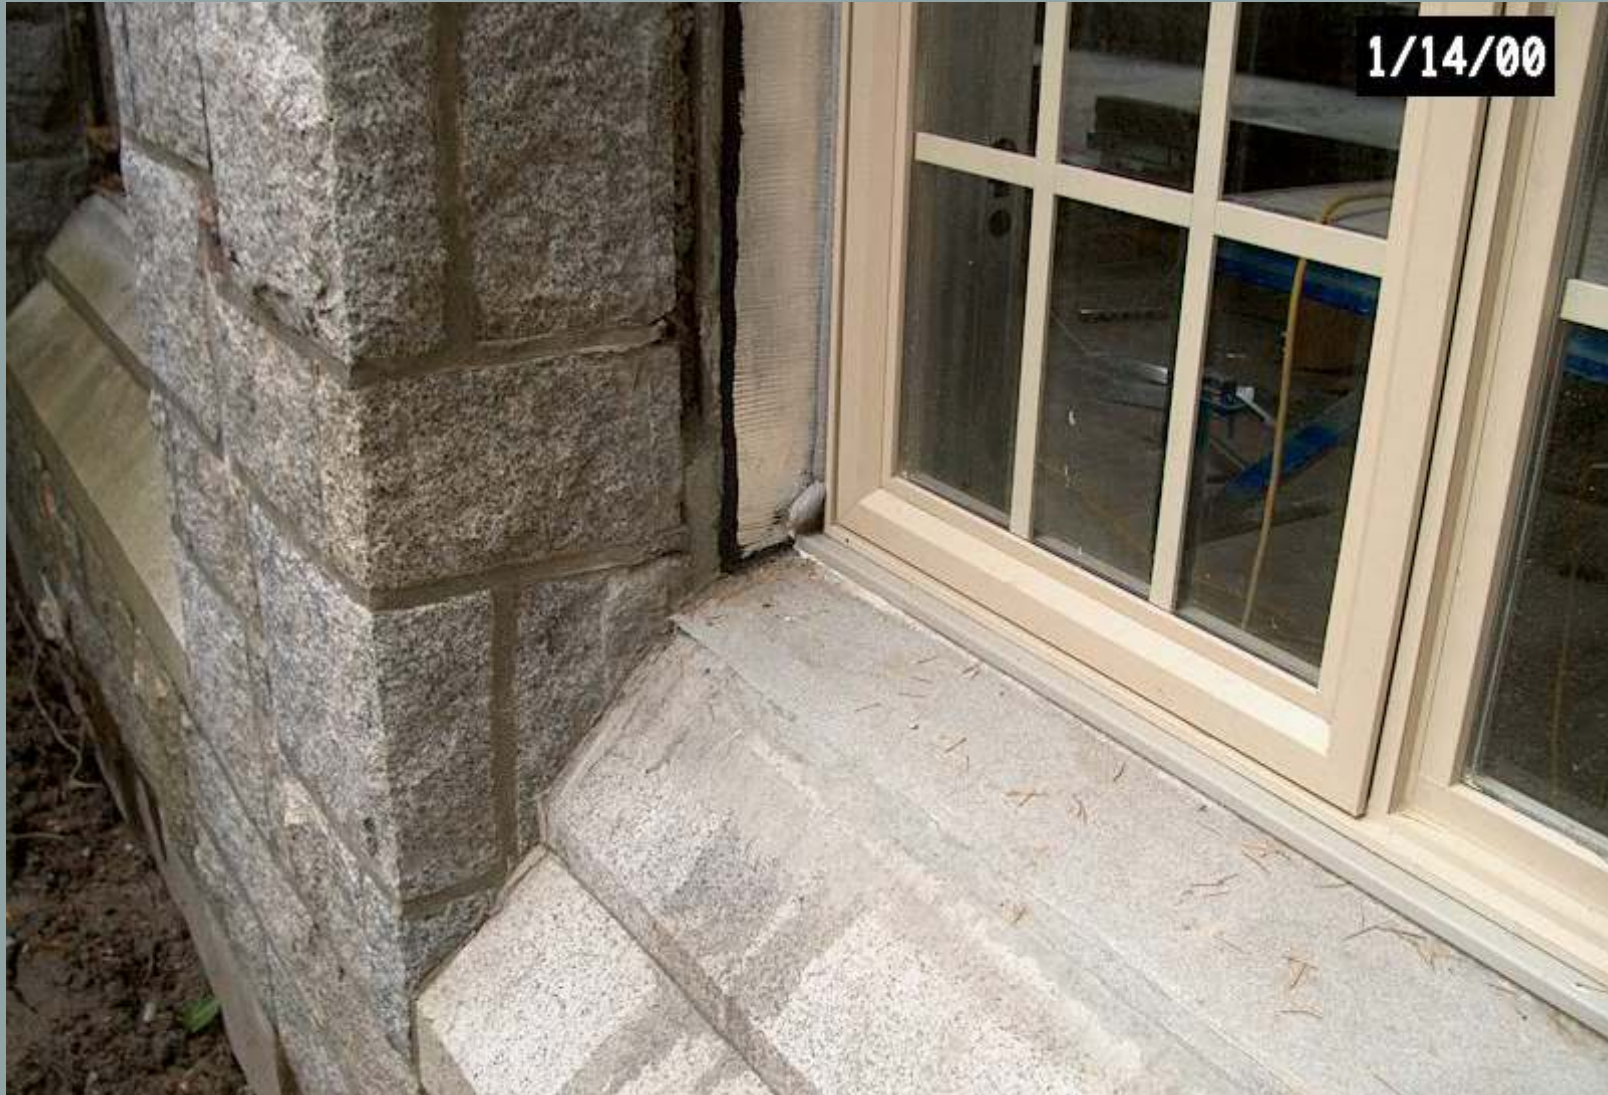
80 year old school- The basics: Saddles

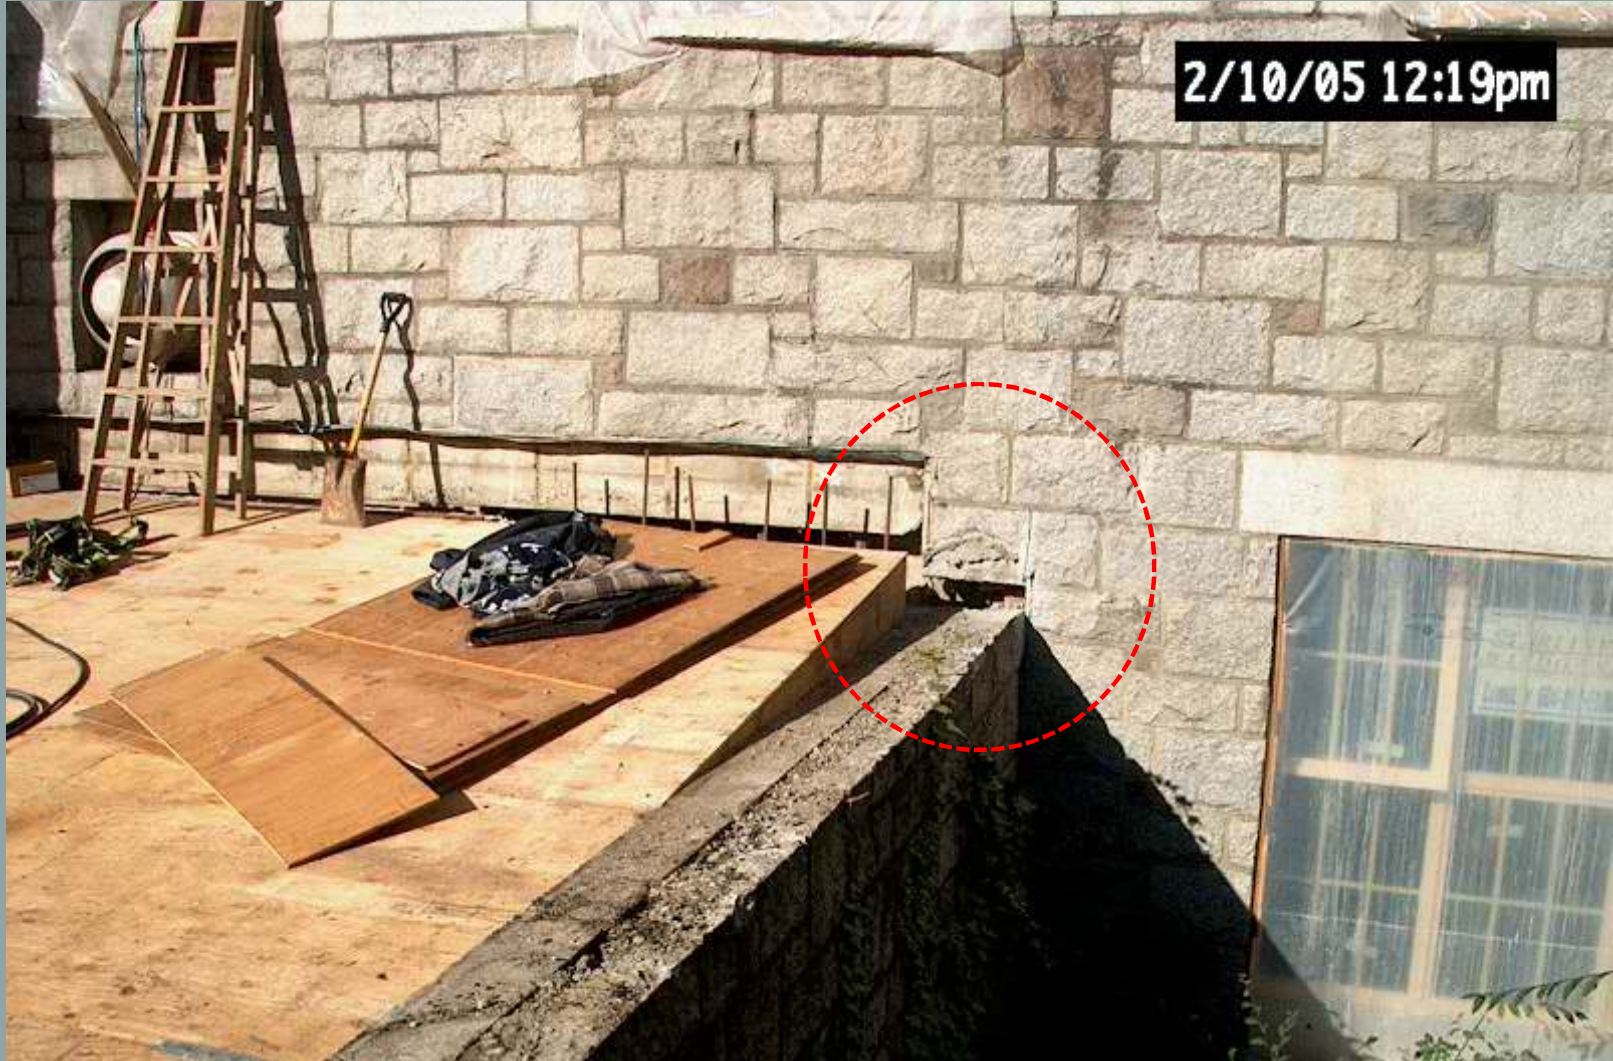
Parapet walls are frequently structurally inadequate to resist seismic forces

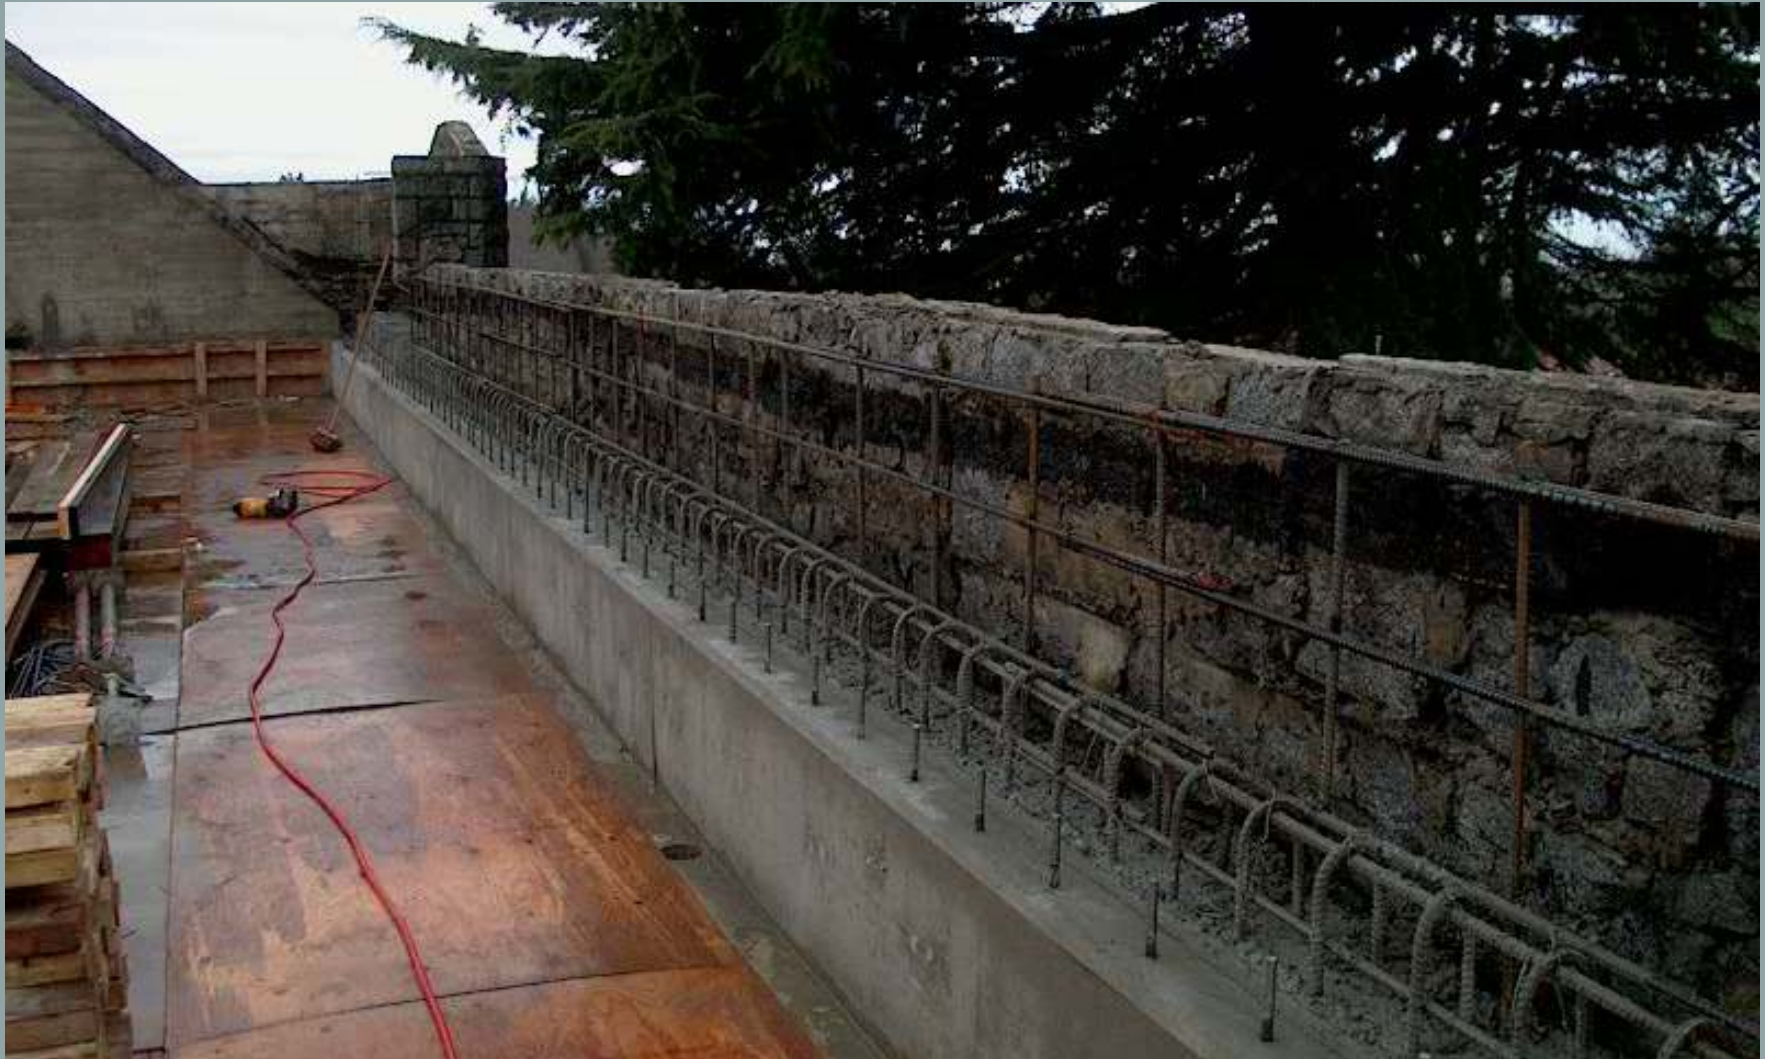
New Rule

If a masonry building is over 25 years old, check the condition of the shelf angles.

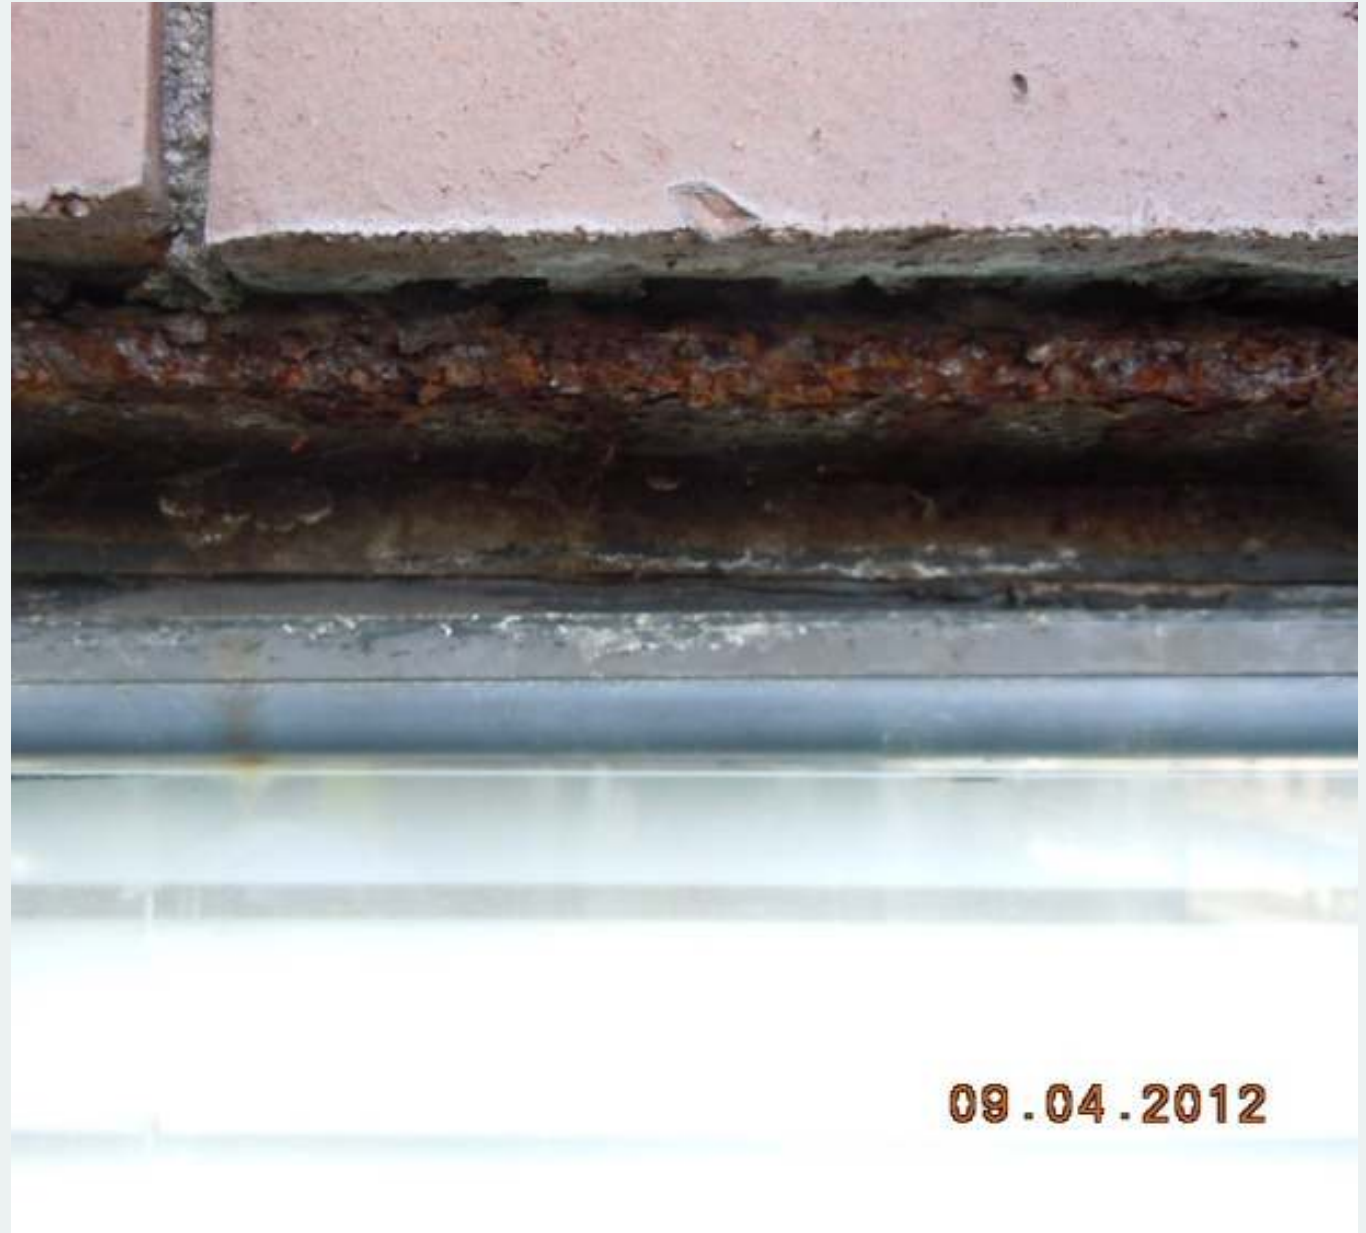
Carbonation of Concrete

- TOW (Time of Wetness) No Hours above 80%RH
- Ph lowers RH at which corrosion occurs
