HISTORICAL BUILDING RESTORATION

Pierre-Michel Busque, P.Eng

Case Studies

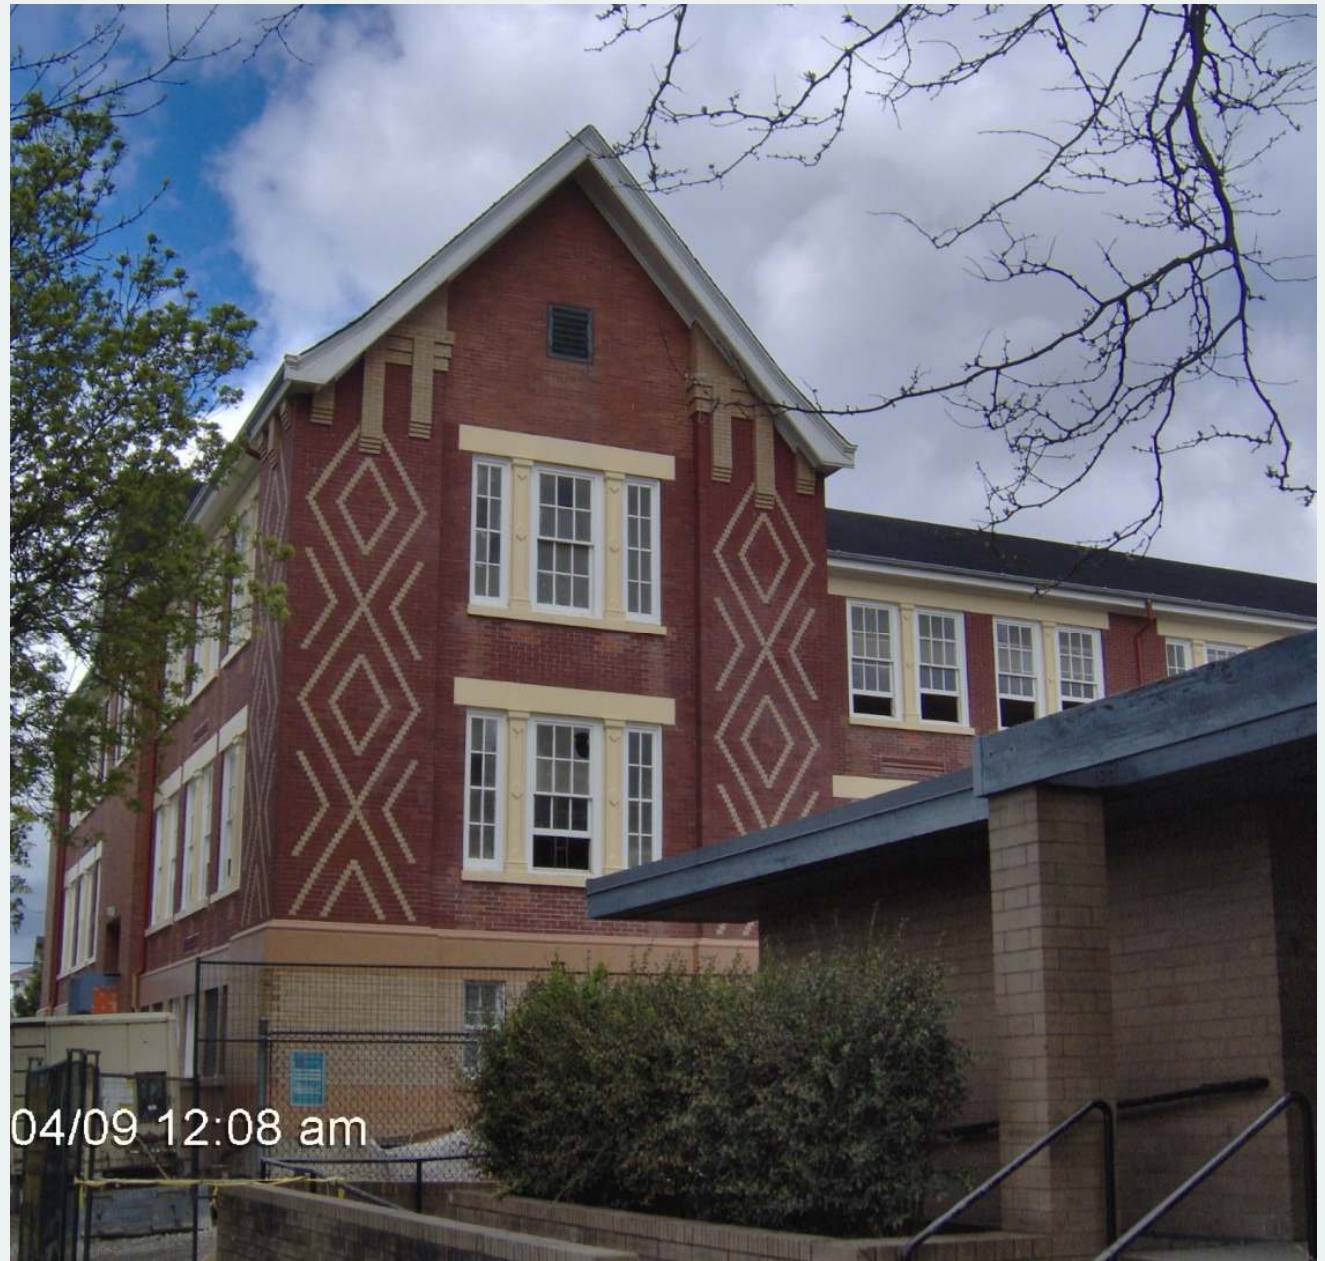
Assessing the Freeze-Thaw Resistance of Clay Brick for Interior Insulation Retrofit Projects

- *“frost dilatometry can be used to determine the critical degree of saturation at which freeze-thaw damage is likely to occur....”*
- or... walk around the building and check the condition of bricks in the unheated portions of the building.
