# Higher Performance Buildings

ENERGY EFFICIENCY UPGRADES: DESIGN AND INSTALLATION CHALLENGES ON  
BUILDING ENCLOSURE REHABILITATION PROJECTS

BCBEC / EGBC

JUNE 20<sup>TH</sup>, 2019

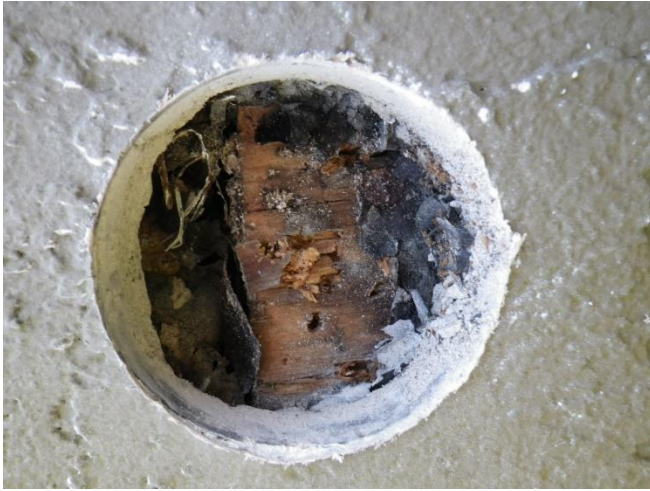
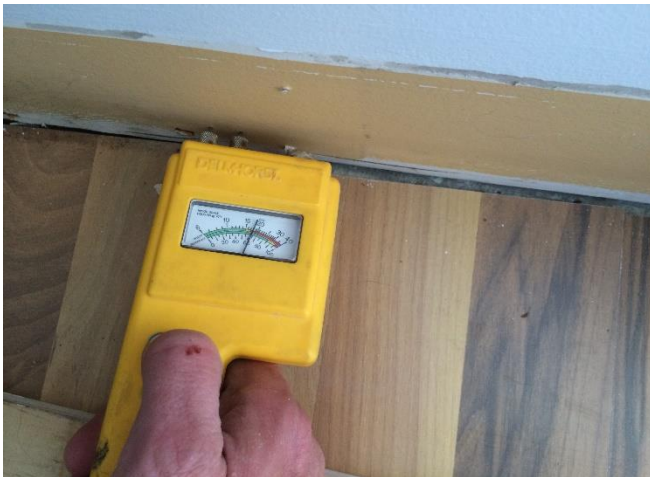
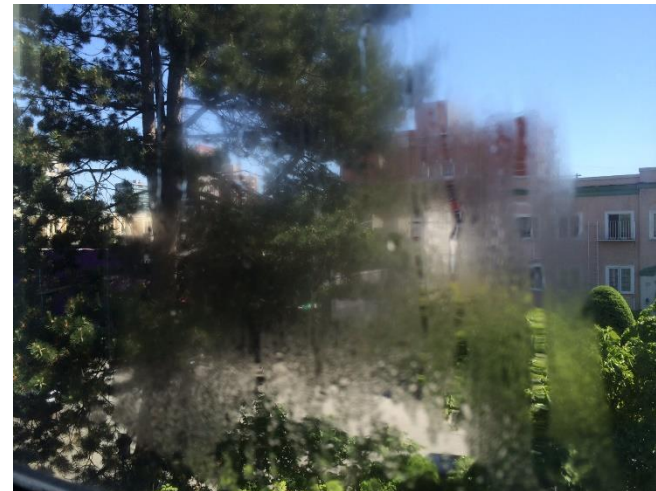
## Low-Rise MURB 1 – Deficiencies

- Localized water ingress and high moisture content at face-sealed stucco walls
- Systemic condensation and evidence of water ingress at windows

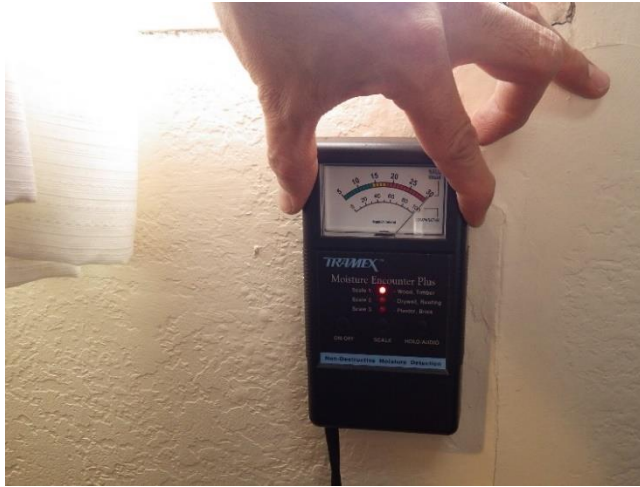
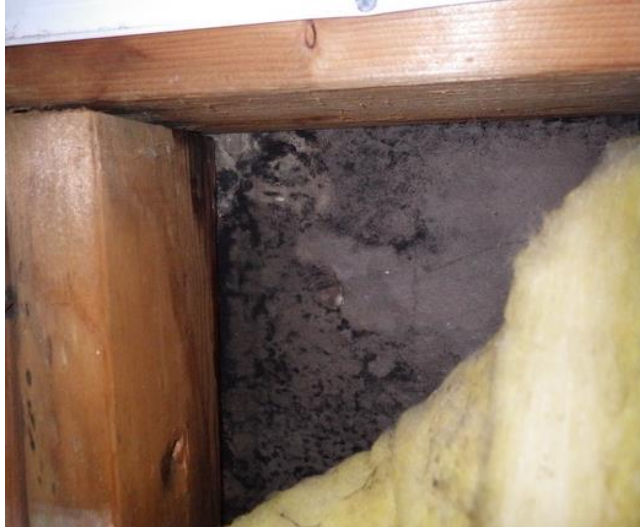
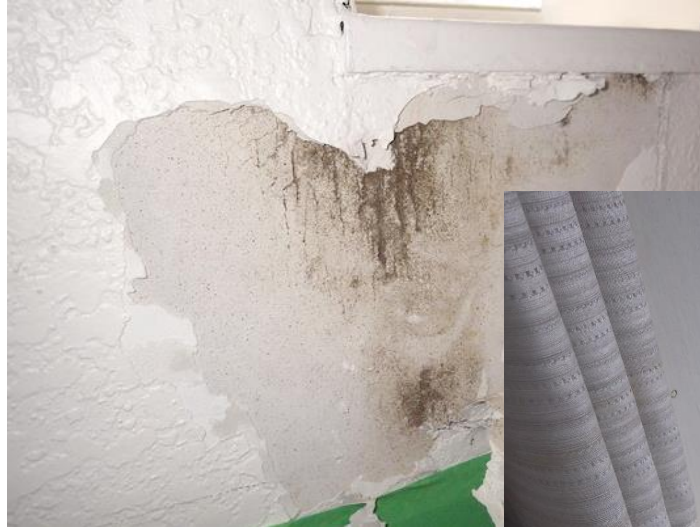
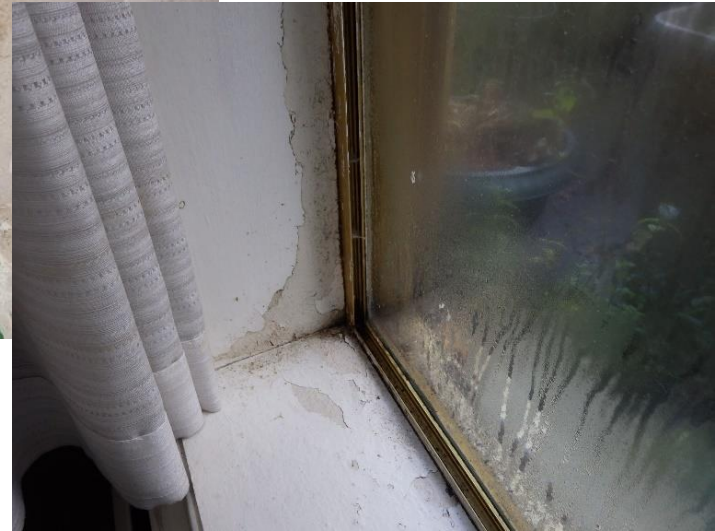
# Lord Harley – Deficiencies

- Localized water ingress and high moisture content at face-sealed stucco walls
- Systemic condensation and evidence of water ingress at windows

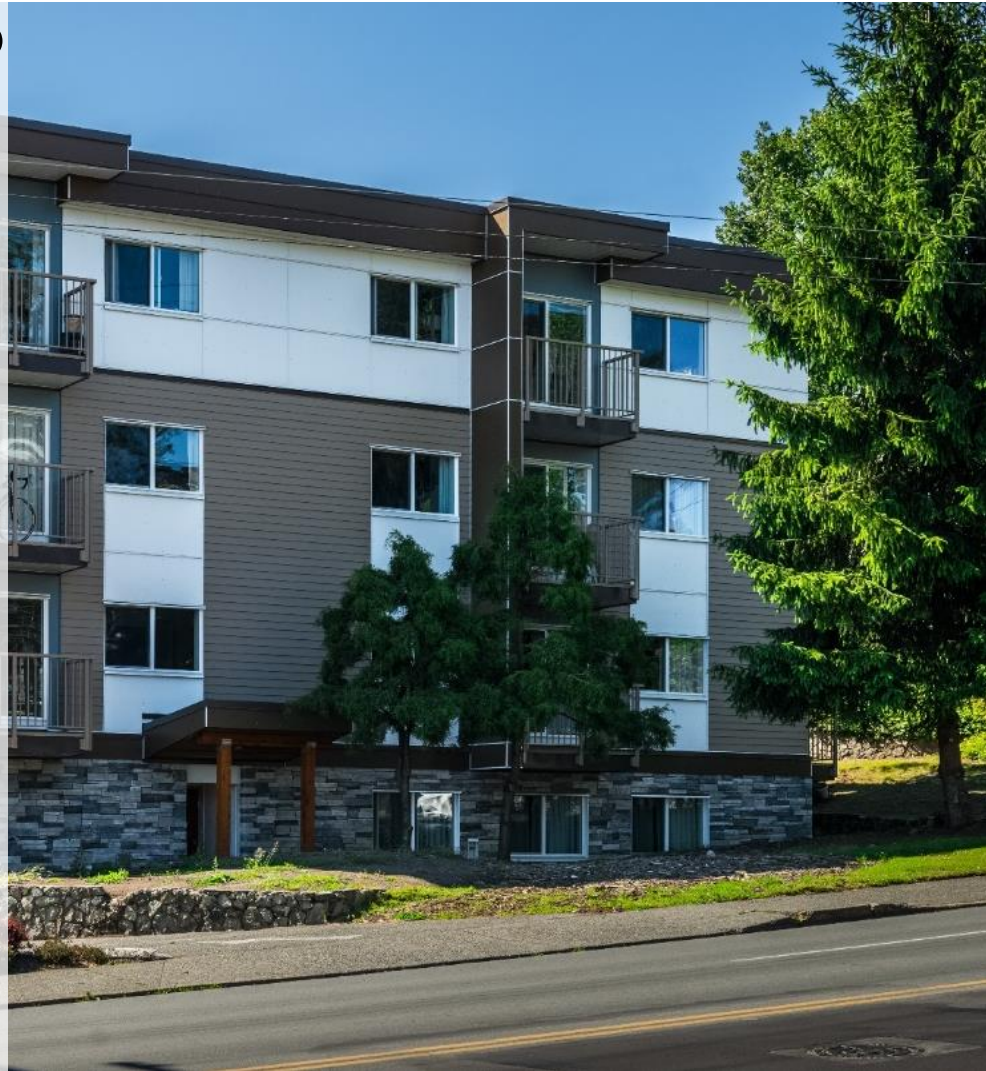
- Individual Owner, looking to make a long-term investment
- Desire to minimize ongoing maintenance work and operational costs
- Desire to update aesthetic and make the rental units more attractive

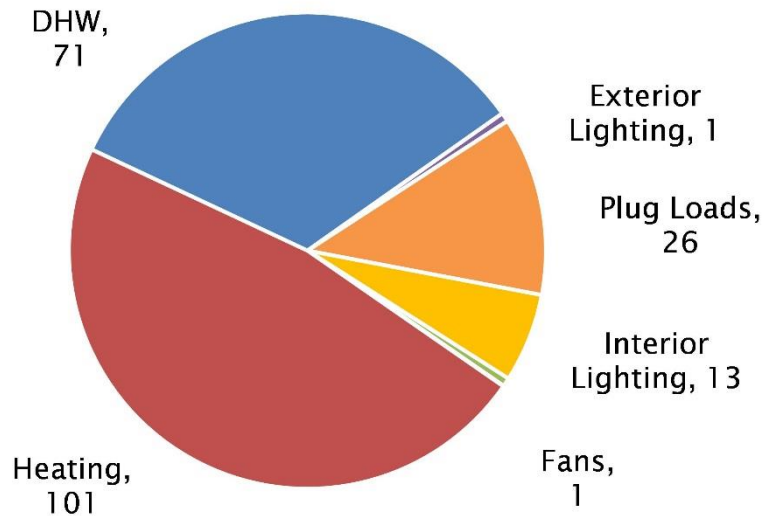
**ADJUSTED PRE-RETROFIT MODEL:  
END-USE BREAKDOWN (kWh/m<sup>2</sup>)**

TEUI: 213 kWh/m<sup>2</sup>/yr

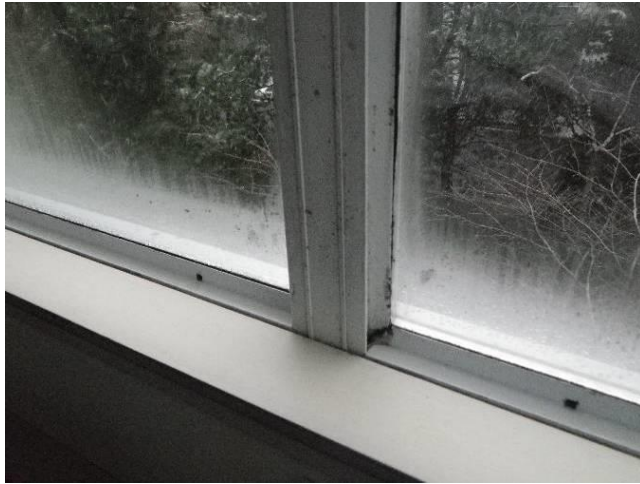
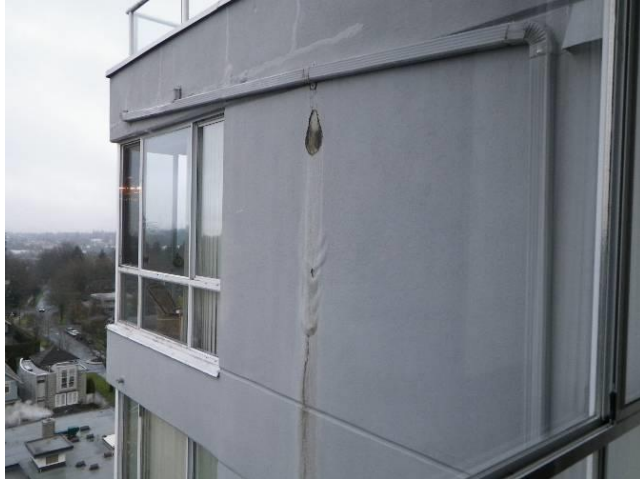
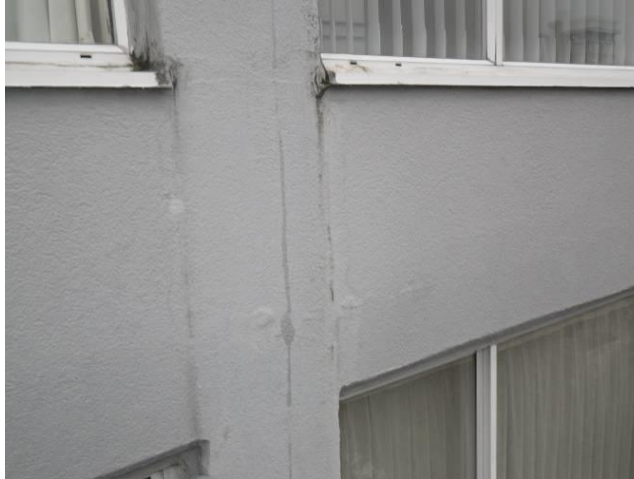
# The Belmont – Deficiencies

- Systemic condensation and evidence of water ingress at windows
- Localized deficiencies in acrylic coating, cracks and cold joints

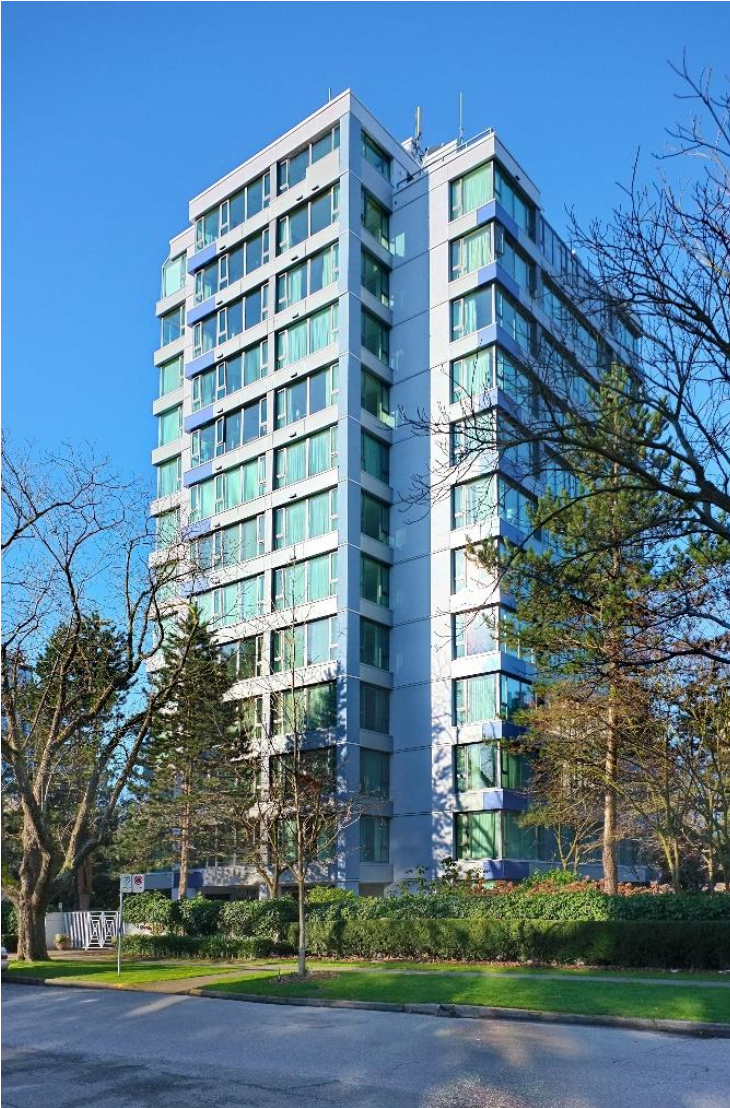
- Desire to reduce ongoing maintenance and renewal costs
- Desire to improve thermal comfort
- Desire to modernize appearance
- Desire to reduce energy consumption
- Funding was available to help offset some of the capital costs

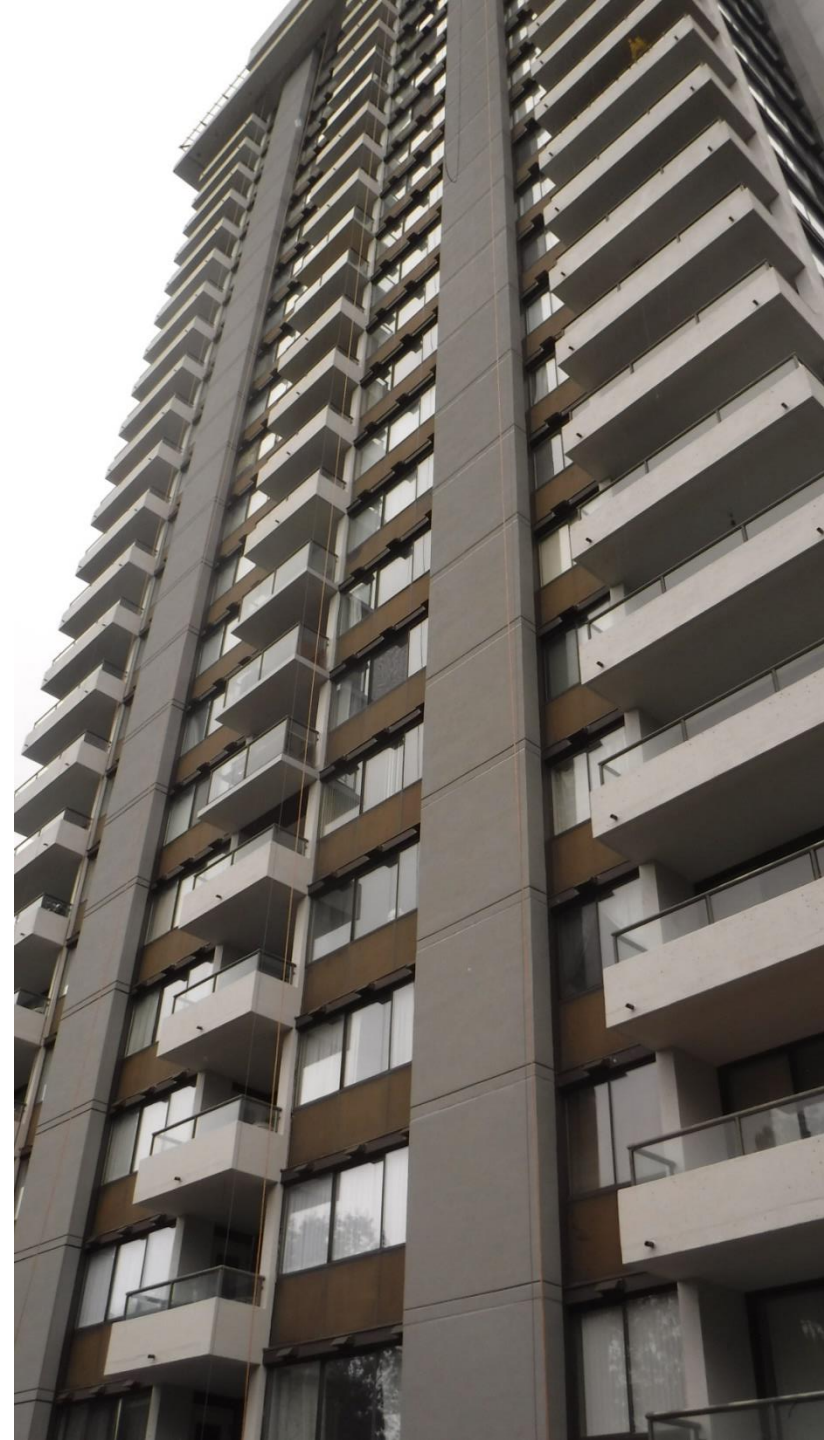
- Of the relatively limited number of (energy upgrade) renewal and rehabilitation projects that went from Energy Studies through to construction, we noticed two most common challenges:
  - Attachment of cladding through exterior insulation to structure
  - Municipality requirement (building permit) challenges

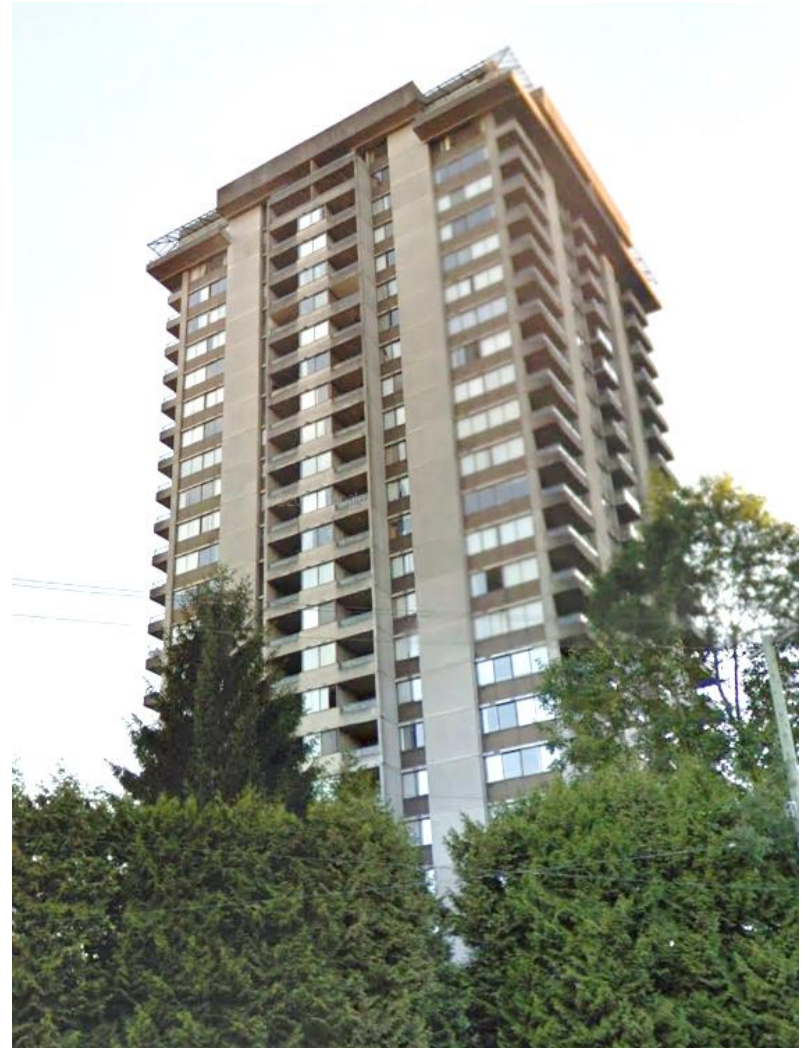
- Highrise + townhouse complex
  - Constructed in 1981
- 25 storeys, 188 suites (not sprinklered)
  - Reinforced concrete structure
  - Cast-in-place concrete
  - Precast concrete panels
  - Early window wall type of glazing assemblies

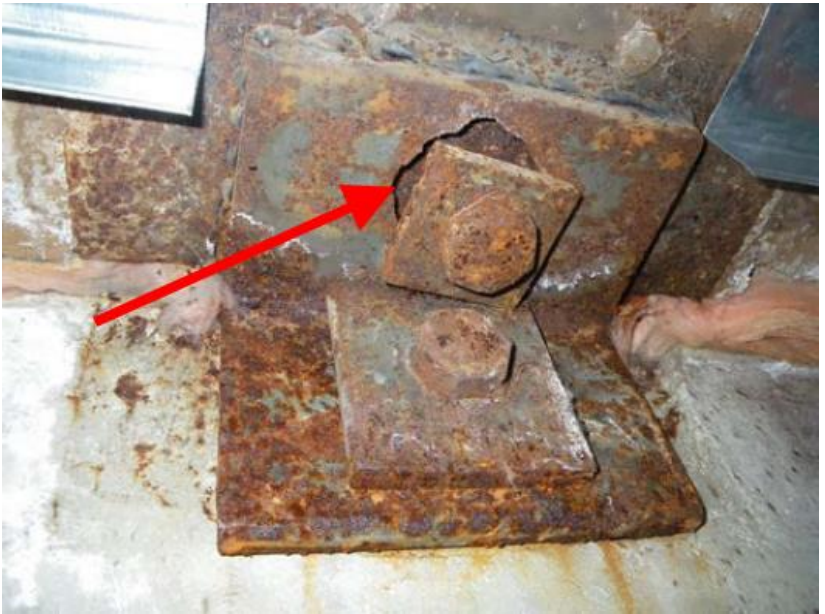
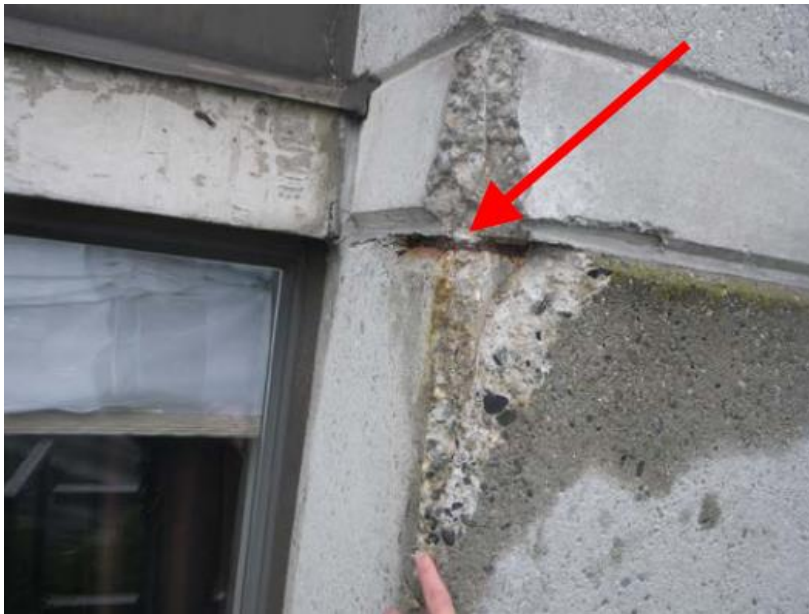
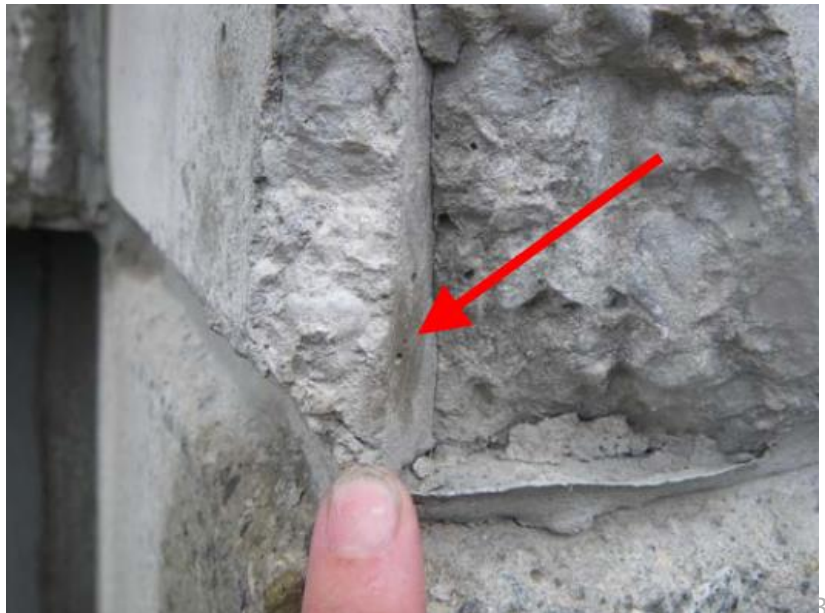
- Water ingress resulted in:
  - Corrosion of brackets
  - Spalling of concrete

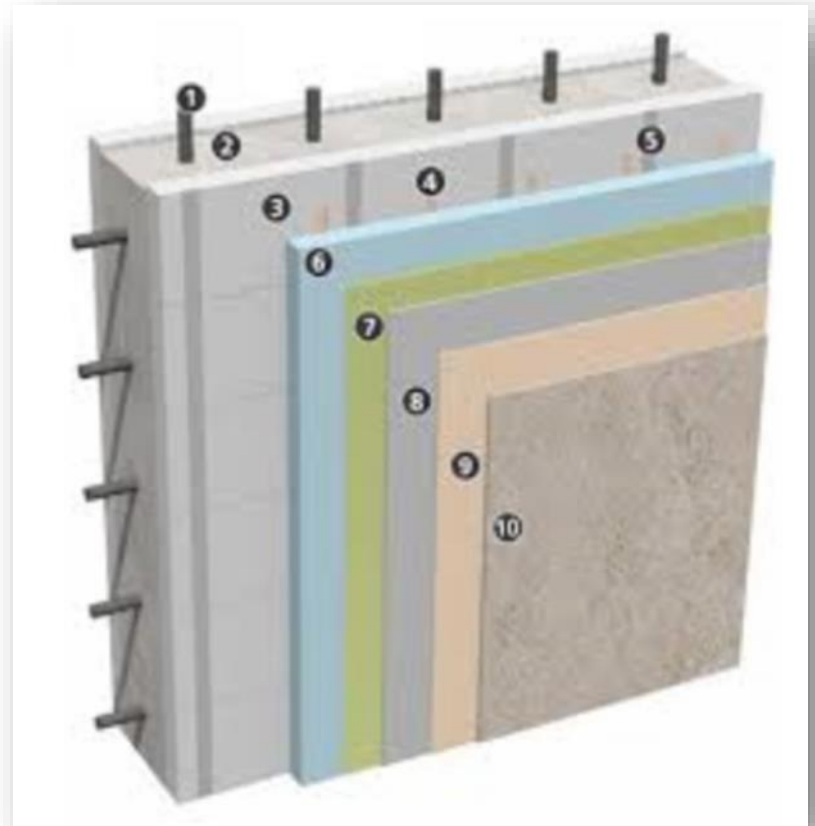
- Solution was to overclad the pre-cast concrete panel walls with an exterior insulated finish system (EIFS)
  - Due to the building being unsprinklered, mineral fibre insulation must be installed
- Effective R-Value was to increase from R4 to R18
- Great, so how do we attach mineral fibre insulation to pre-cast concrete?

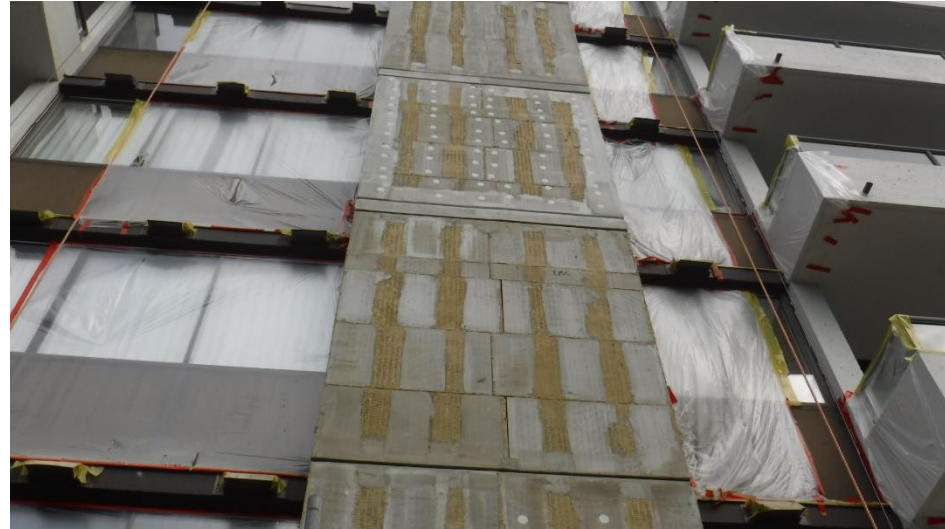
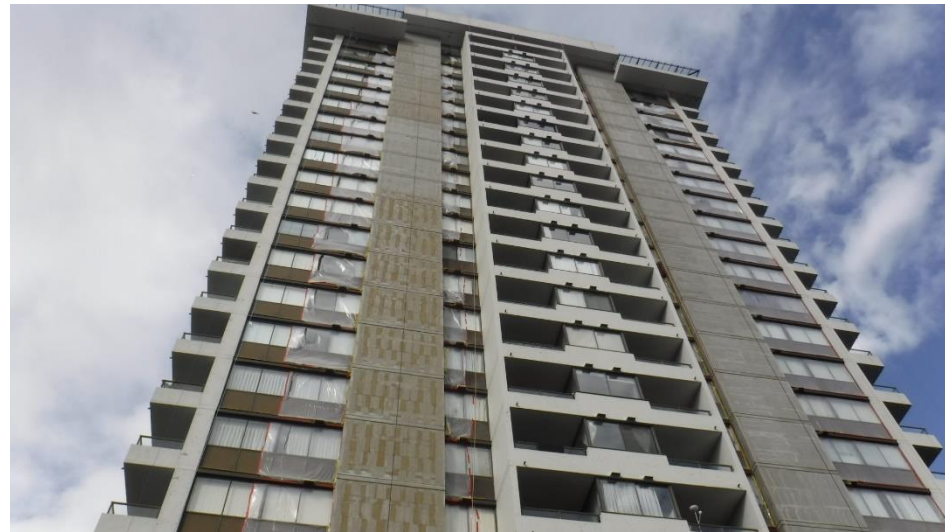
- Pull testing confirmed designed system provided sufficient pull-out resistance
- Thicker-than-typical EIFS lamina provided durability to absorb subtle movements of the mineral fibre insulation boards

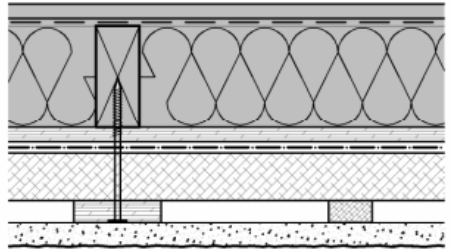
W1	TYPICAL STUCCO CLAD EXTERIOR WALL ASSEMBLY	<ul style="list-style-type: none"><li>• EXISTING INTERIOR GYPSUM WALLBOARD</li><li>• EXISTING POLY VAPOUR BARRIER</li><li>• EXISTING BATT INSULATION (REPLACE DETERIORATED INSULATION AS DIRECTED BY CONSULTANT)</li><li>• EXISTING 2 x 4 WOOD FRAMING (REPLACE DETERIORATED FRAMING AS DIRECTED BY CONSULTANT). PROVIDE ADDITIONAL 2 x 4 WOOD STUDS AS REQUIRED</li><li>• 1/2" PLYWOOD SHEATHING</li><li>• WEATHER BARRIER MEMBRANE</li><li>• 2" HIGH DENSITY MINERAL FIBRE INSULATION</li><li>• 3/4" AIR SPACE</li><li>• 3/4" x 3" PLYWOOD VERTICAL STRAPPING (INSTALLED PLUMB AND SNUG TO INSULATION) @ 16" O.C. max., C/W LAG SCREWS @ 16" O.C. VERTICALLY INTO CENTRE OF EXISTING WOOD STUDS</li><li>• HIGH DENSITY MINERAL FIBRE VERTICAL SUPPORT STRIPS MIDPOINT BETWEEN VERTICAL STRAPPING</li><li>• 7/8" STUCCO ASSEMBLY C/W STUCCO BACKING PAPER &amp; ACRYLIC FINISH COAT</li></ul>

<p>The diagram shows a cross-section of a wall assembly. The interior side (top) shows a layer of insulation with a vertical stud. The exterior side (bottom) shows a layer of insulation with a vertical stud. The diagram is labeled 'INTERIOR' at the top and 'EXTERIOR' at the bottom.</p>

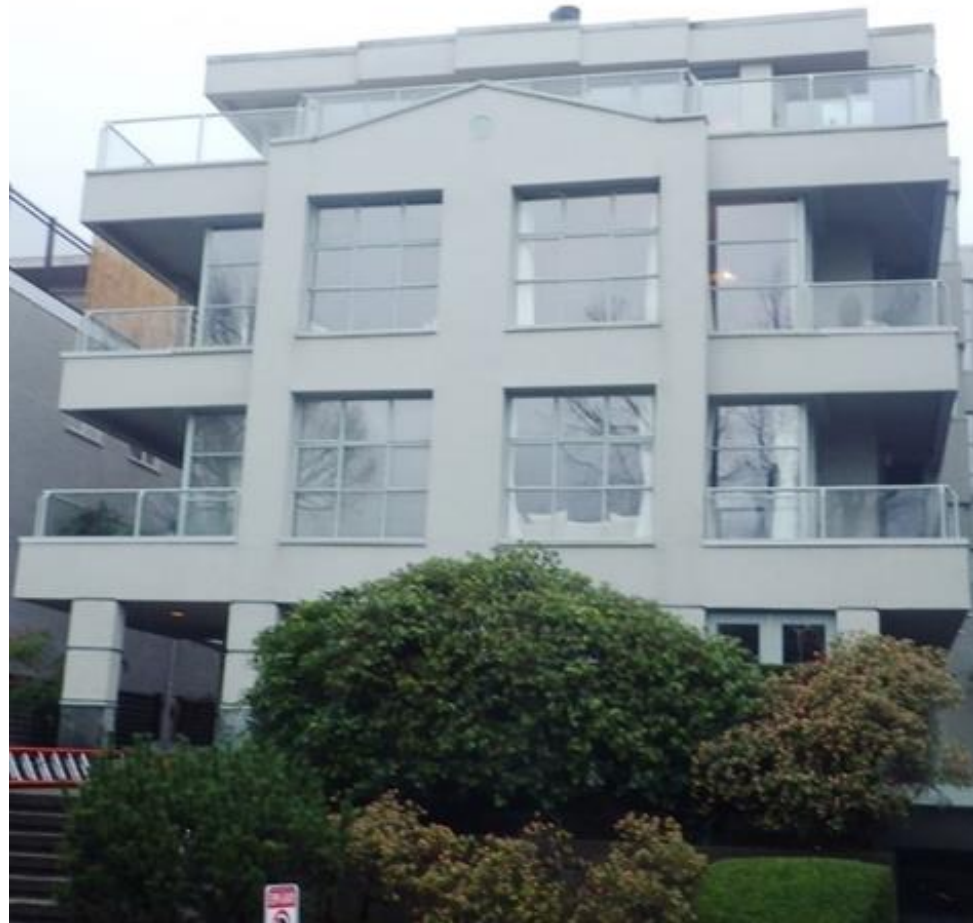
- Four storeys, 7 suites
- Non-combustible construction
- Circa 1983 construction
- Full building enclosure rehabilitation
