GLAZING RENEWAL

The Finite Life Of IGUs...
Like Death And Taxes – You Can't Avoid It!

CONCEPTUAL SUMMARY:

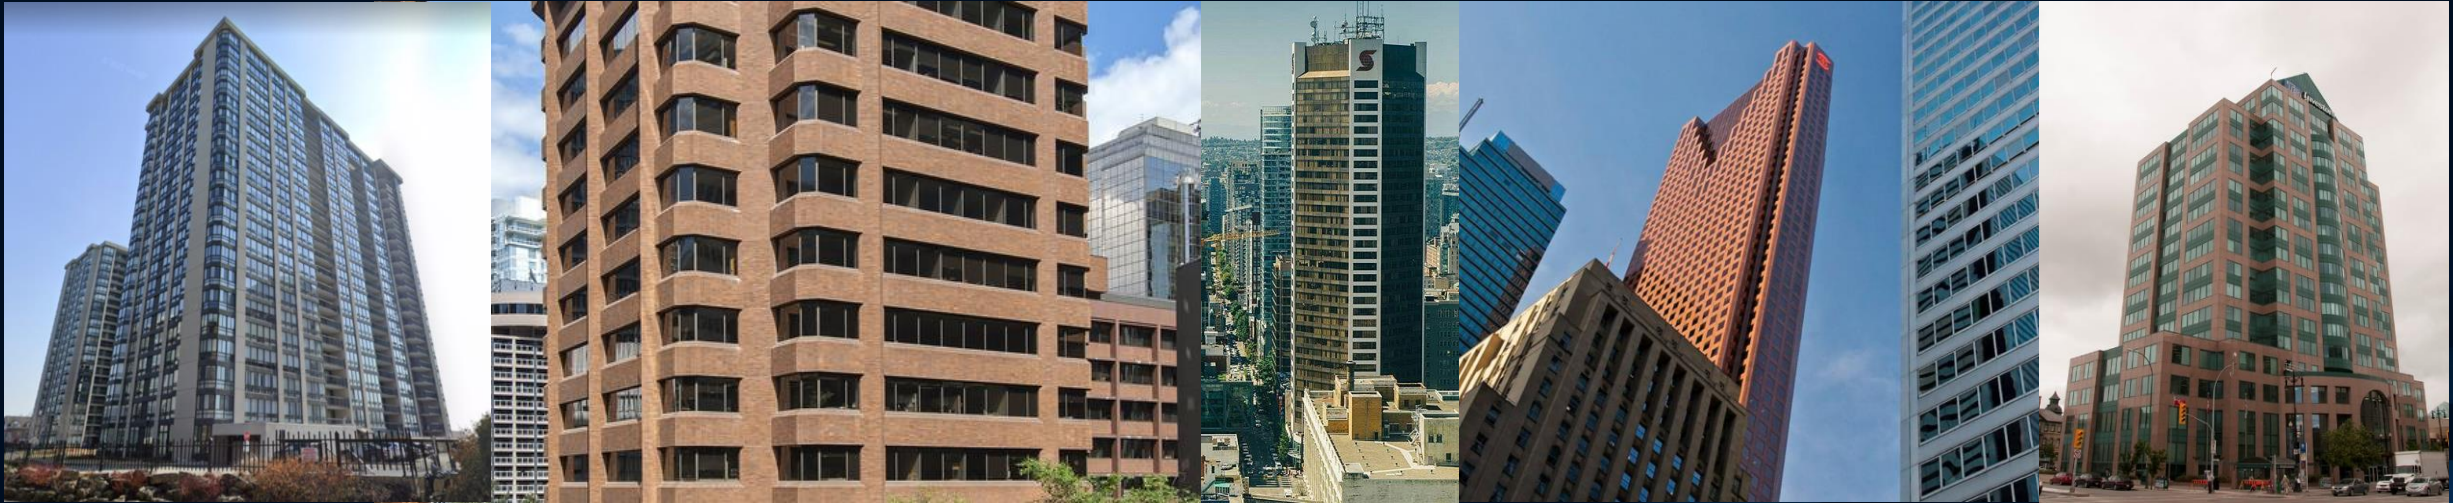
In 2000, 280 million m² of IGUs
manufactured globally – >80% in NA & Europe

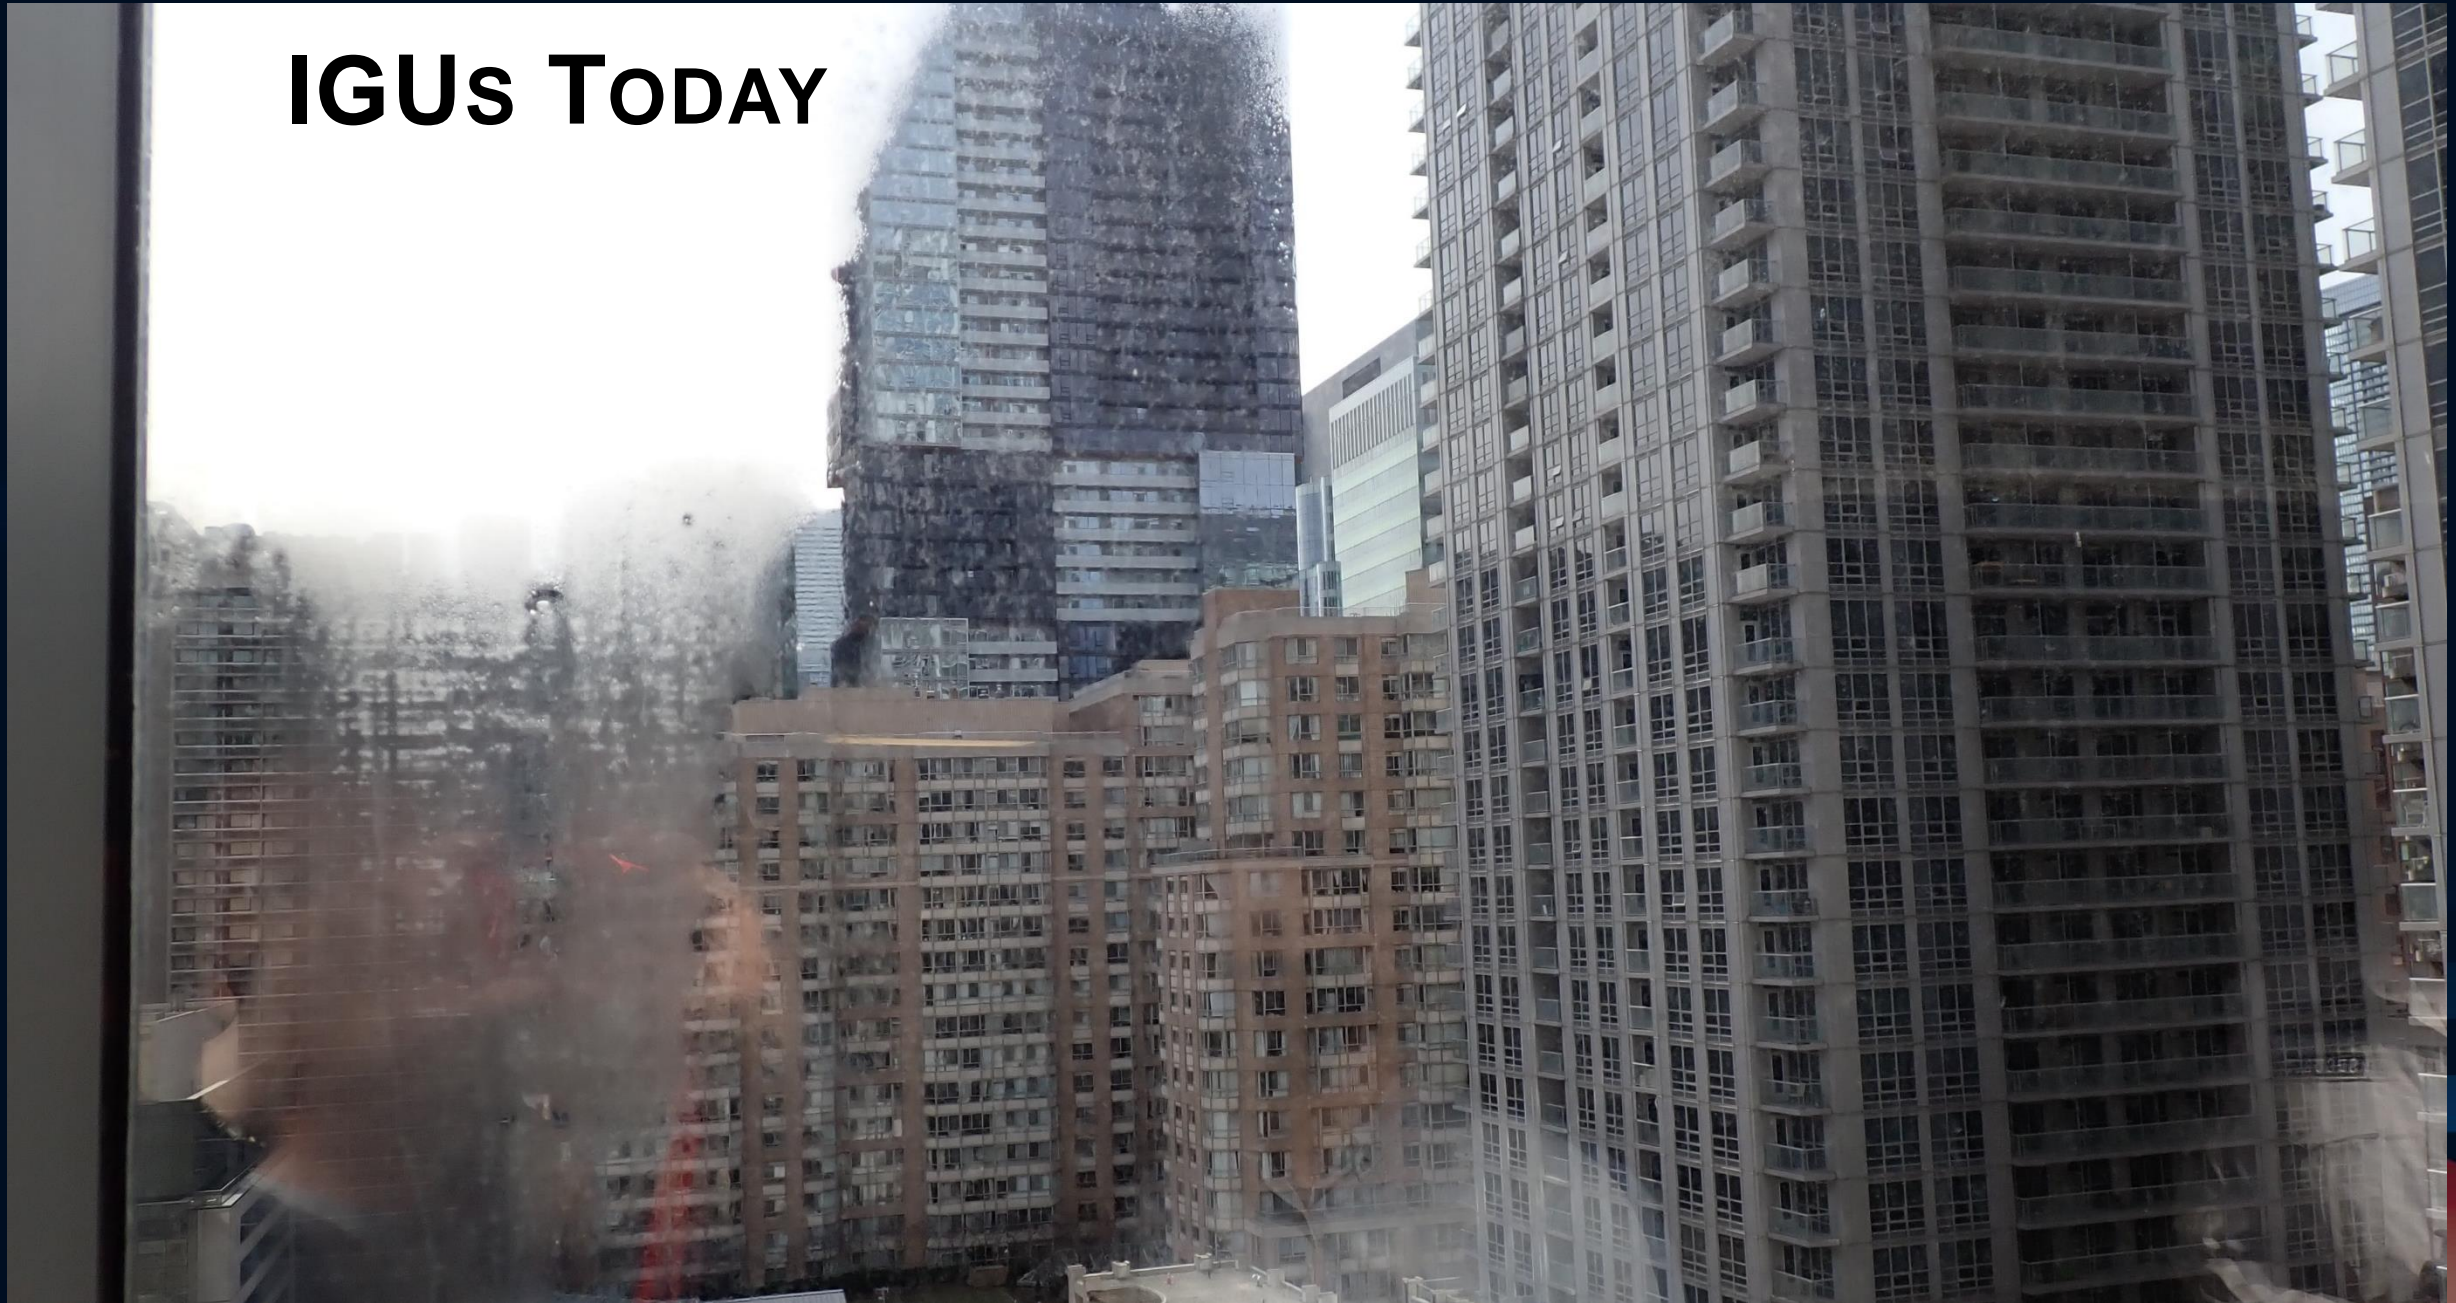
Condensation accumulation within IGU – between glass lites

Moisture, fog or dirt collection on glass surfaces located within air space...permanent material obstruction of vision through unit due to accumulation of dust, moisture or film on internal surface of glass

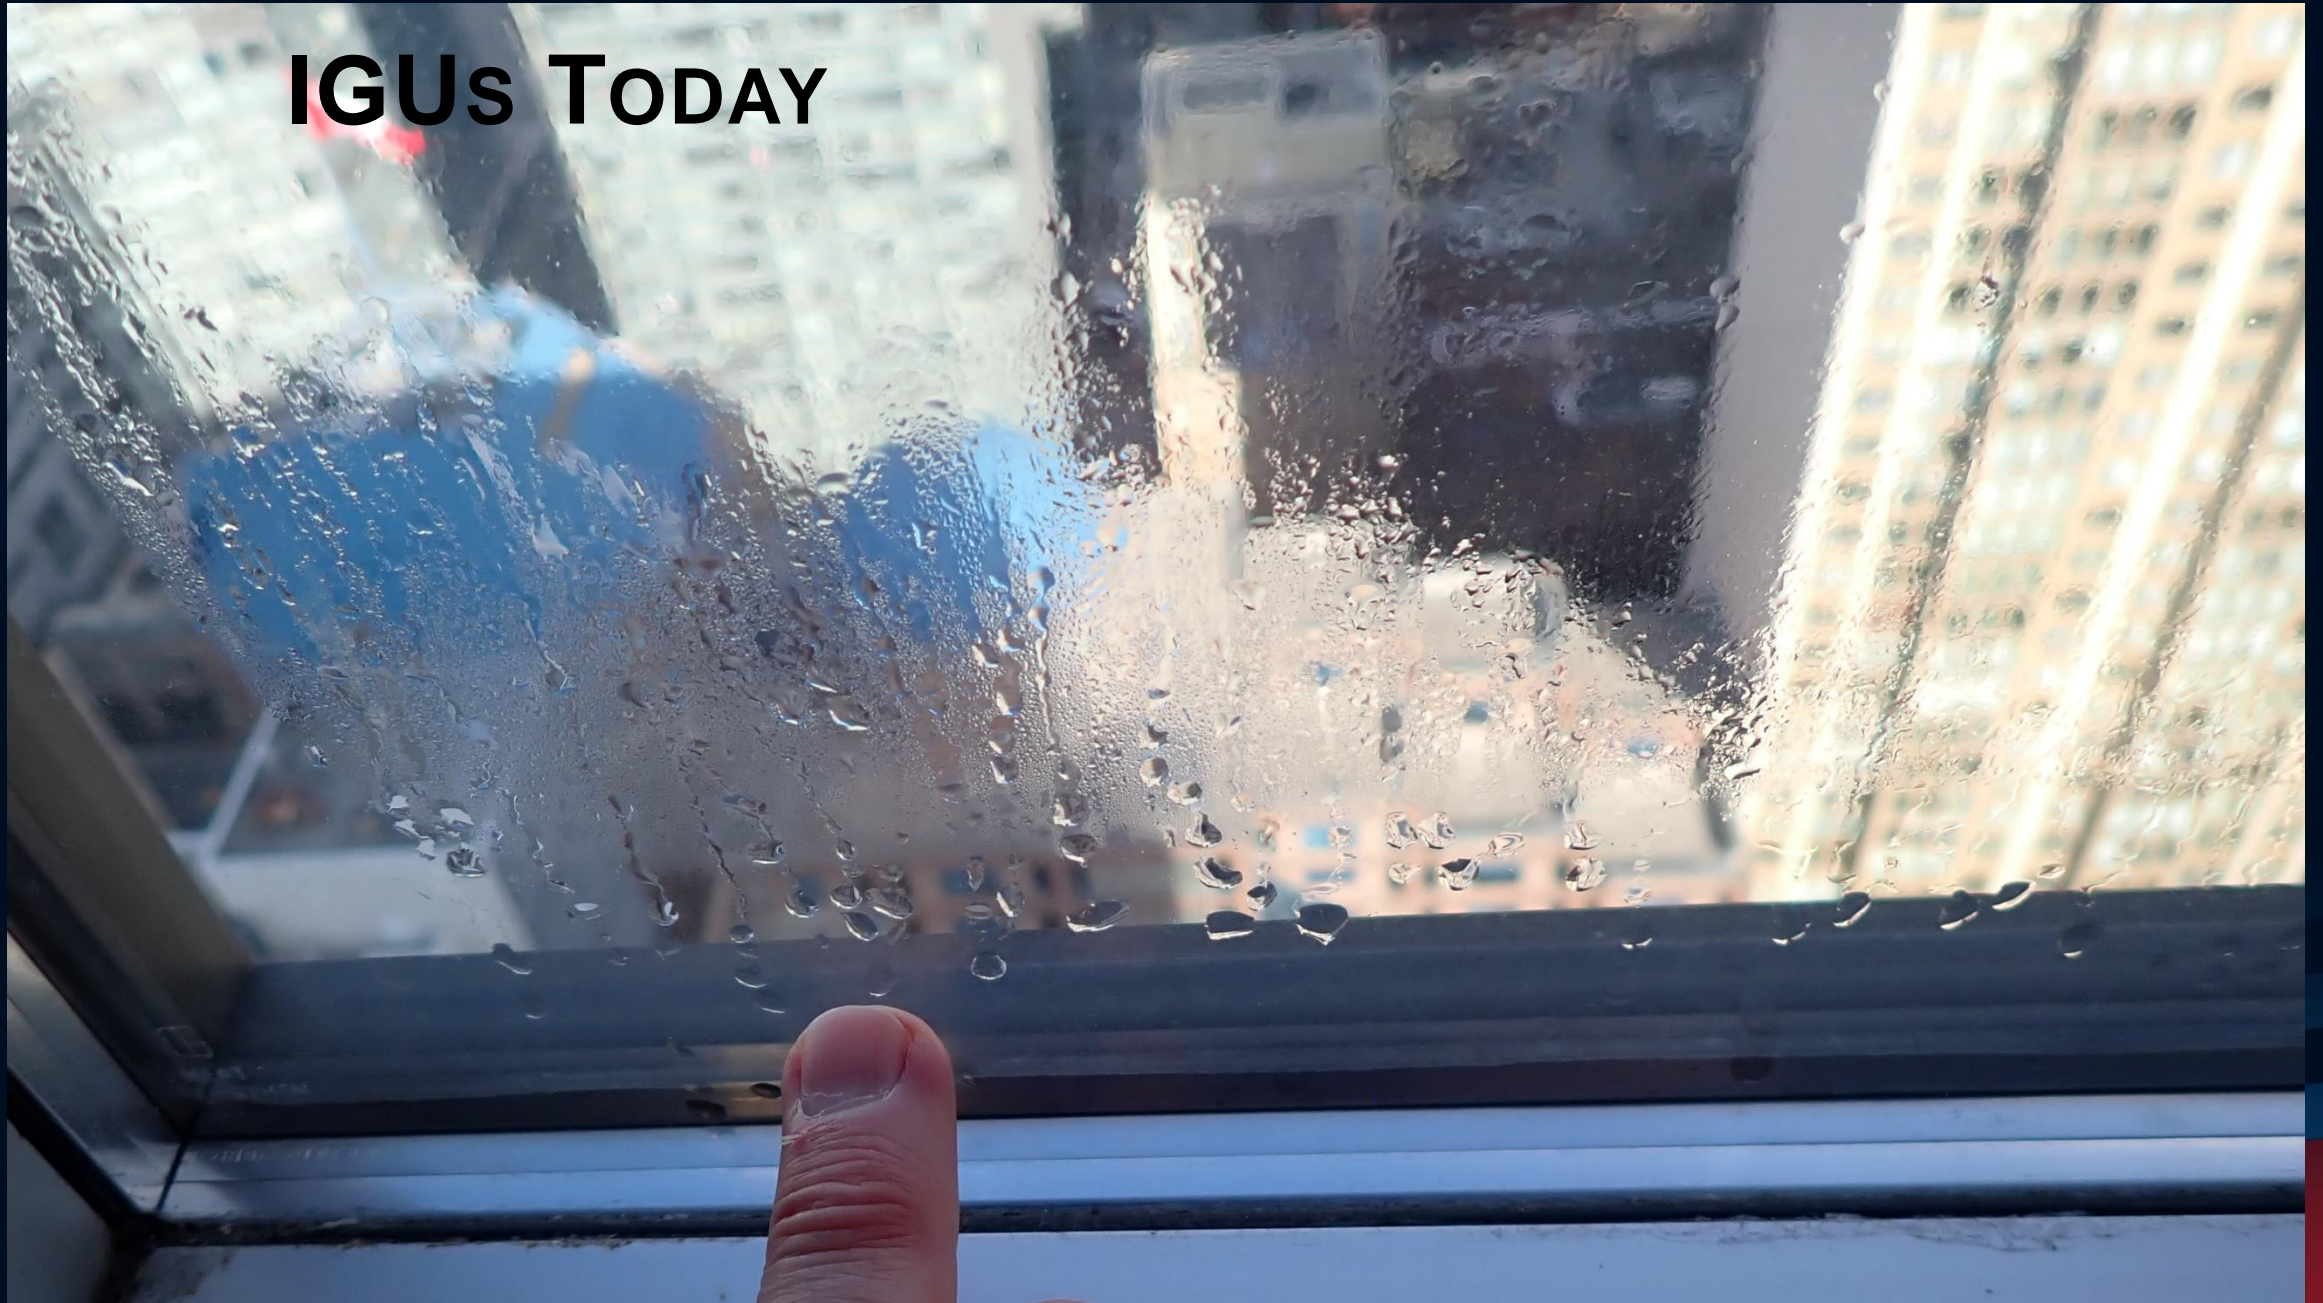
Condensation accumulation within IGU – between glass lites

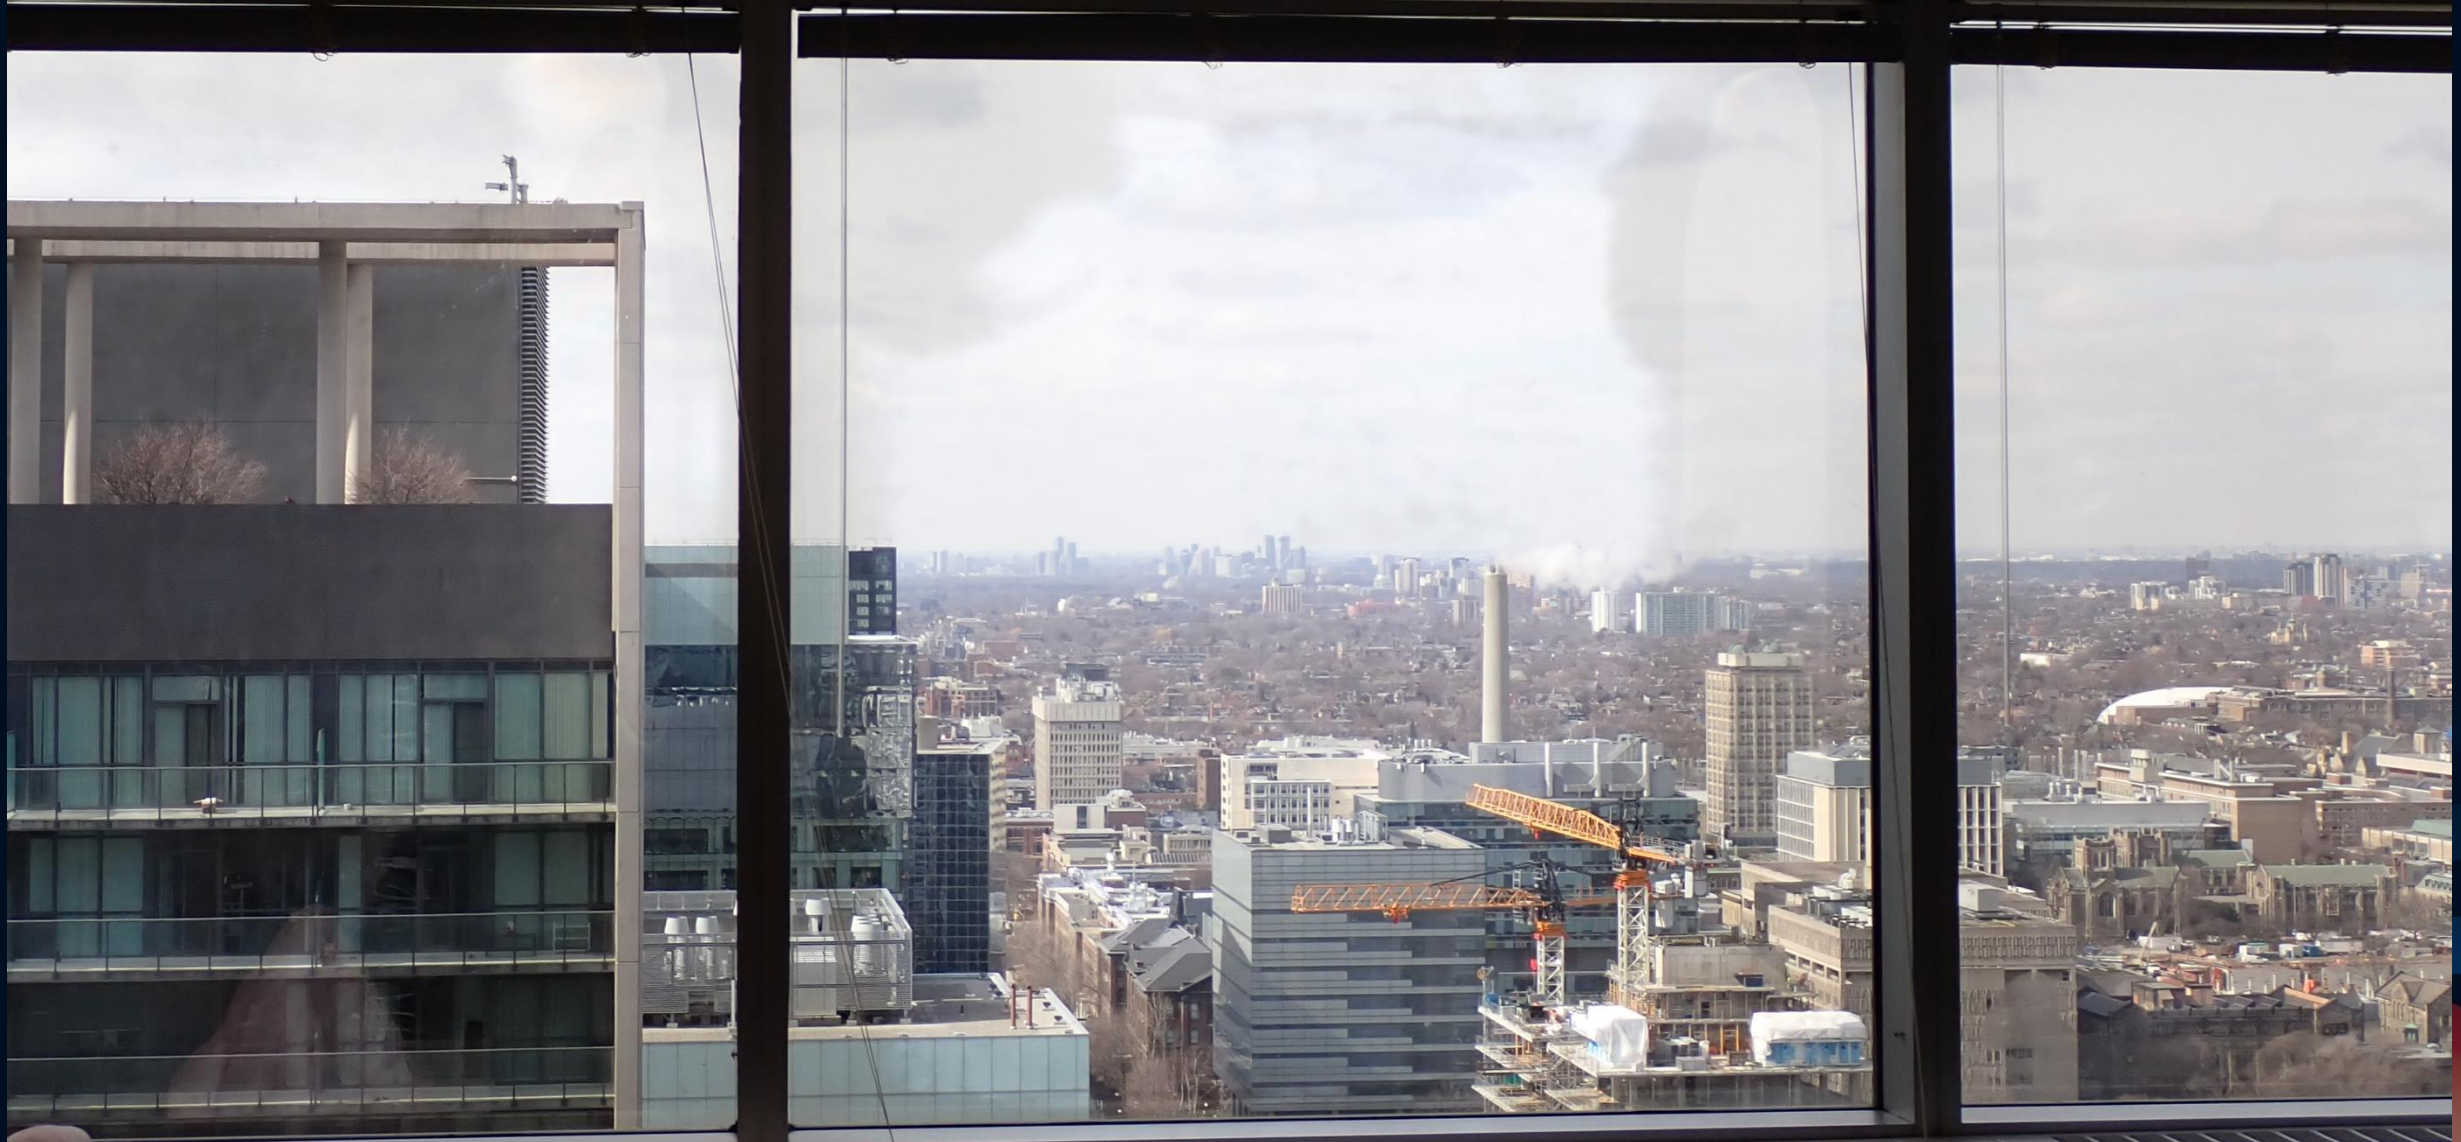
Deteriorating reflective coating (aesthetic anomaly = pending failure)

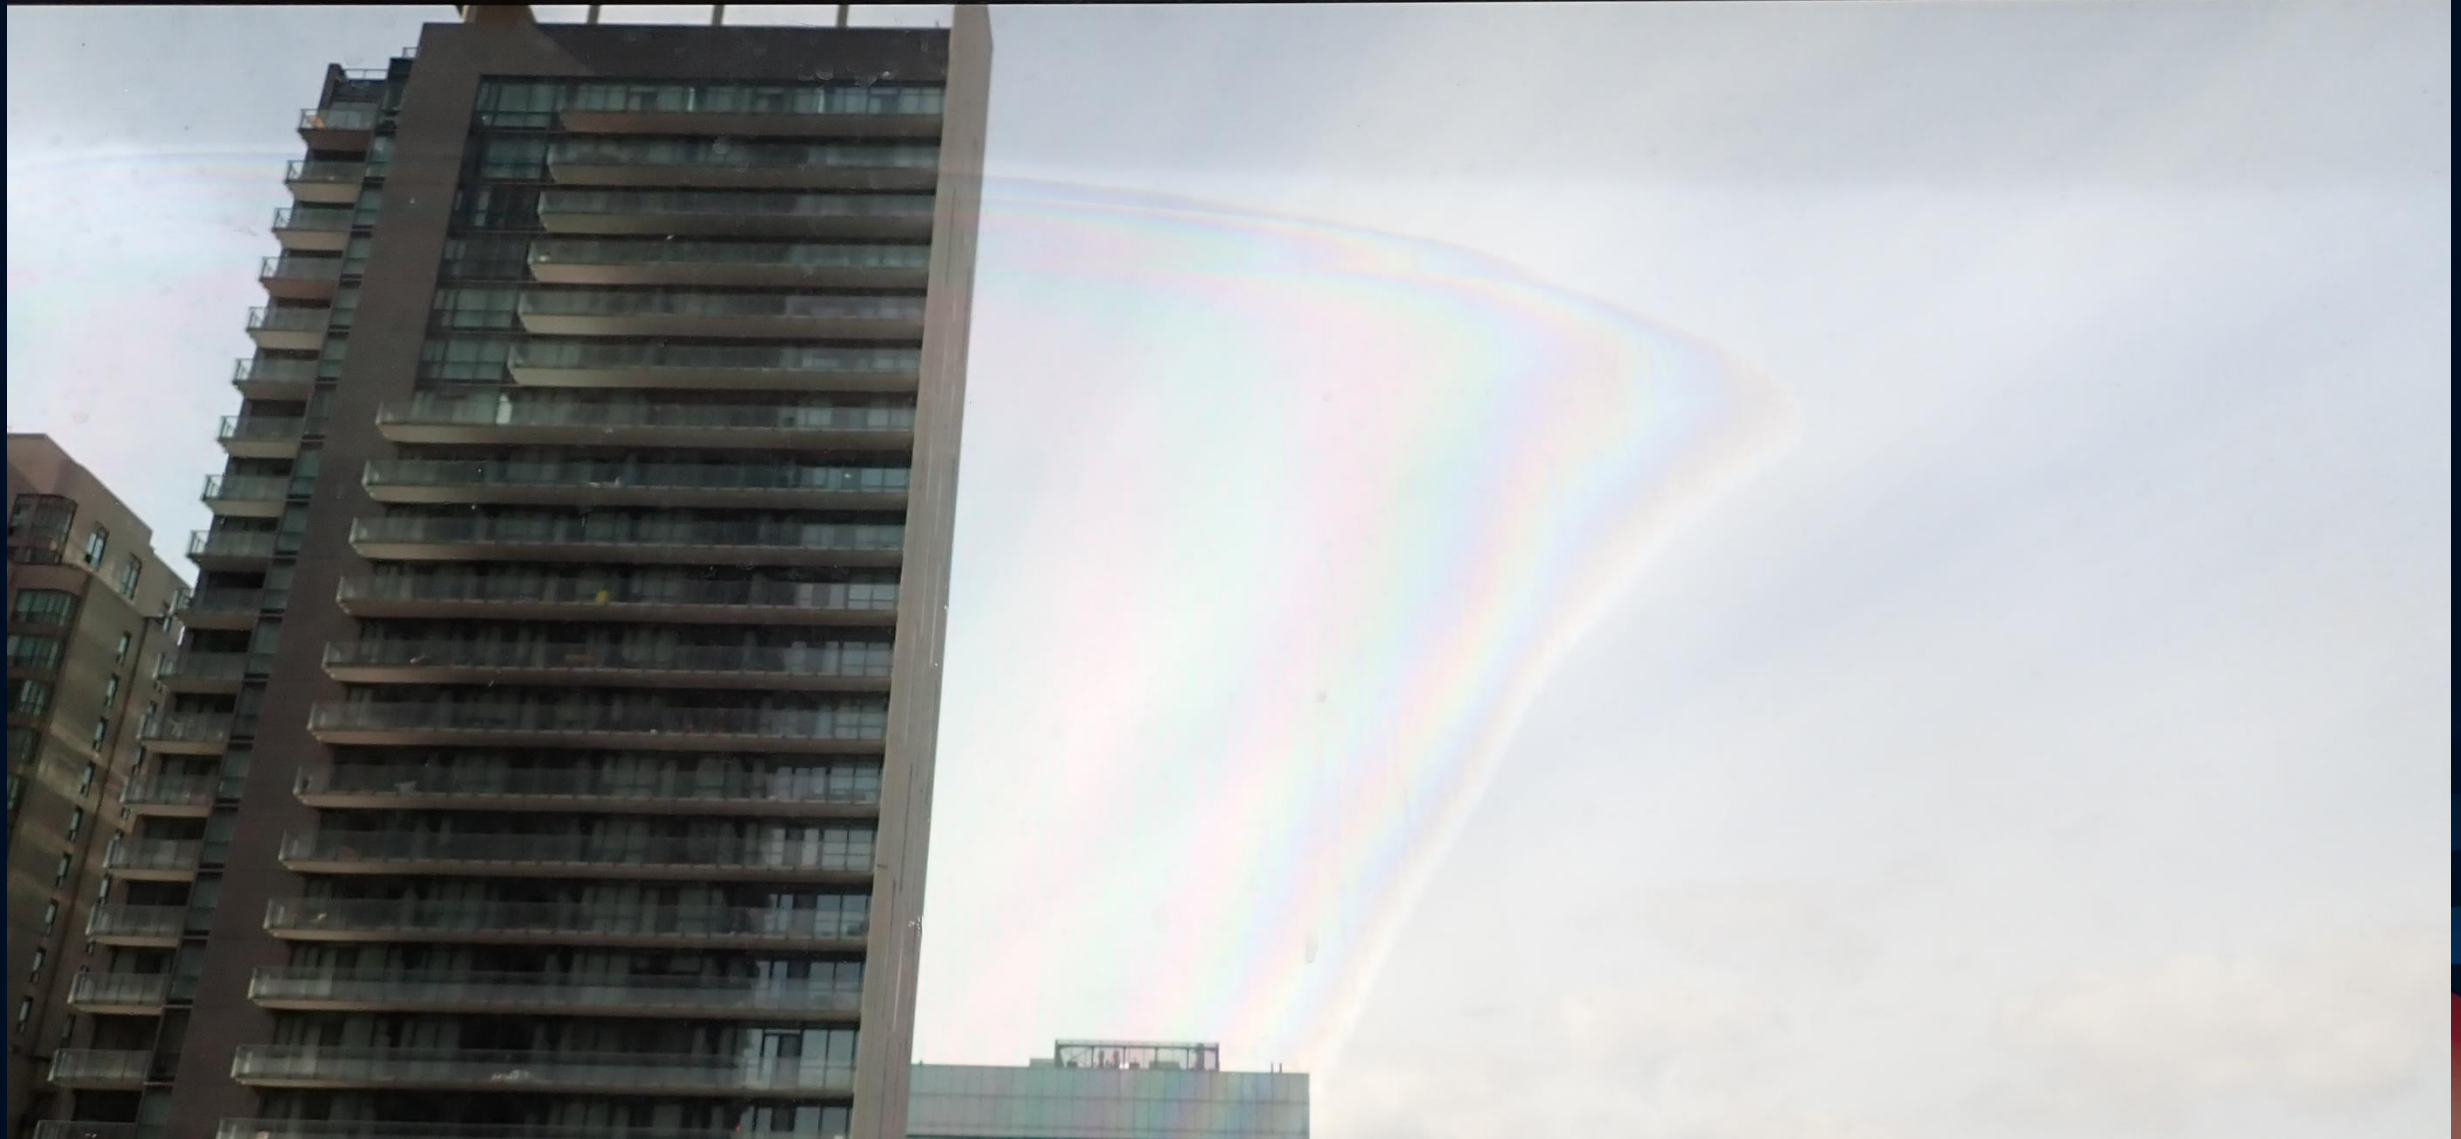
Deteriorating reflective coating (oily appearance)

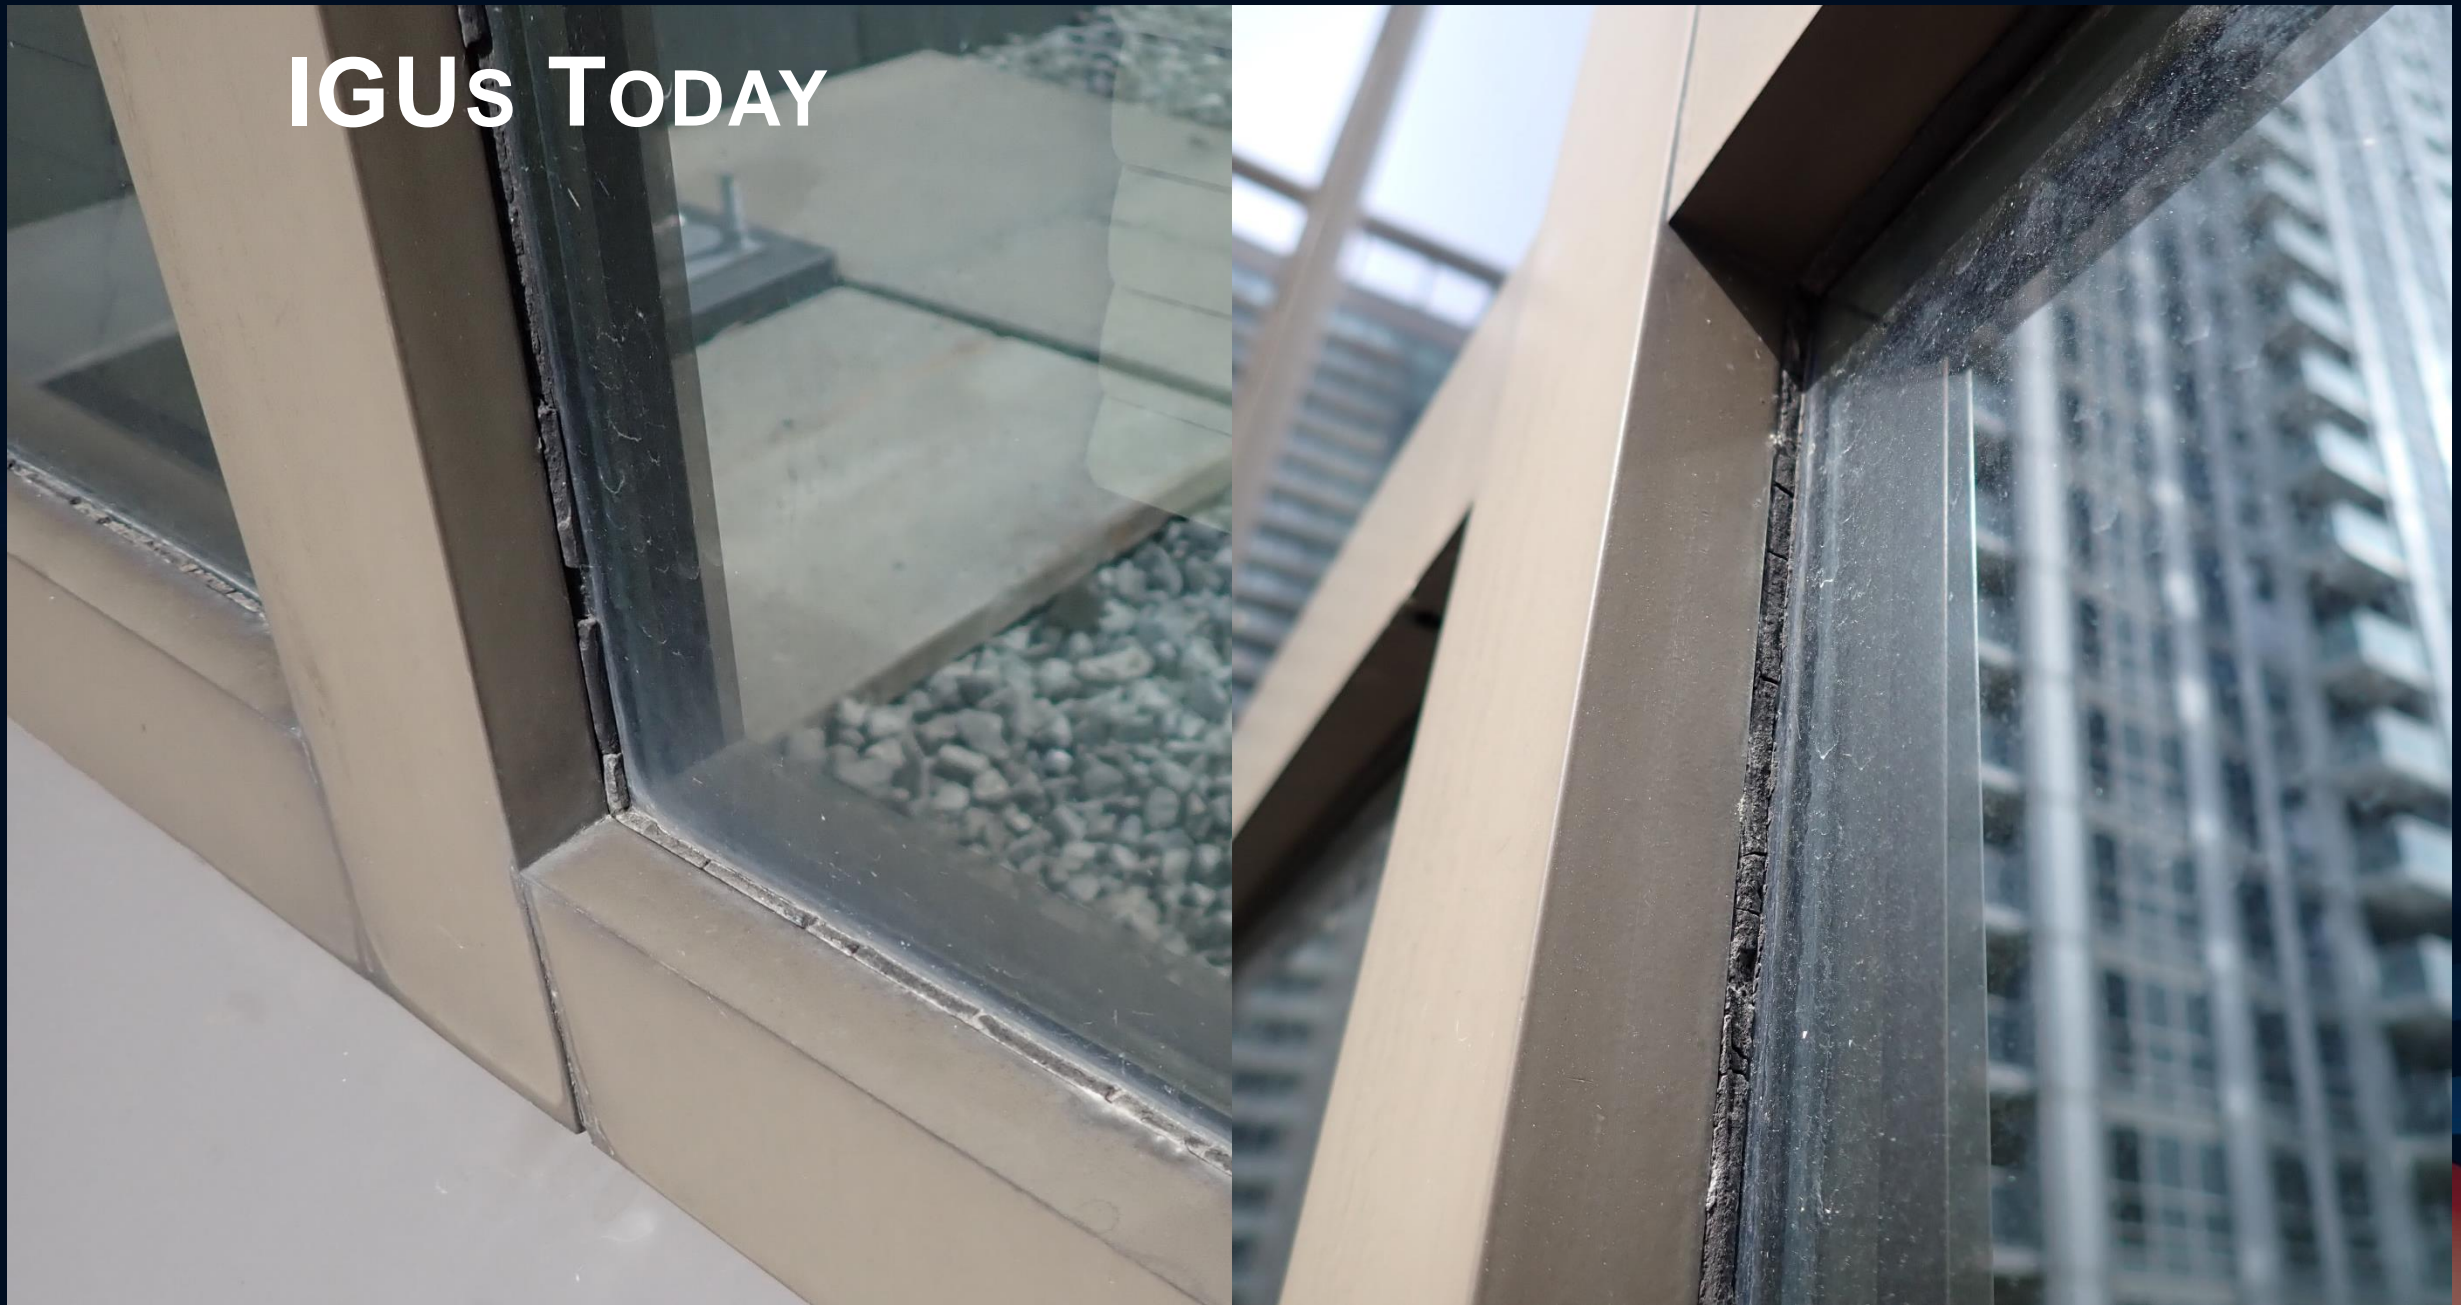
Deteriorating and aging exterior seals

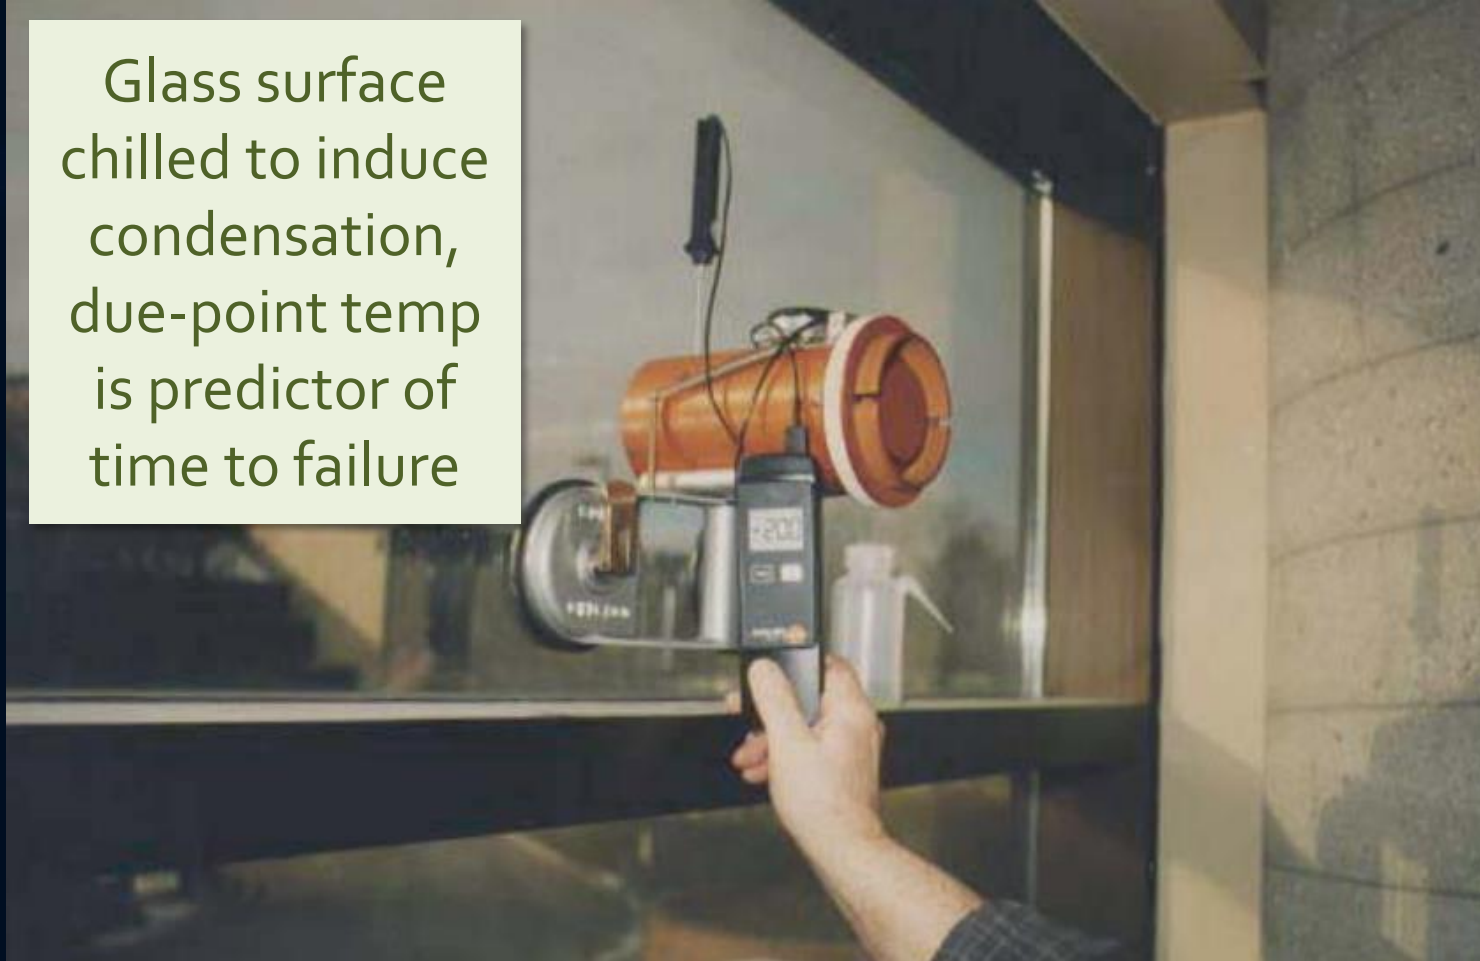
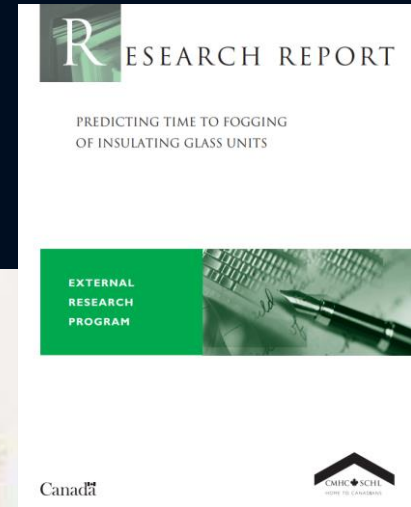
Glass surface chilled to induce condensation, due-point temp is predictor of time to failure

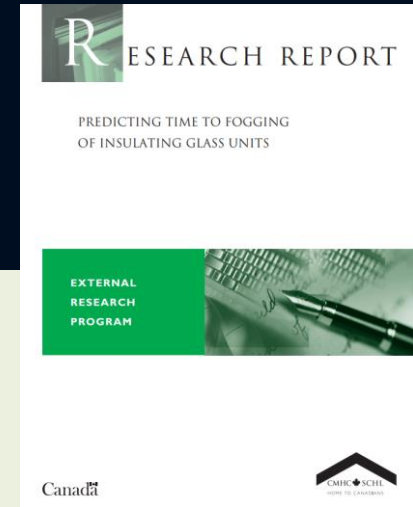
Pre-Study Method

- Relates dew-point temp to desiccant manufacturer's technical data
- Inability to predict failure beyond a two-year period

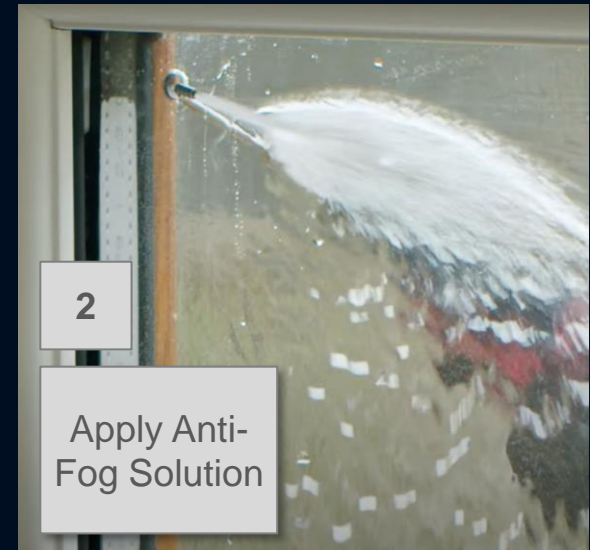
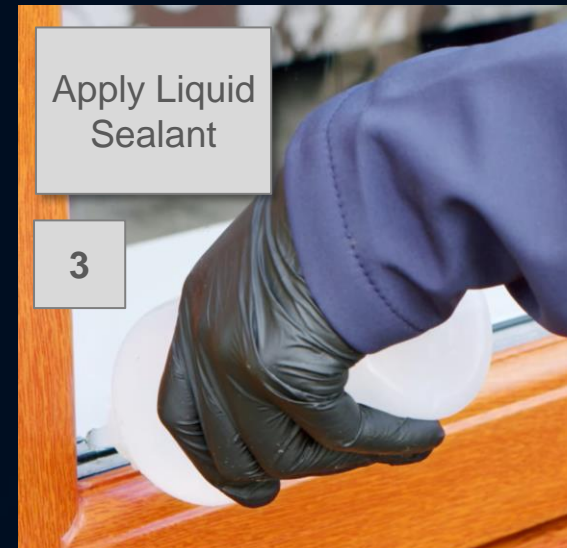
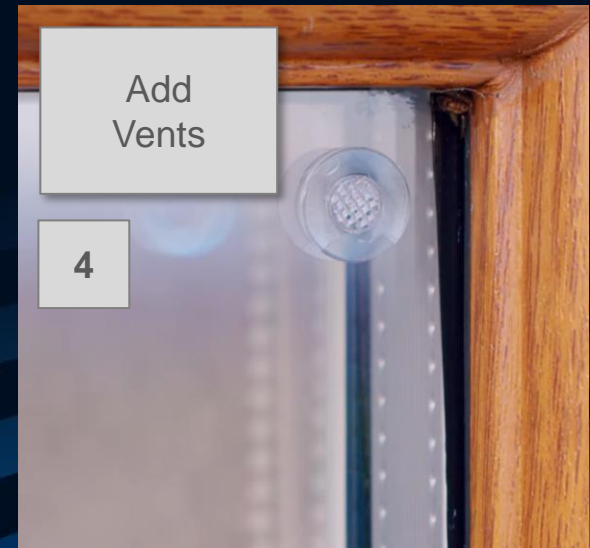
- IGUs repaired as failures happen
 - see steps:

- Worse-than-Like
 - Lower thermal performance (no gas fill, breathes)
 - Potential impact on coatings
 - Drilling not possible if outer glass is coated &/or strengthened
- Extended life, huge \$ savings
- Avoided Waste

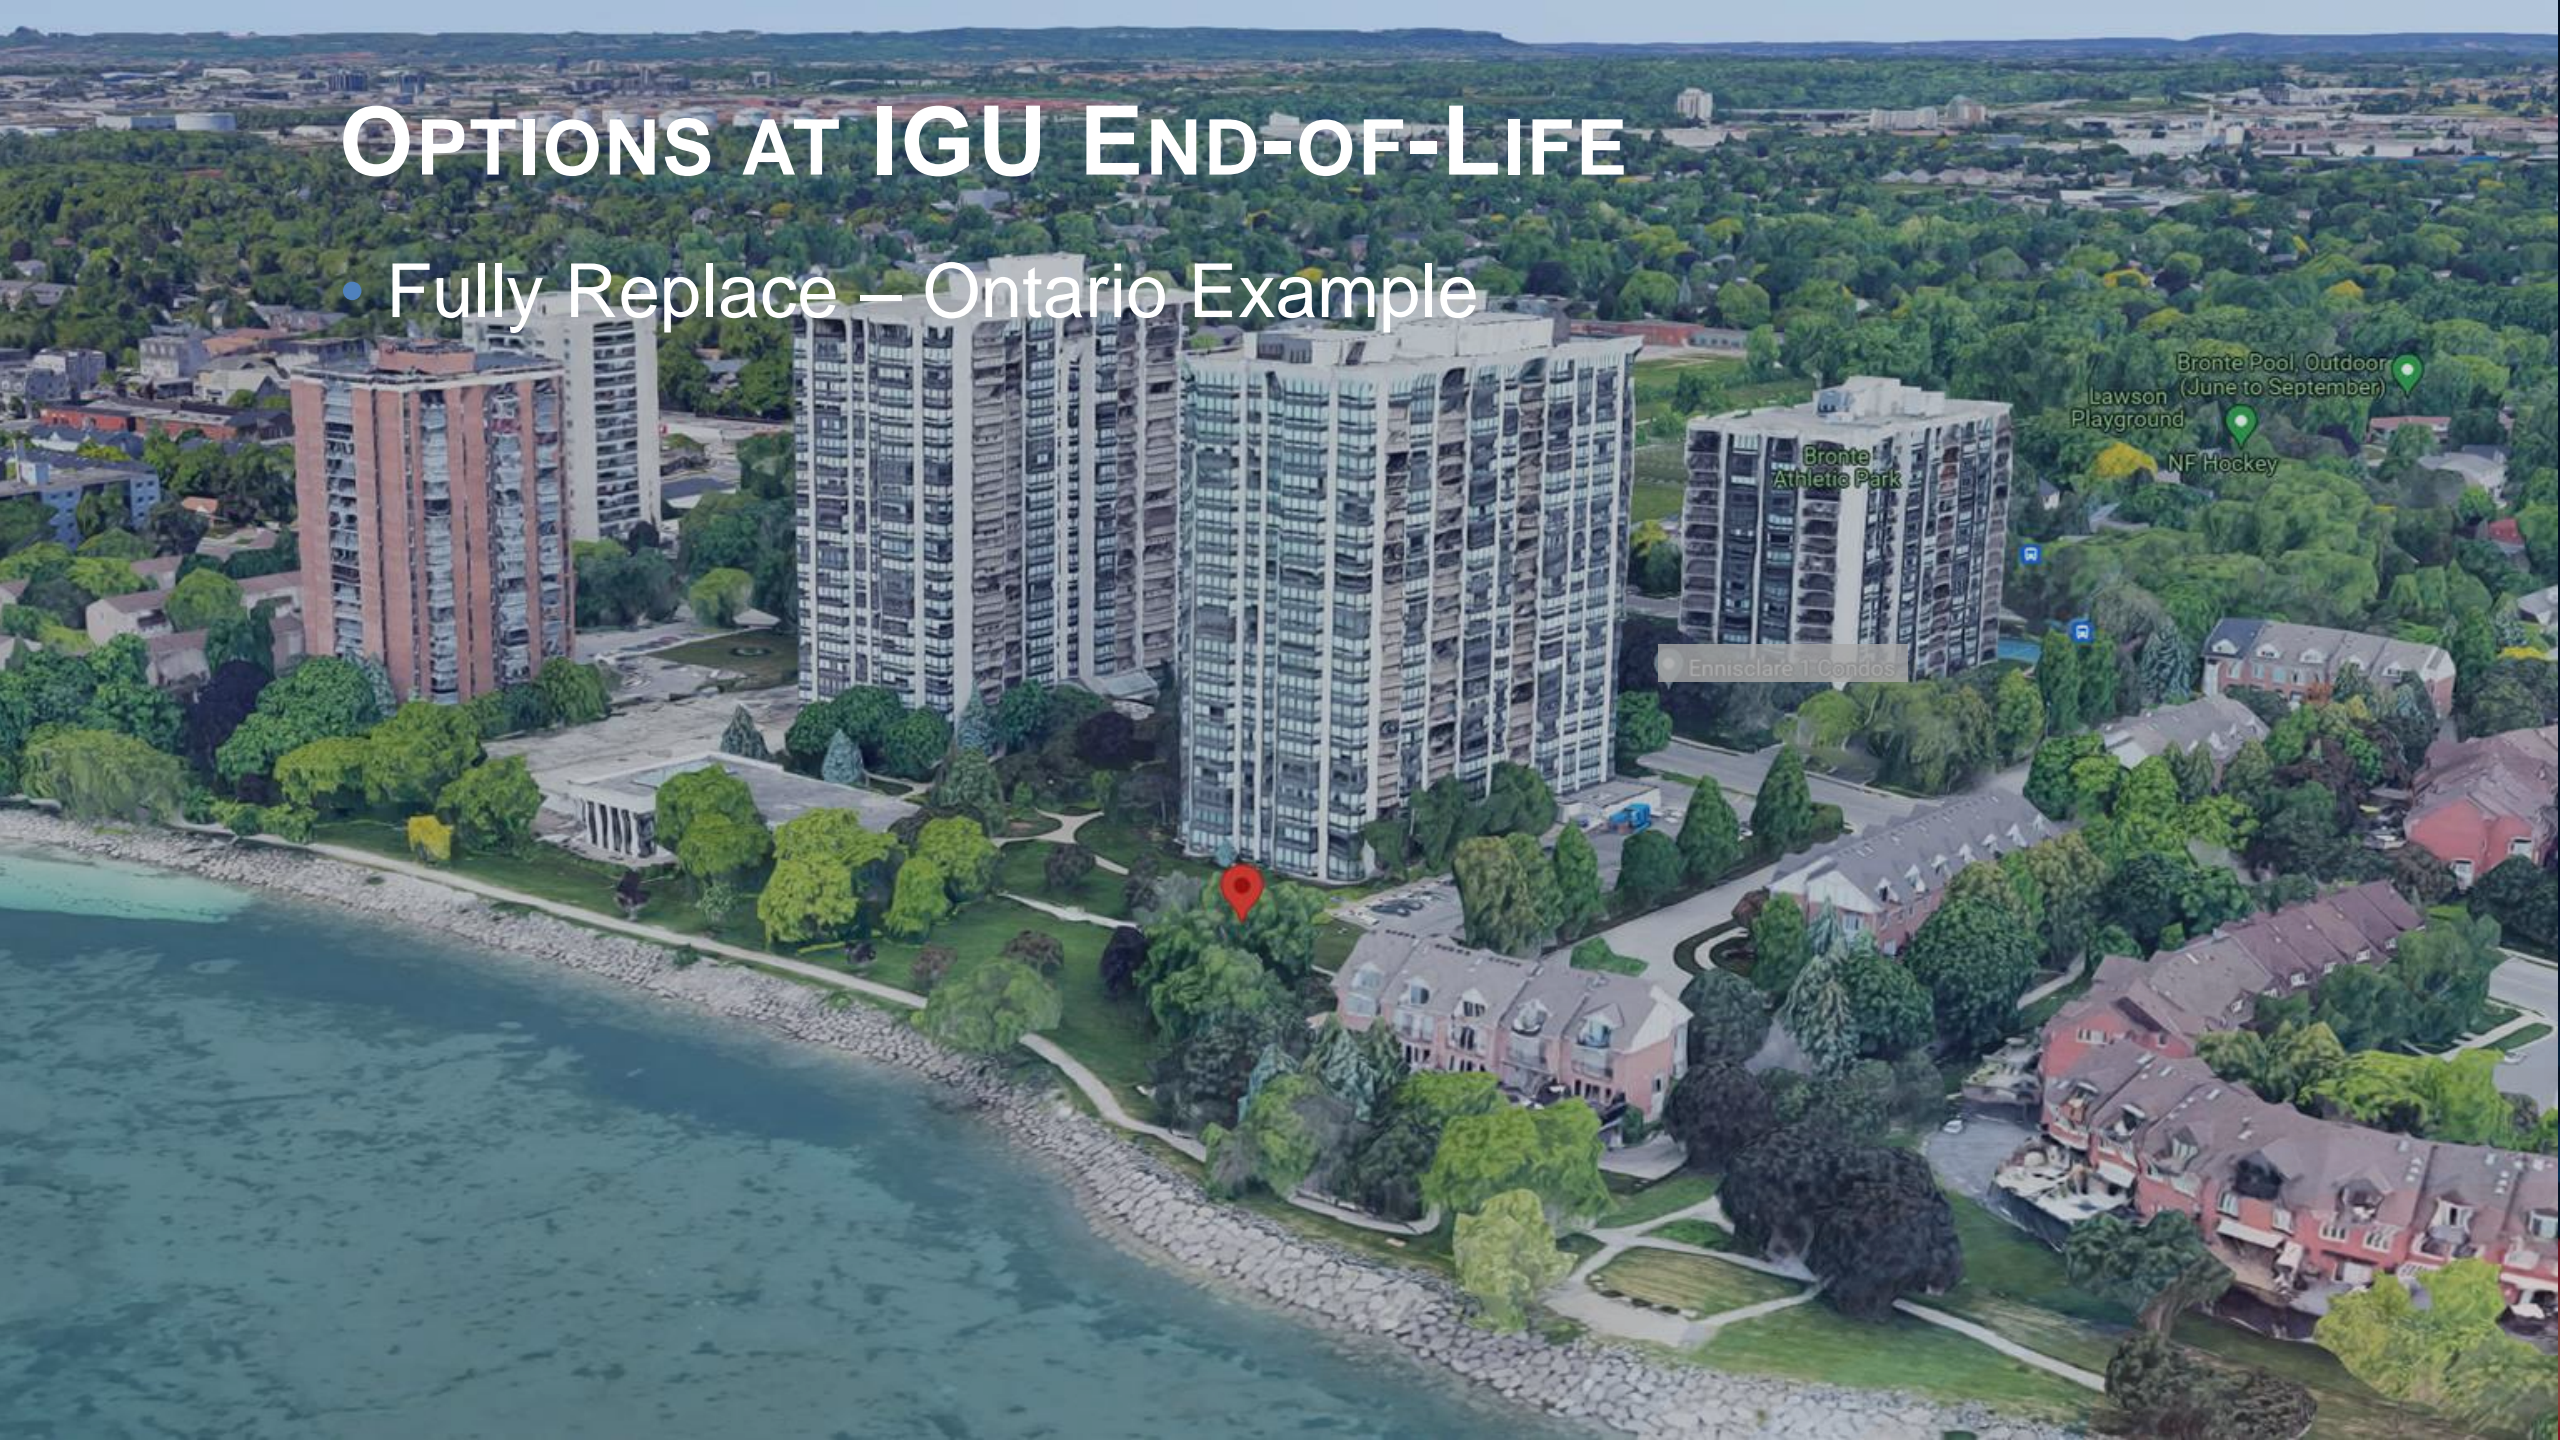
- Fully Replace – Ontario Example

- 1-coat low E (2 or 3 coat options)
- Warm edge spacers & Argon-filled
- Client decided to replace all at once
