GLAZING RENEWAL

The Finite Life Of IGUs...
Like Death And Taxes – You Can't Avoid It!

CONCEPTUAL SUMMARY:

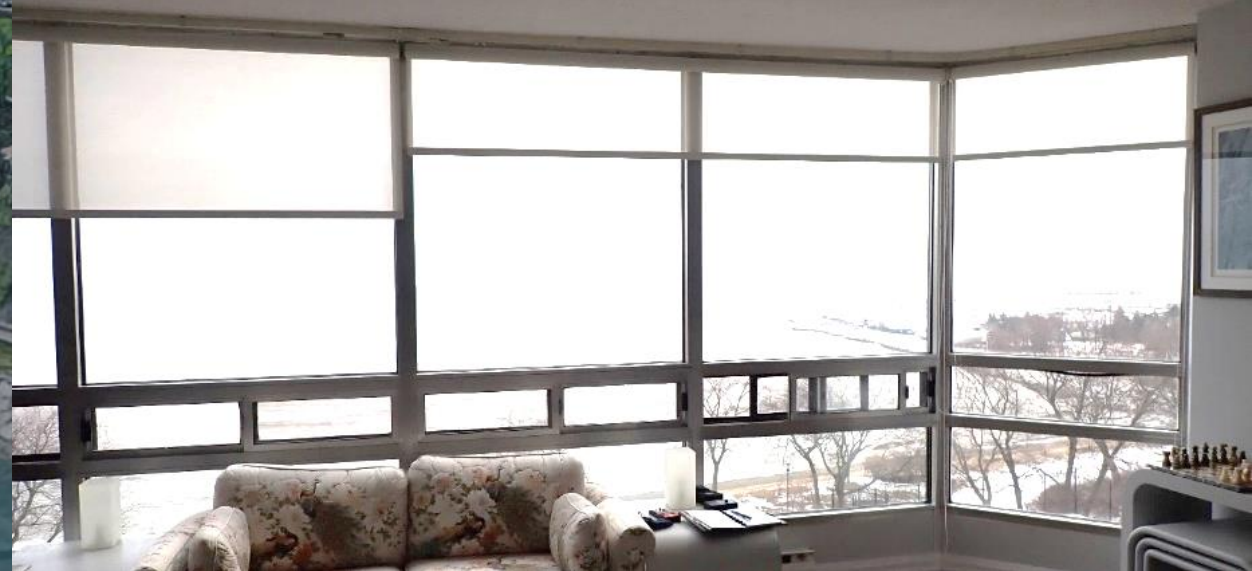
Better-than-Like Features:

- 1-coat low E (2 or 3 coat options)
- Warm edge spacers & Argon-filled
- Client decided to replace all at once

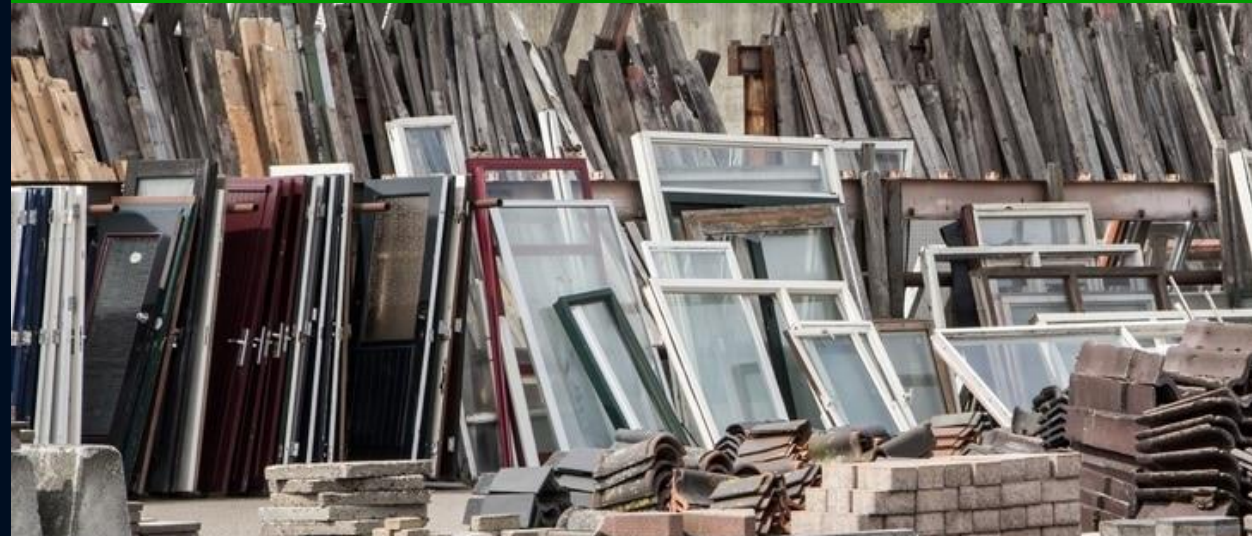
- Clear glass is infinitely reusable/recyclable
- However, measures intended to enhance performance in service (colour, coatings, lamination, etc.), render primary glass material unsuitable for recycling (in current recycling market)

Future IGUs need to be optimized for both energy & eventual reuse of all components

Future recycling markets need to better value non-clear &/or treated glass

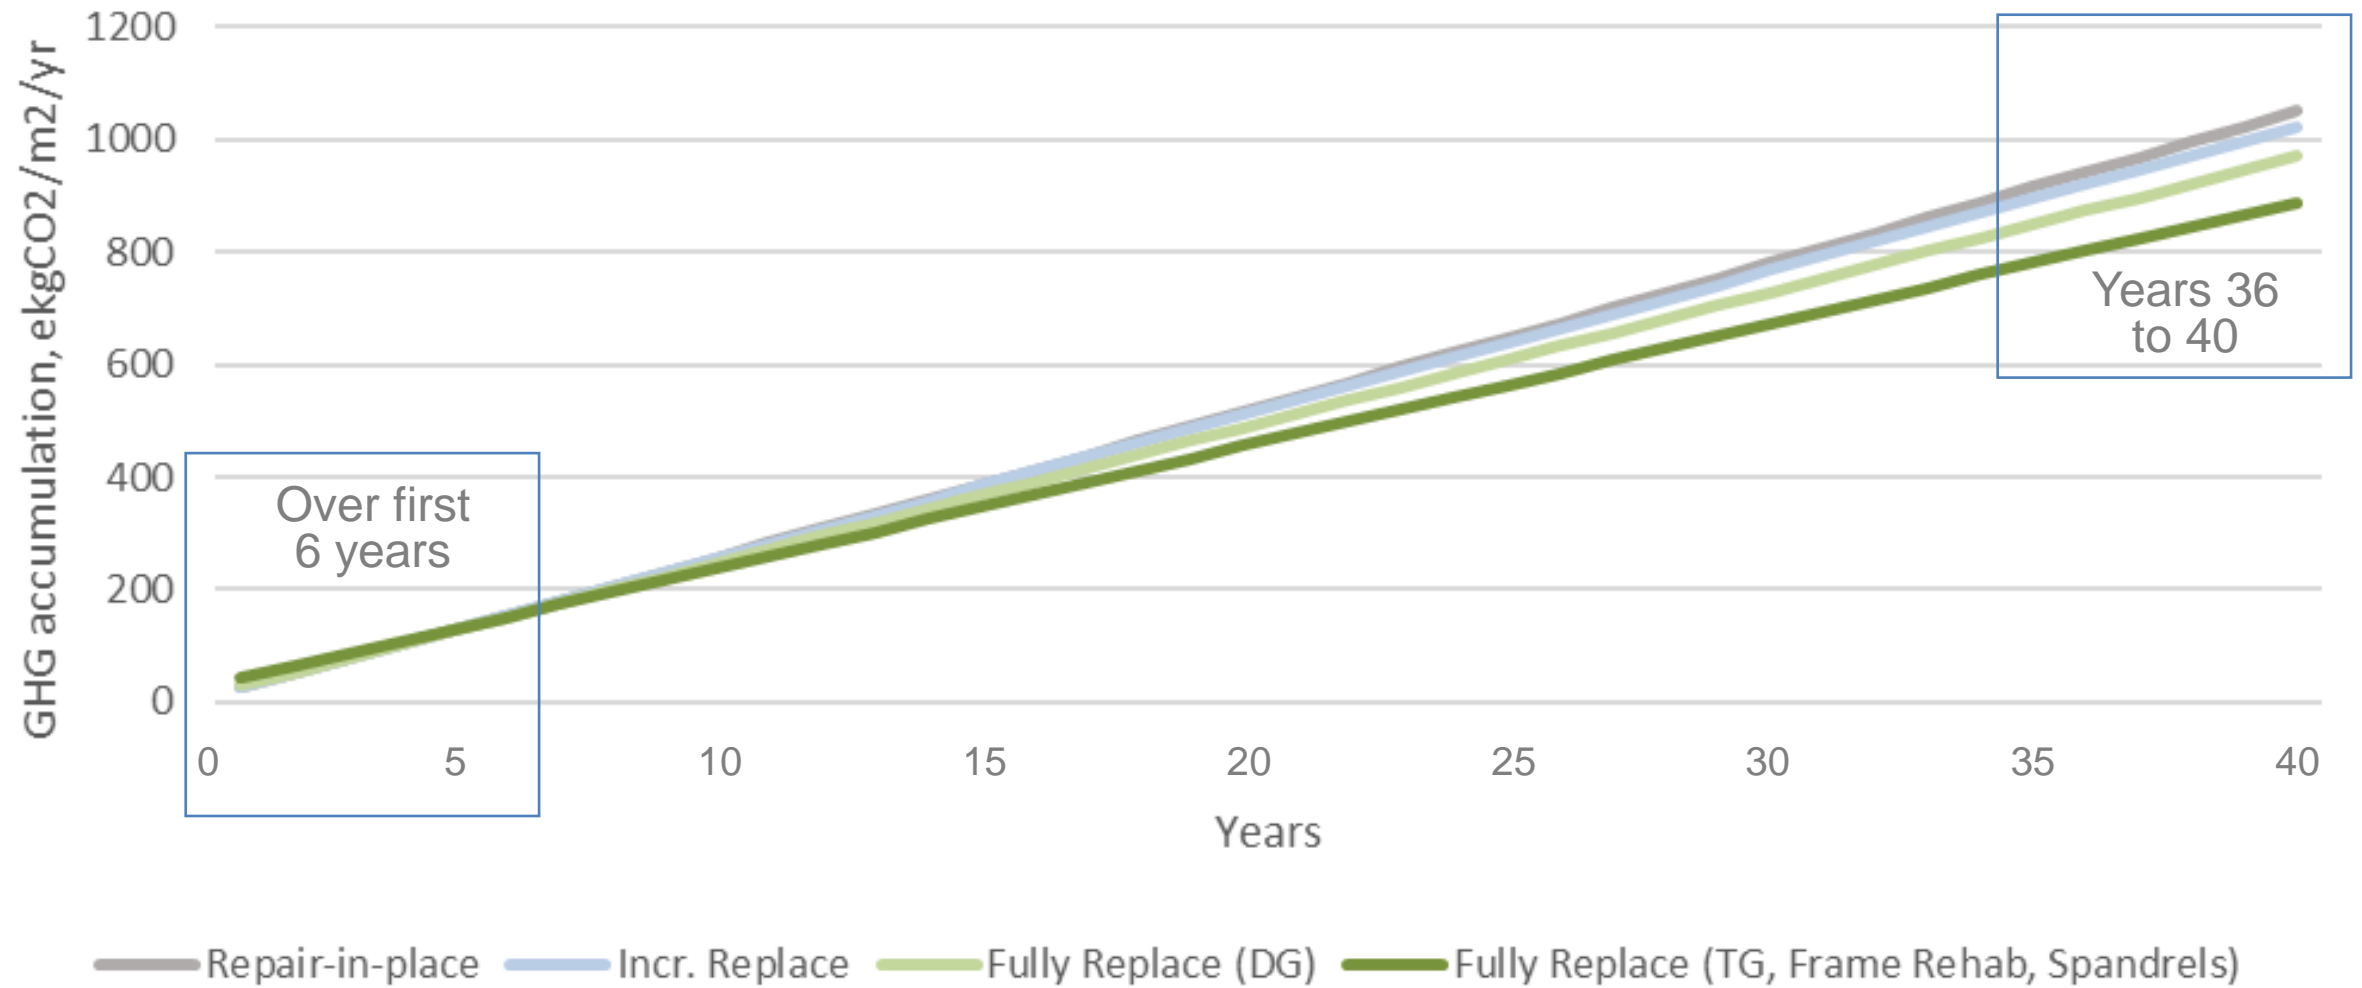
GHG over 40 years

High Rise Office Building Glass Curtain Wall	Embodied Carbon Impact	Ongoing Impacts During Service Life			Embodied Carbon Impact
	Global Warming (kg CO ₂ e/m ²)	Greenhouse Gas Intensity – GHGI (ekgCO ₂ /m ² /yr)	Total Energy Use Intensity – TEUI (ekWh/m ² /yr)	Thermal Energy Demand Intensity – TEDI (ekWh/m ² /yr)	Total use of primary energy (ekWh/m ²)
Repair-in-Place (Worse-than-Like, 50+/yr)	NA	25.5 (year 1) 27.3 (year 40)	251 (year 1) 268 (year 40)	145 (year 1) 155 (year 40)	NA
Incr. Replace (Like-for-Like, 50+/yr)	> 1	25.5 (year 1) 27.3 (year 40)	251 (year 1) 268 (year 40)	145 (year 1) 155 (year 40)	> 1
Fully Replace (D. Glazing)	6	24.1 (-6%)	240 (-4%)	135 (-7%)	29
Fully Replace (T. Glazing, Frame Rehab, Spandrels)	21	21.7 (-15%)	221 (-12%)	115 (-21%)	109
