REAL-TIME MONITORING FOR LEAK LOCATING WITH WIRELESS MOISTURE CONTENT SENSORS IN NON-COMBUSTIBLE CONSTRUCTION

Jason Teetaert, P.Eng, SMT Research Ltd.,
Brennan Vollering, M.A.SC., P. Eng., LEED® AP, Sense Engineering

EXTENDED ABSTRACT

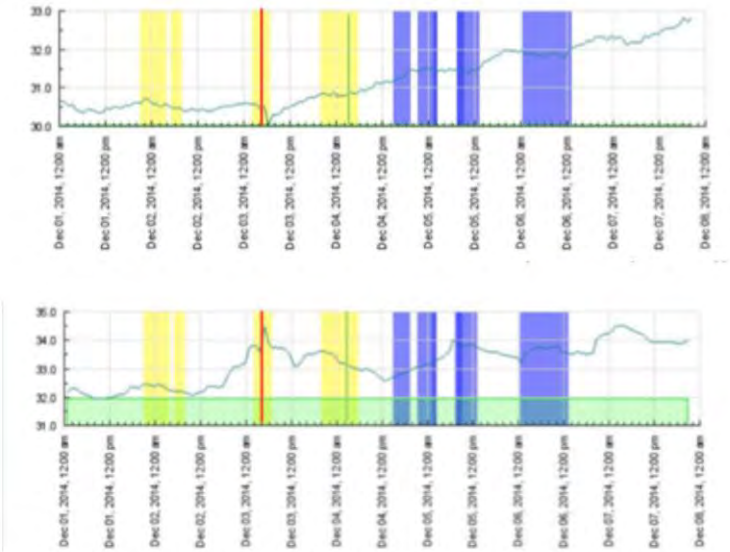
Figure 3: Sensors having elevated moisture content in the 2nd floor of Townhouse 108.

Red line indicates the approximate time of the wall water test.
The green line indicates the approximate time of the roof planter test.

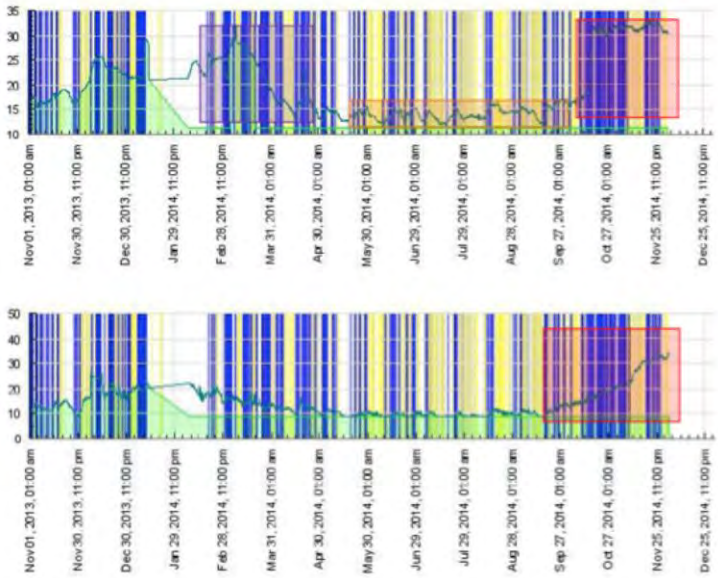
Townhouse 108

Figure 3: Sensors having elevated moisture content in the 2nd floor of Townhouse 108.
