PASSIVE HOUSE WALL ASSEMBLY PERFORMANCE – A CASE STUDY

Robert Lepage, M.A.Sc., P.Eng., Christy Love, P.Eng., Kyle Jang

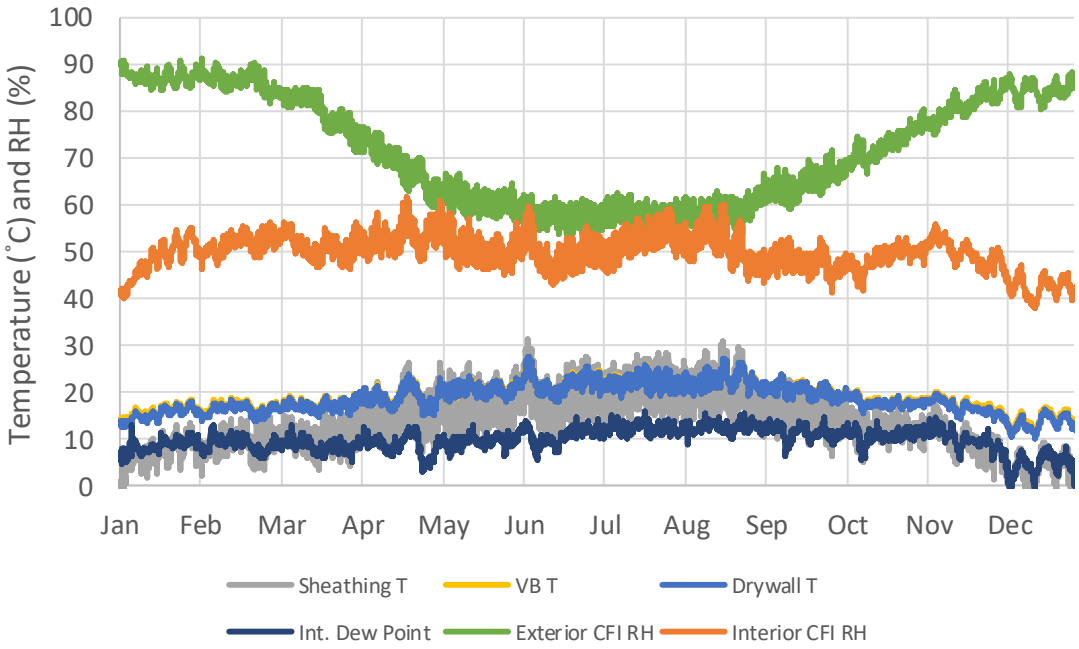
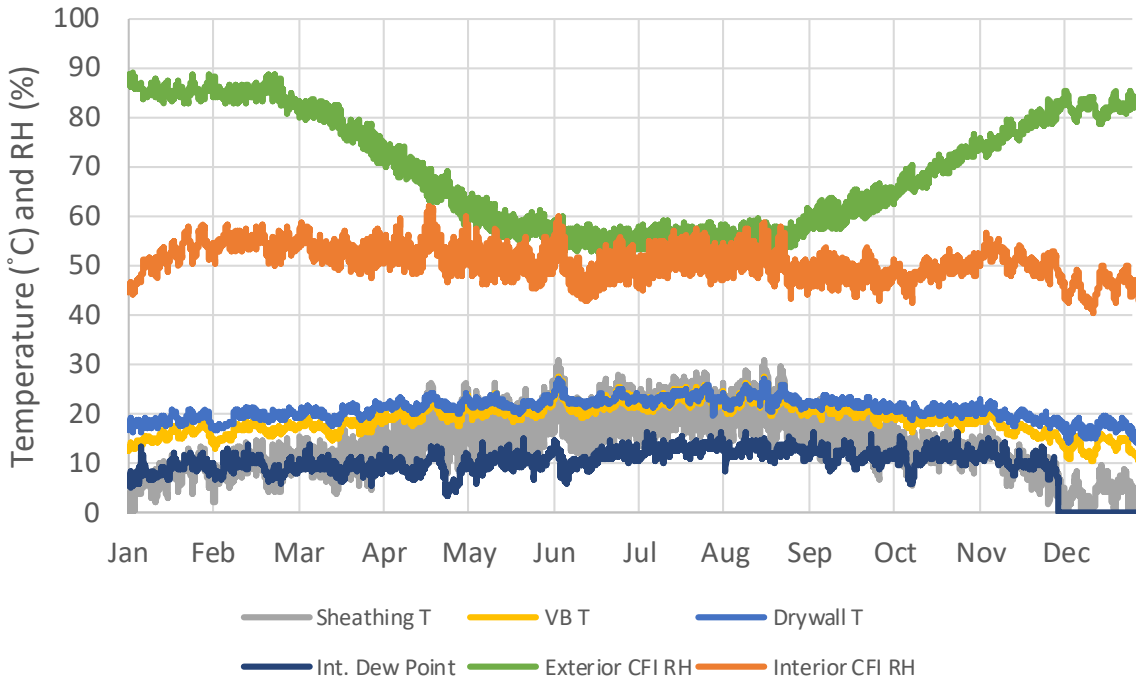
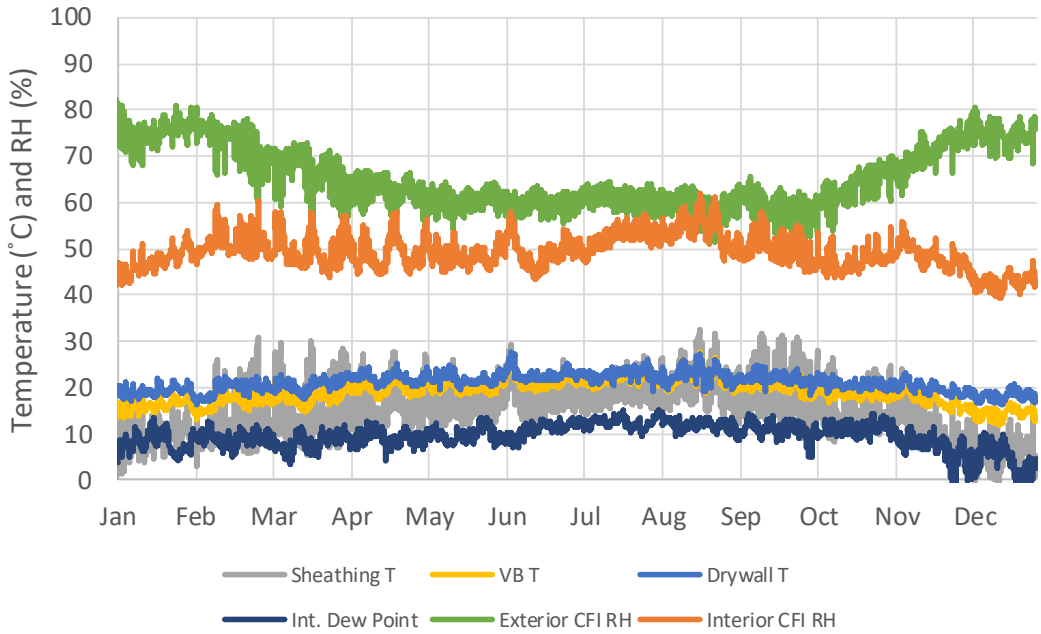
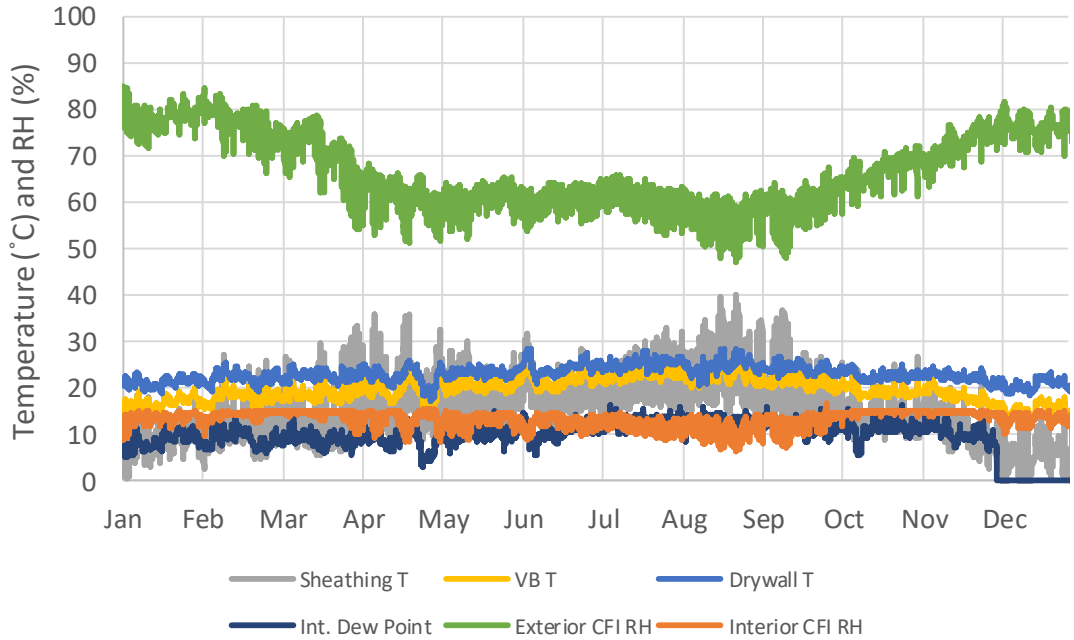
Figure 4: N2 wall data for Sheathing, Vapour Barrier (VB) and Drywall temperatures, including indoor air dew point temperature, and the exterior/sheathing and interior cellulose fibre insulation relative humidity from January to December, 2016.

Figure 5: N3 wall data for Sheathing, Vapour Barrier (VB) and Drywall temperatures, including indoor air dew point temperature, and the exterior/sheathing and interior cellulose fibre insulation (CFI) relative humidity from January to December, 2016.

Figure 6: S2 wall data for Sheathing, Vapour Barrier (VB) and Drywall temperatures, including indoor air dew point temperature, and the exterior/sheathing and interior cellulose fibre insulation (CFI) relative humidity from January to December, 2016.

Figure 7: S3 wall data for Sheathing, Vapour Barrier (VB) and Drywall temperatures, including indoor air dew point temperature, and the exterior/sheathing and interior cellulose fibre insulation (CFI) relative humidity from January to December, 2016. The Interior CFI RH sensors is malfunctioning.

From Figures 4 to 7, the temperature of the vapour barrier remains above the interior dew-point at all times throughout the year. This indicates that there would be no risk of condensation from indoor moisture at the vapour barrier. The sheathing temperature however, does dip below the dew point temperature, particularly on the north walls. This indicates that there is potential for condensation to develop on the sheathing from exfiltrating air through the enclosure. However, the rigorous air leakage testing requirements of Passive House and the location of the air barrier within the assembly mitigate concerns of air leakage condensation.

From Figures 4 to 7, it can be seen that the relative humidity on the exterior of the insulation is higher in the north walls and that it is susceptible to higher variation in the south walls. These observations hint at the effects of inward driven moisture (e.g. moisture driven into the wall assembly by high outdoor vapour pressures) and to the general drying effect of a solar heated south elevation (i.e. with drier cellulose insulation on the south orientation).

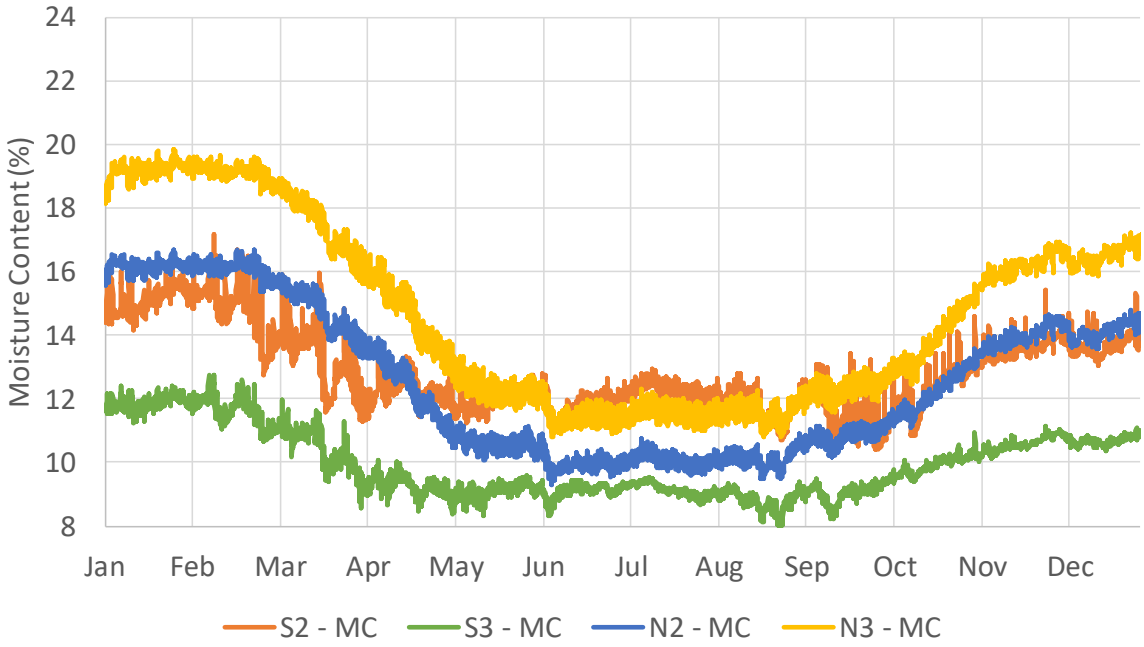
Figure 9: Sheathing Moisture Content (MC) for North and South Walls, on Levels 2 and 3.

The sheathing moisture contents are generally less on the south orientation than the north. This is due to higher temperatures caused by solar heating, which permits increased drying rates. An exception to this is the S2 assembly, which may experience greater cladding precipitation run-off from the S3 wall above that is subsequently driven in by solar vapour drives. The lowest threshold for superficial mould growth is around 16%, whereas the structurally damaging rot is known to occur when the plywood reaches the fibre saturation point, at around 25-28%. The sheathing moisture content of all locations fell below 20% for the entirety of the year and therefore does not appear to be at risk of rot. The sheathing moisture content on both the north orientation sensors did, however, have periods above 16%, which is above the lowest threshold for mould growth.

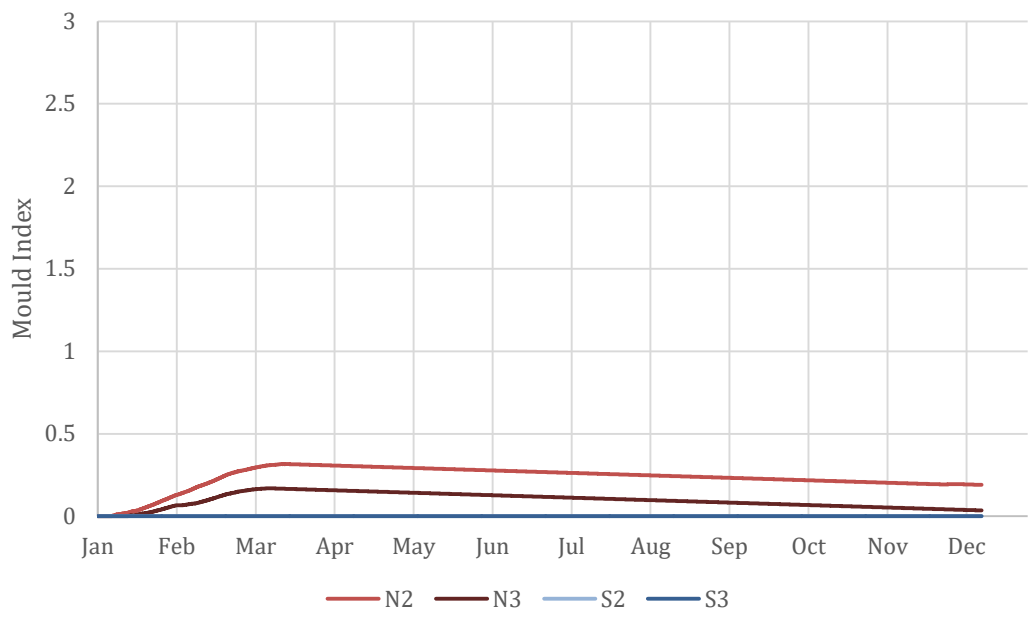
Figure 10: VTT Mould Index for N2, N3, S2, and S3 walls

From Figure 10, models for the S2 and S3 walls were shown to have no mould growth due a lack of moisture. The north walls, however, were modeled to be sufficiently cool and humid that microscopic mould growth could occur. Over the one year monitoring period, a slight increase in predicted microscopic growth was calculated during the spring season as the humidity increases concurrently with temperatures creating conditions suitable for mould growth. Despite the N3 wall having a higher moisture content, the combination of temperature and relative humidity in the N2 wall were both sufficiently high that the N2 wall appears to have a marginally higher mould index. In the model, the summers were sufficiently dry that the plywood sheathing in both N2 and N3 dried out and the mould went into stasis. To determine the maximum mould growth condition the model was run iteratively until the starting and final mould indices for the modeled year were approximately equal. The results, including the number of iterations (i.e. years), are provided in Figure 11.

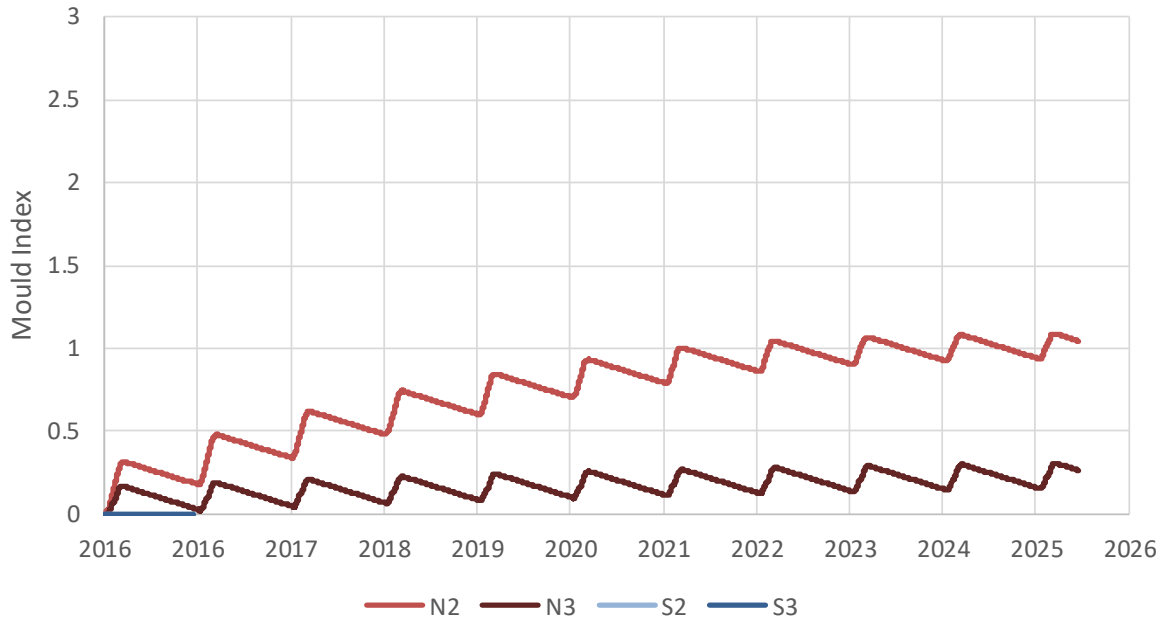
Figure 11: Maximum Supportable Mould Conditions for North and South Walls on the 2nd and 3rd Storeys

The iterative simulations suggest that after about a decade, a mould growth index of around 1 could be anticipated for the N2 wall and around 0.25 for the N3 wall. This assumes that each year is identical to the measured year. This suggests that localized initial stages of growth may be found microscopically, but would not pose a durability risk to the structure. Risks to human health would also be limited, as the air barrier system of a Passive House is rigorously tested and would thus significantly inhibit any spore or fungal cell laden air movement across the air barrier assembly.

A strategy to help further minimize this risk of mould growth is to keep the sheathing slightly warmer. The slight temperature increase of the south elevation was sufficient to have virtually zero risk of mould growth. This could be accomplished by adding insulation to the exterior of the sheathing. This was investigated and supported in a research paper by Smegal et al. (2016). Despite the vapour resistance of the plywood sheathing, the effects of inward driven moisture were measurable on the exterior side of the vapour barrier. A more permeable exterior layer would therefore permit greater inward vapour flows, which could result in condensation against the exterior side of the vapour barrier.
