# ***Evaluating the effectiveness of window/wall interface details to manage rainwater***

Michael Lacasse, NRC and Silvio Plescia, CMHC

For the  
**2006 British Columbia Building Envelope Council  
Symposium - May 25**

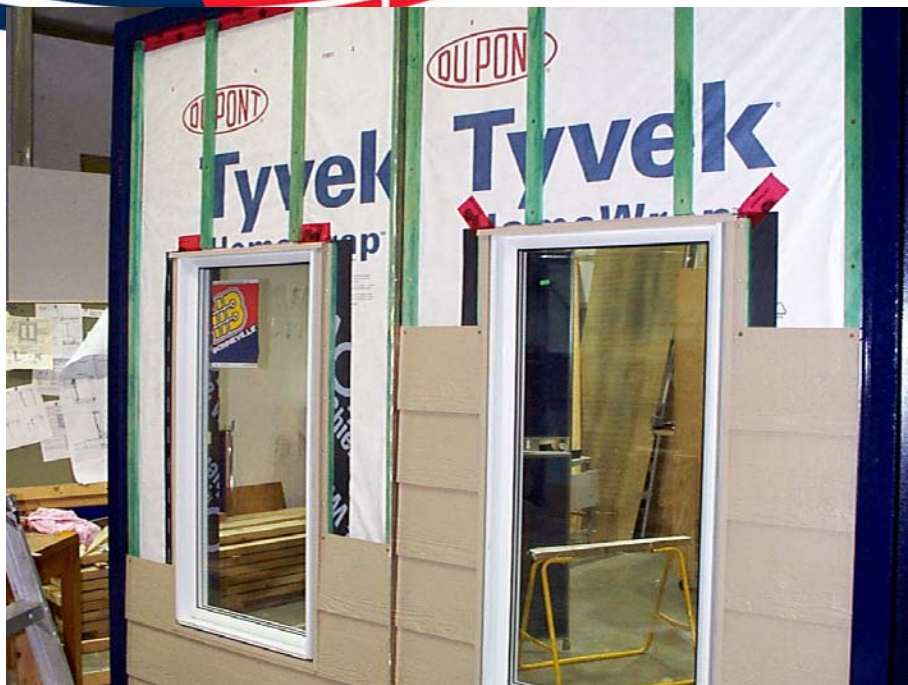
# Specimen Details- W1

- ***Clear cavity behind siding  
(19 mm wood furring strips used)***
- ***Non-finned (box) window frame***
- ***Variation - extra sealant and backer rod at  
the jambs and head***

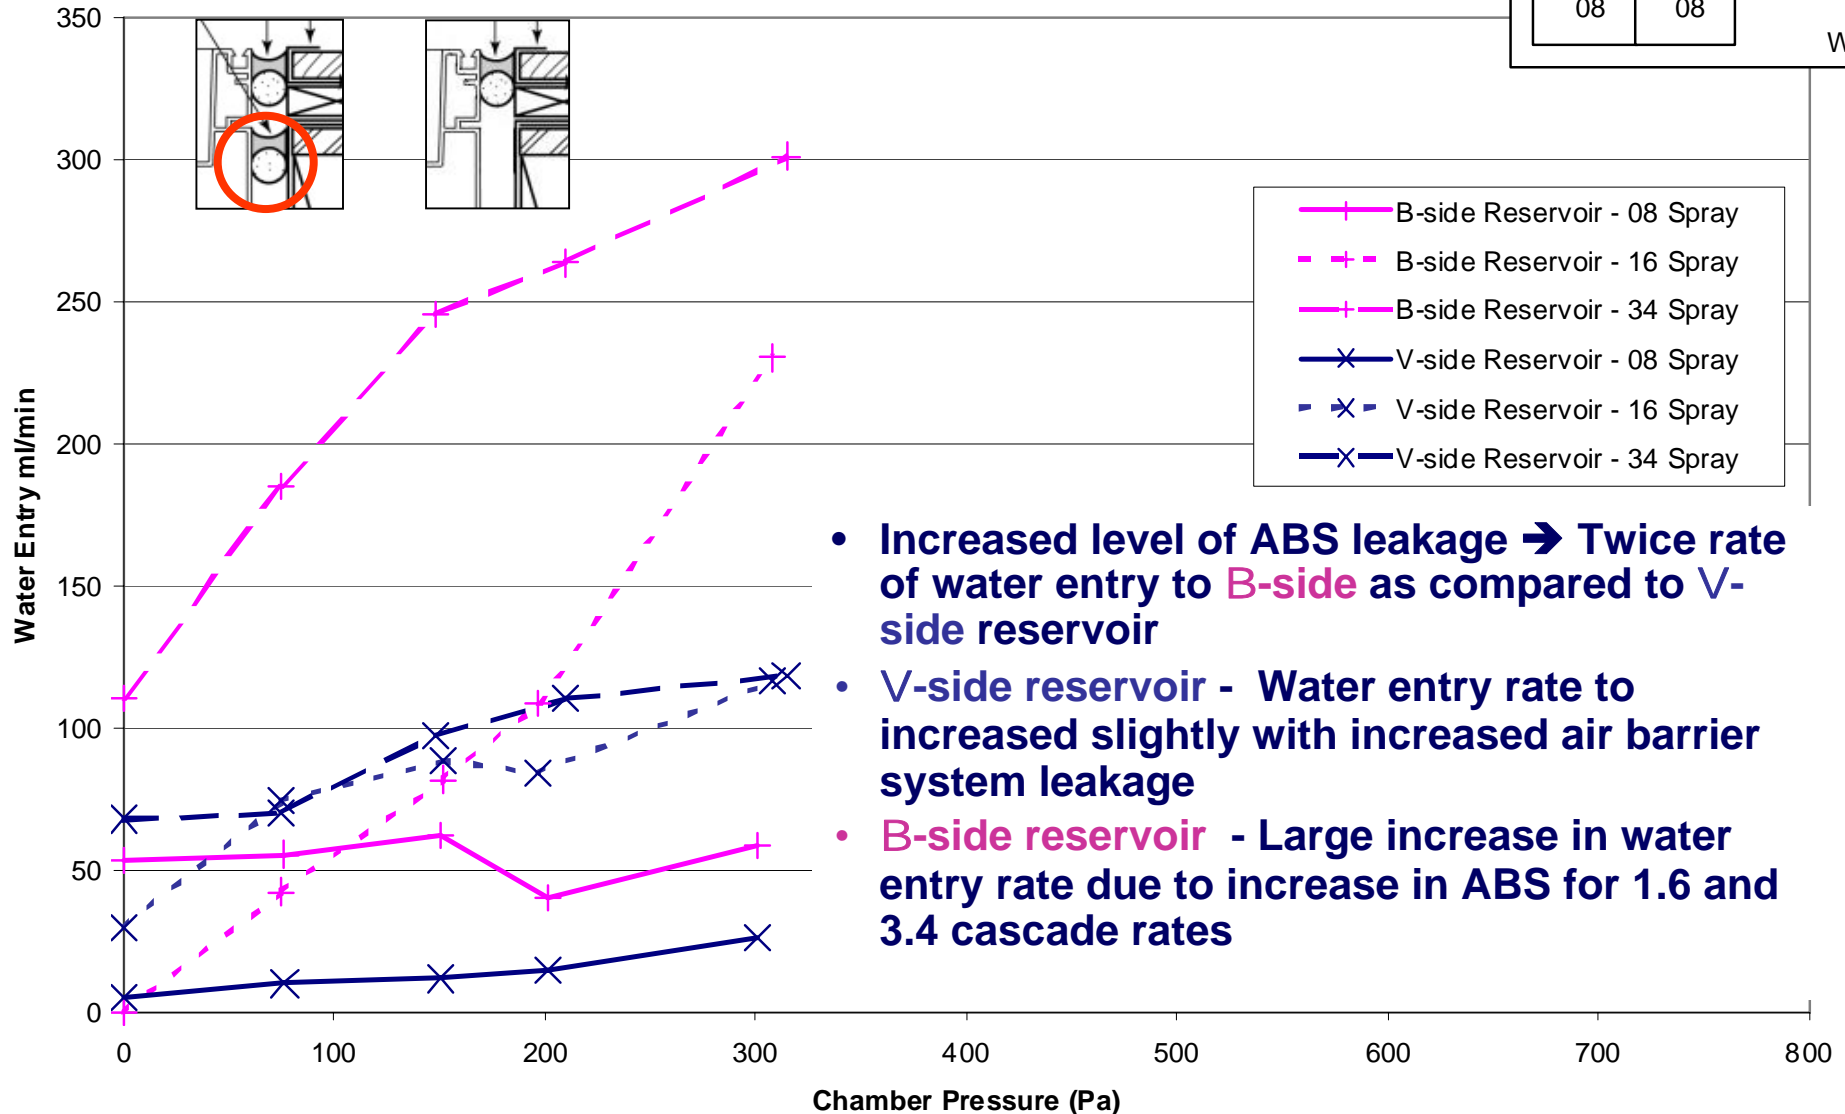
## Reservoir Water Entry - 08 ABS

V-side B-side

V	B
08	08

- Water entry affected by water spray rate and tightness of assembly (air barrier system leakage)
  - Higher rates of water spray and higher system leakage resulted in greater rates of water entry to collection troughs
- Water entry through the windows occurred mainly at:
  - 500 and 700 Pa chamber pressure.
- Restricted water entry for either “B” or “V” interfaces for assemblies having :
  - “NO deficiencies”, and
  - Selected deficiencies, with exception of “Step 4” deficiency
- “Step 4” Deficiency -  
(90 mm of caulking and backer rod removed from horz. joint)
- Significant increases in water entry to reservoir on both sides
  - “V” side permitted about half the rate of water entry as compared to “B” side

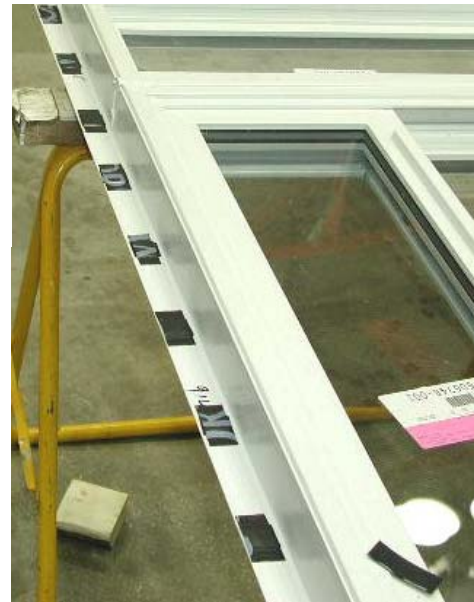
Shims provide gap

- *Clear cavity behind siding (furring strips)*
- *Combination window, solid PVC with integral flange – top slider, bottom fixed*
- *Variation: Two subsill drainage methods of a flat sill with back dam*

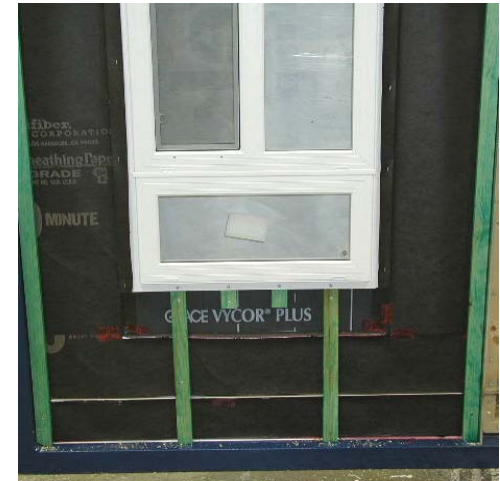
Window installed  
over furring strips

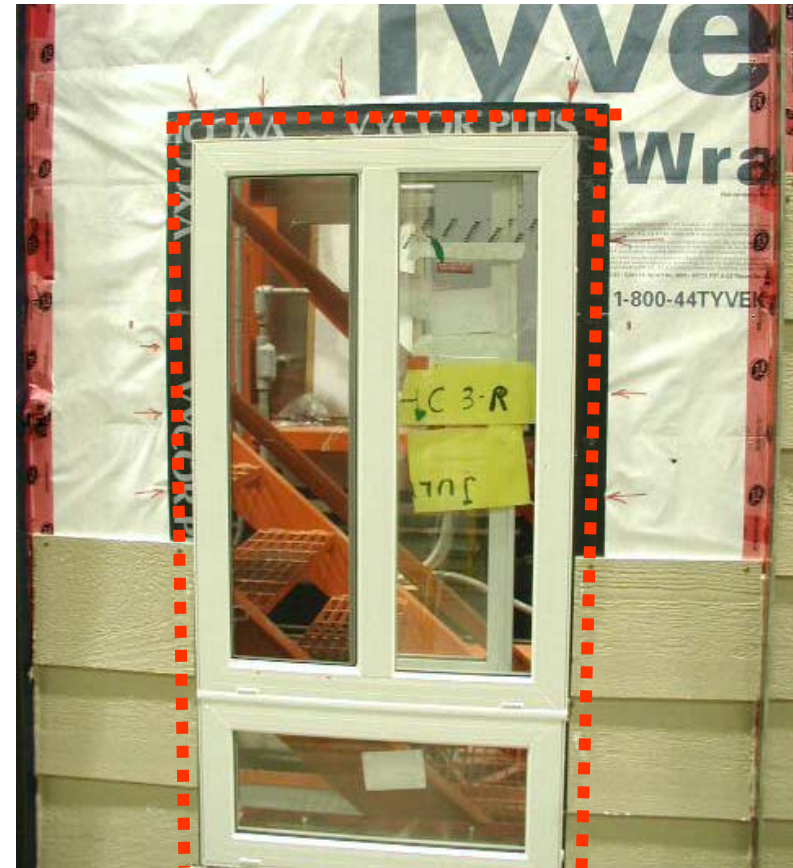
# Self-adhered Membranes

- **Strip of self-adhered flashing membrane over joint between window flange and sheathing membrane (not at sill)**

- ***Sealing joints between window and wall using such approaches - not 100% effective, given that:***
  - ***Water found its way to interior via reverse lapping***
  - ***Created funnels that channelled water to inside***
  - ***Some water was trapped inside assembly***

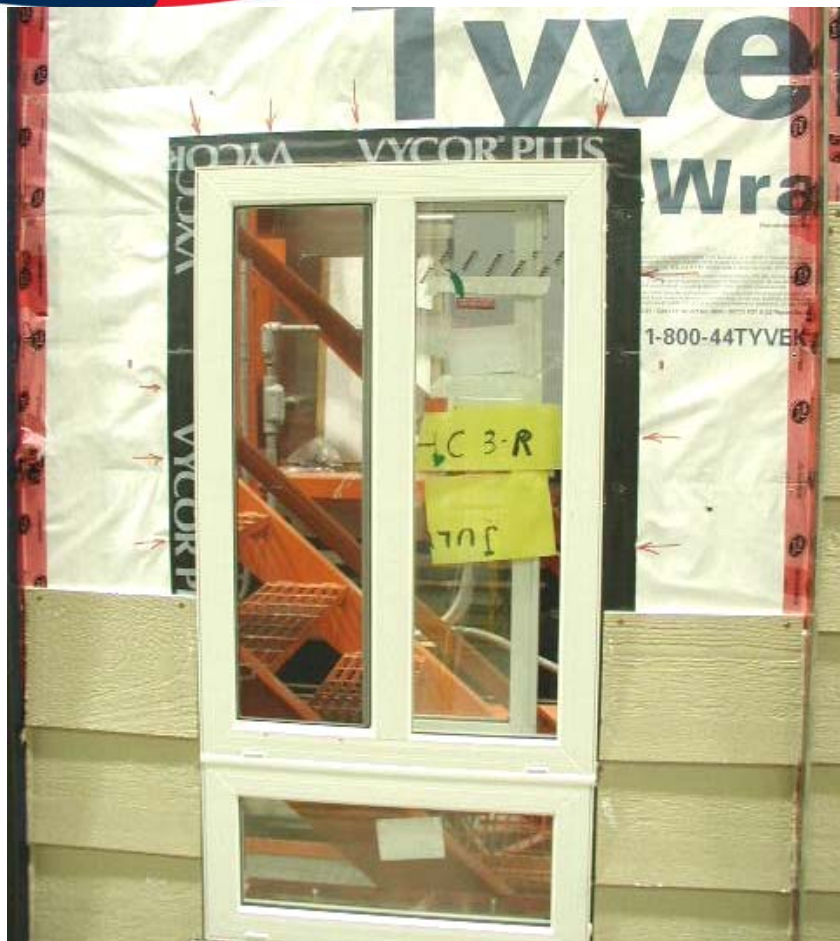
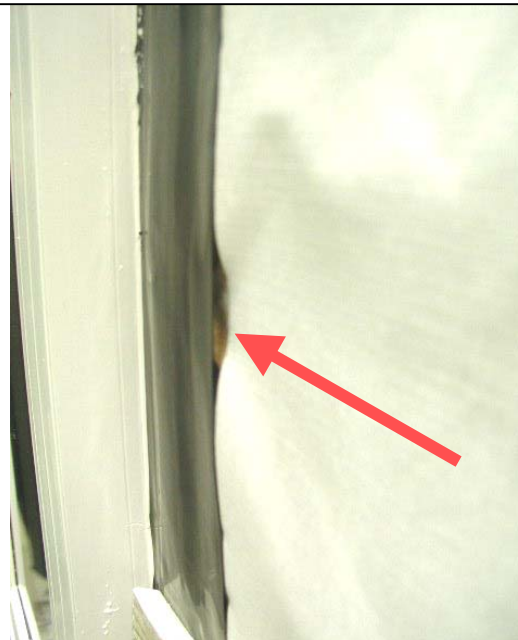
## W4 – “B”

- Review of Selected Practice side showed delamination of flashing membrane from WRB
- Creation of openings for water entry - “fish mouths”
