Building Science Research Highlights

BCBEC
Annual General Meeting & Conference
2009.09.22

Chris Schumacher
Building Science Corp. | Somerville MA
Building Science Consulting Inc. | Waterloo ON

Coquitlam Test Hut

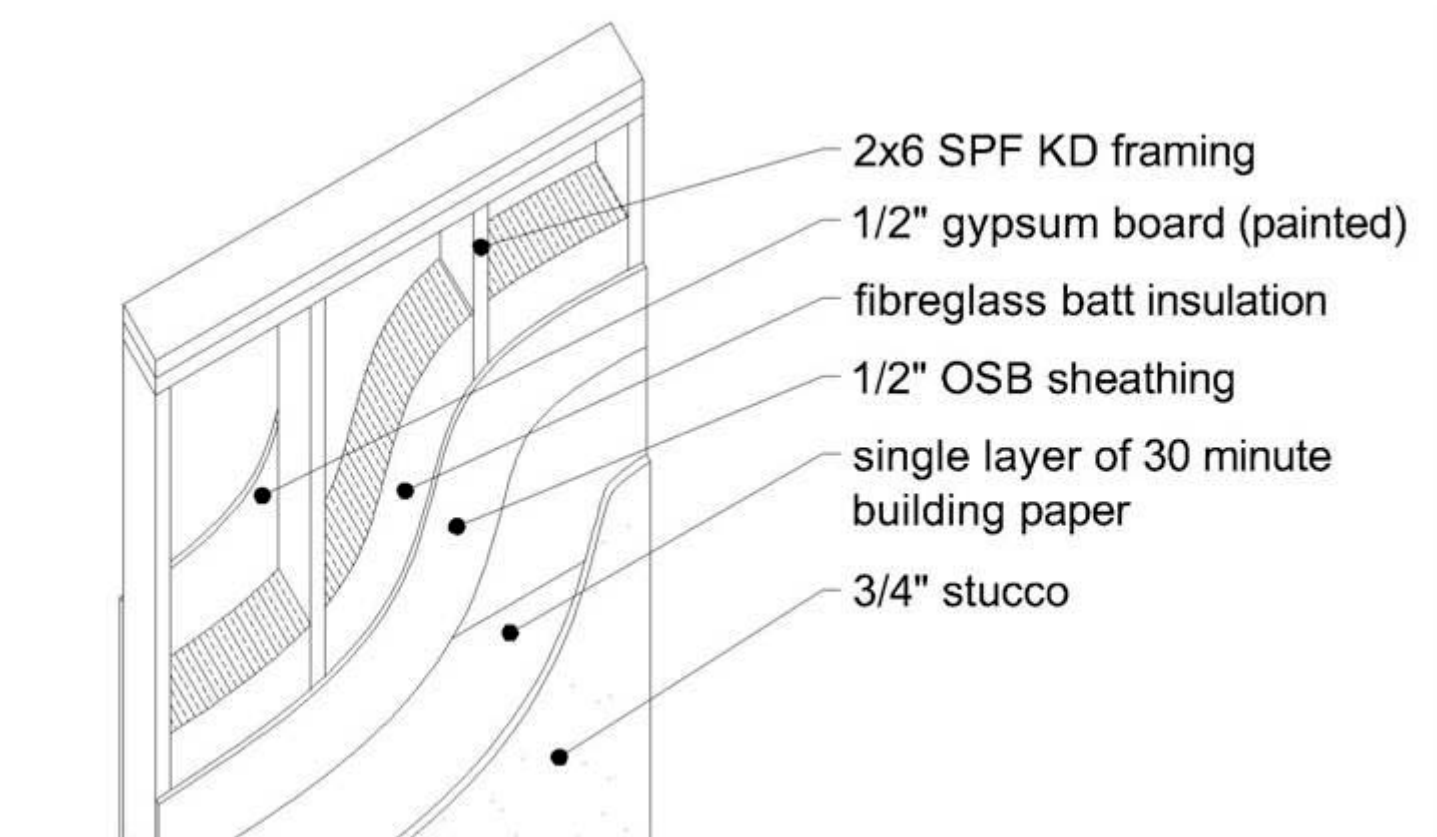
1980s Energy Efficient 2x6 (ADA, no poly)

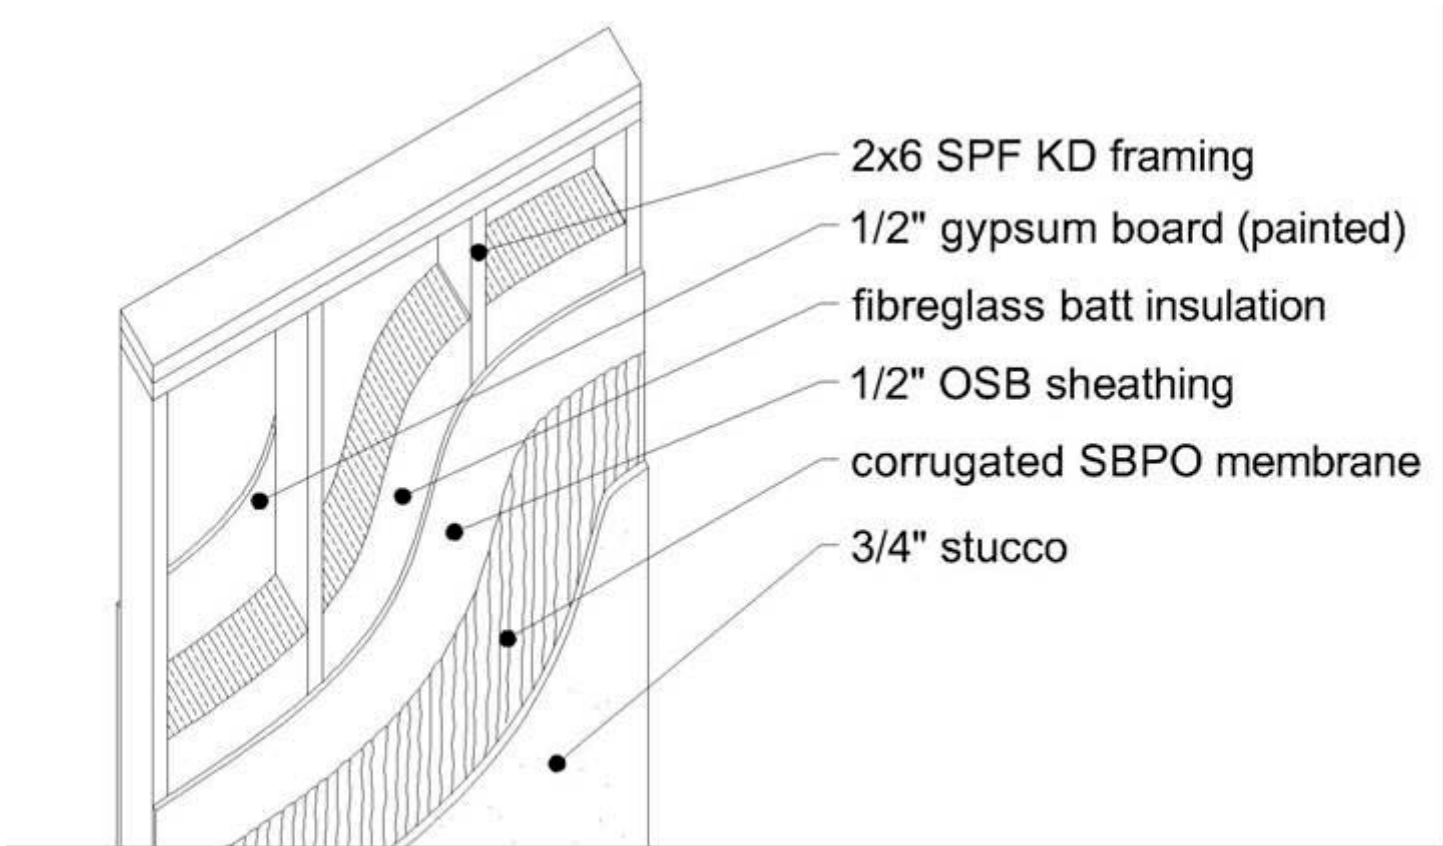
2005 US Energy Efficient, Drained (no poly)

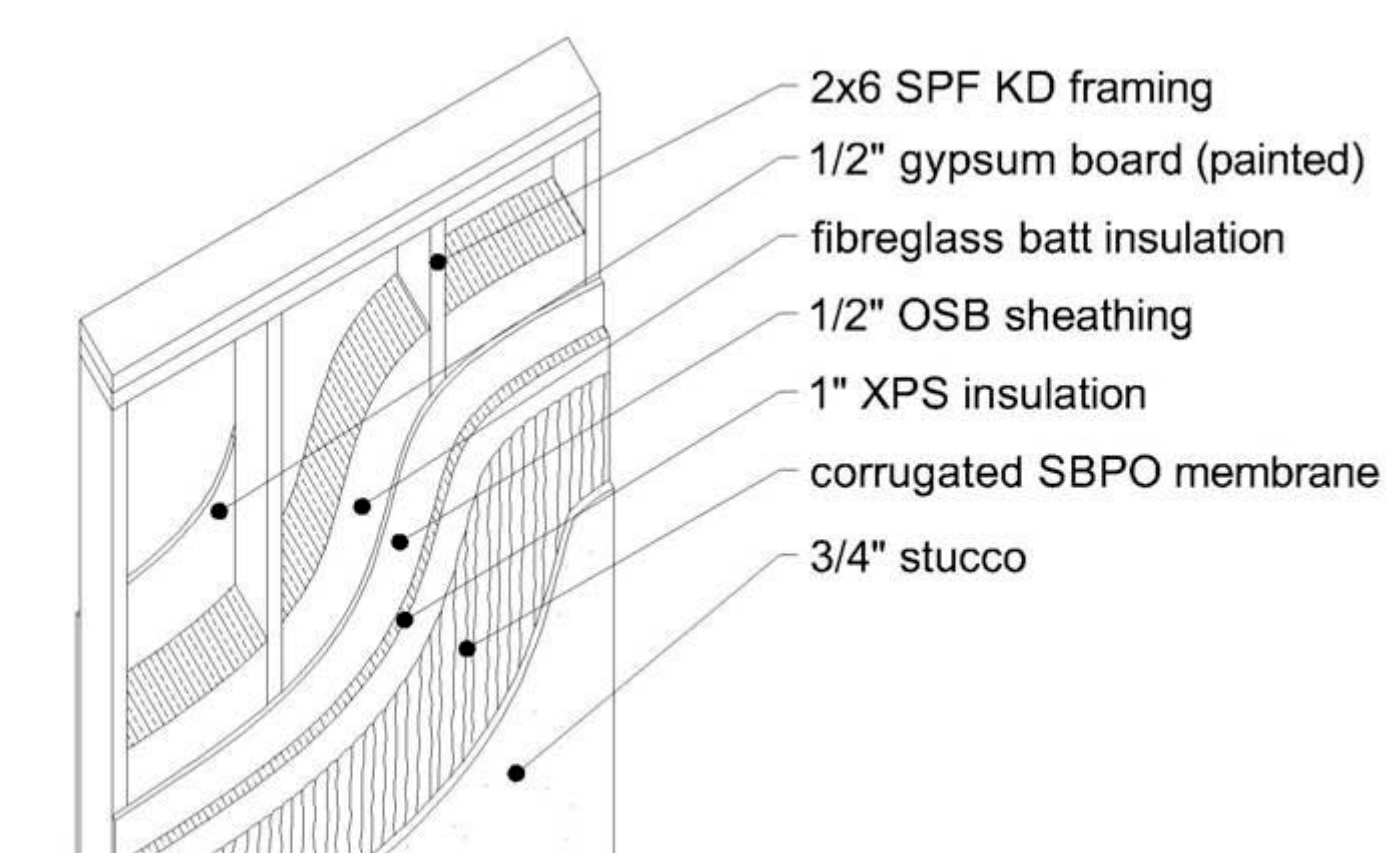
Next Gen (2005+) (no poly, drained, insulation)

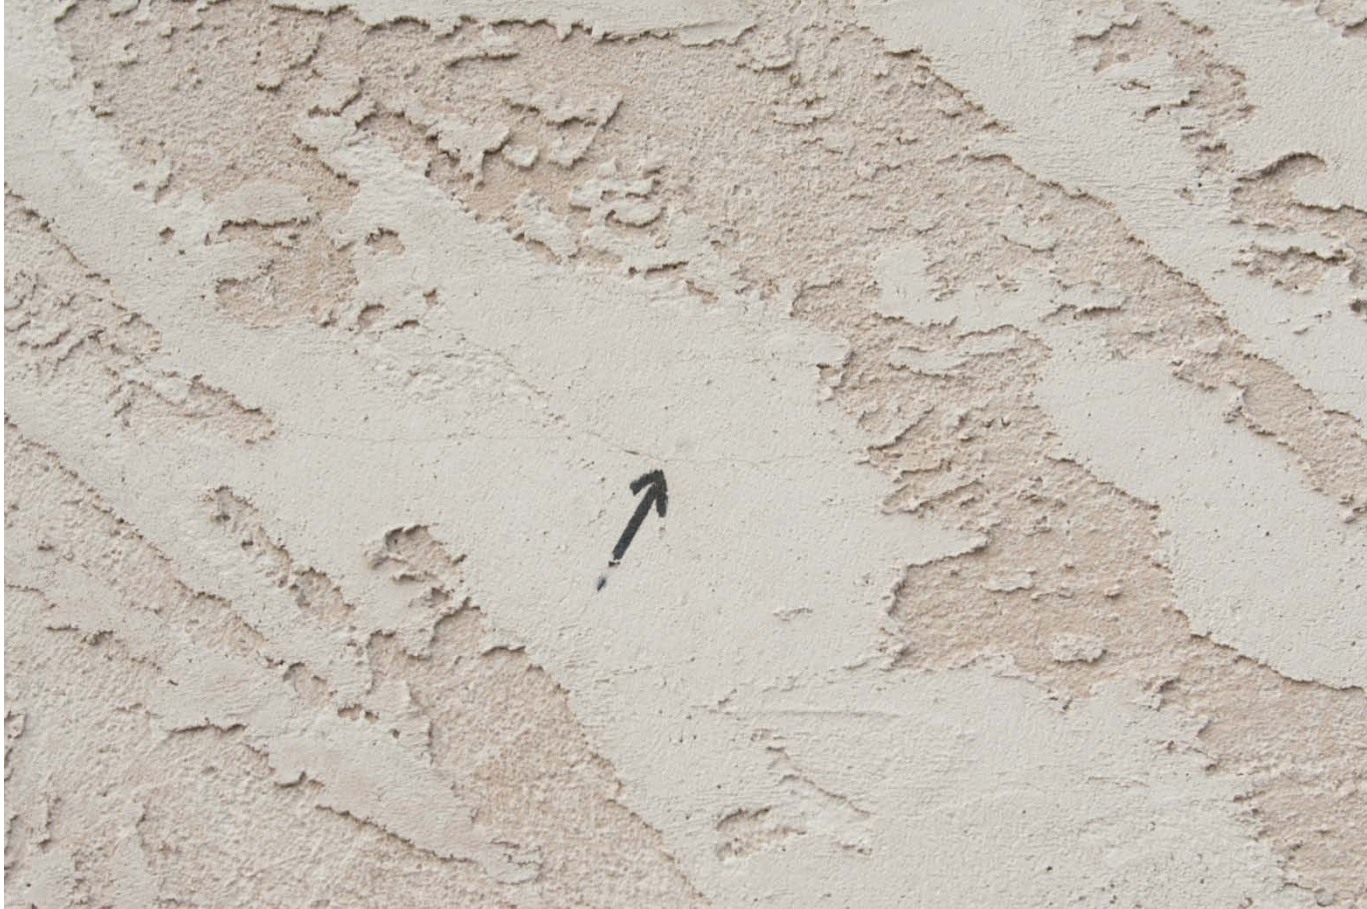
Some Cracking of Stucco

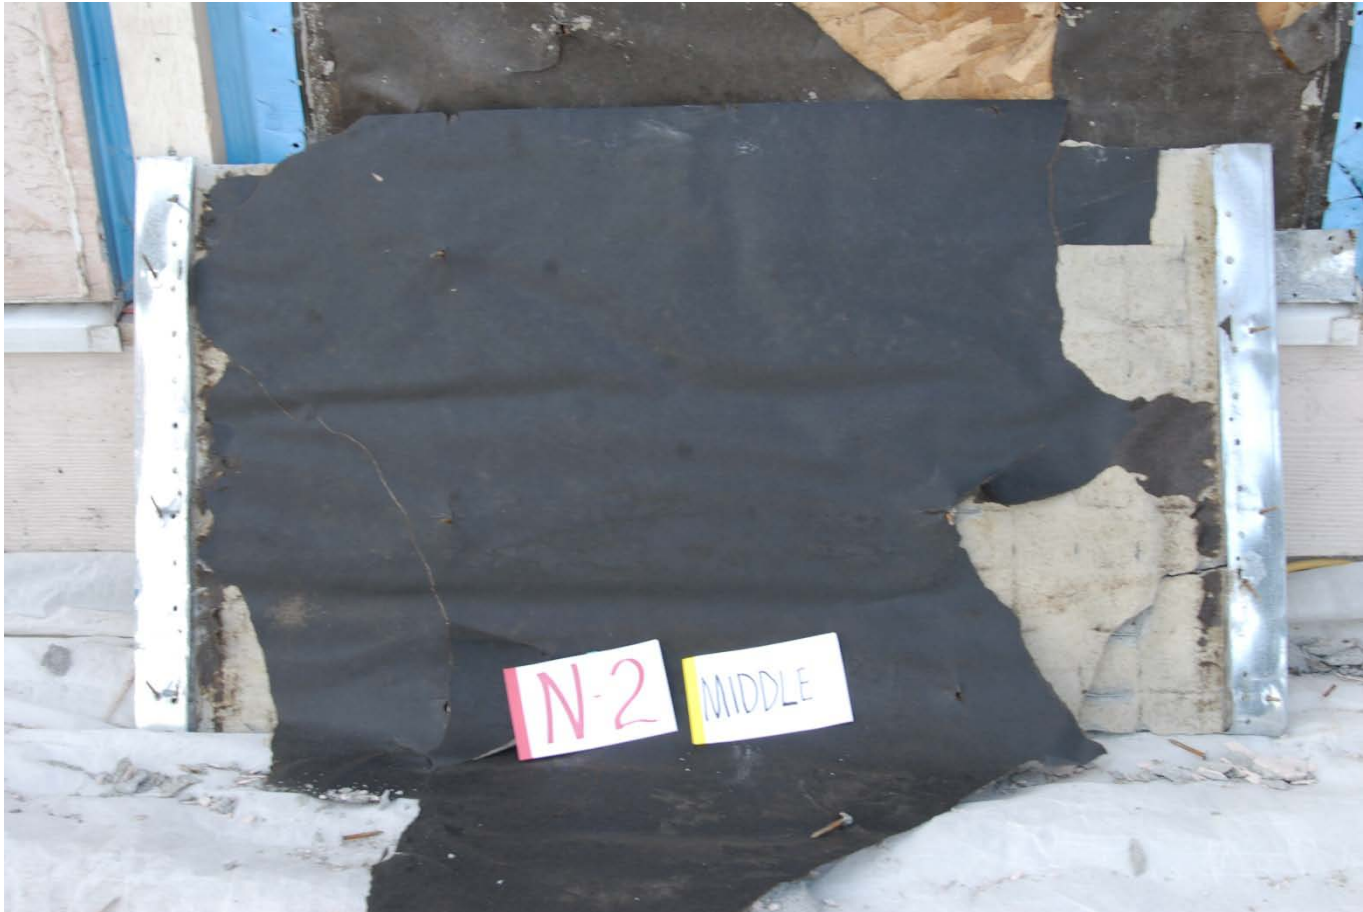
Bldg paper bonded to stucco

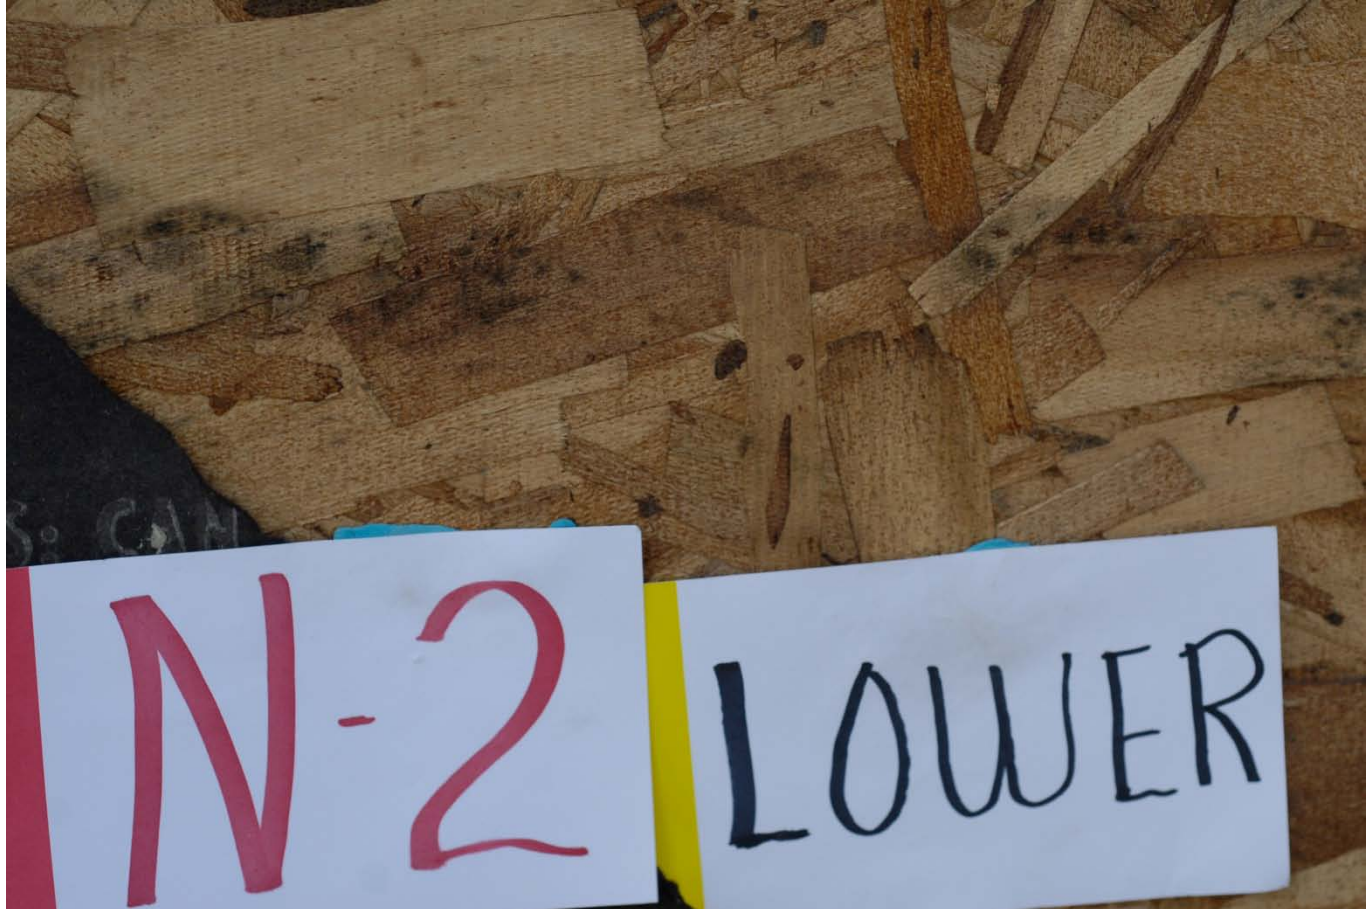
Small amounts of mold on 1980s wall w/ poly

- Some interior vapour control (i.e. vapour resistance) is beneficial, especially if
 - ❑ Indoor humidity levels are high or not controlled
 - ❑ Too little drive to dry to the inside

- Too much interior vapour resistance may reduce ability to dry when
 - ❑ Significant wetting from the outside
 - ❑ Claddings w higher vapour resistance are used

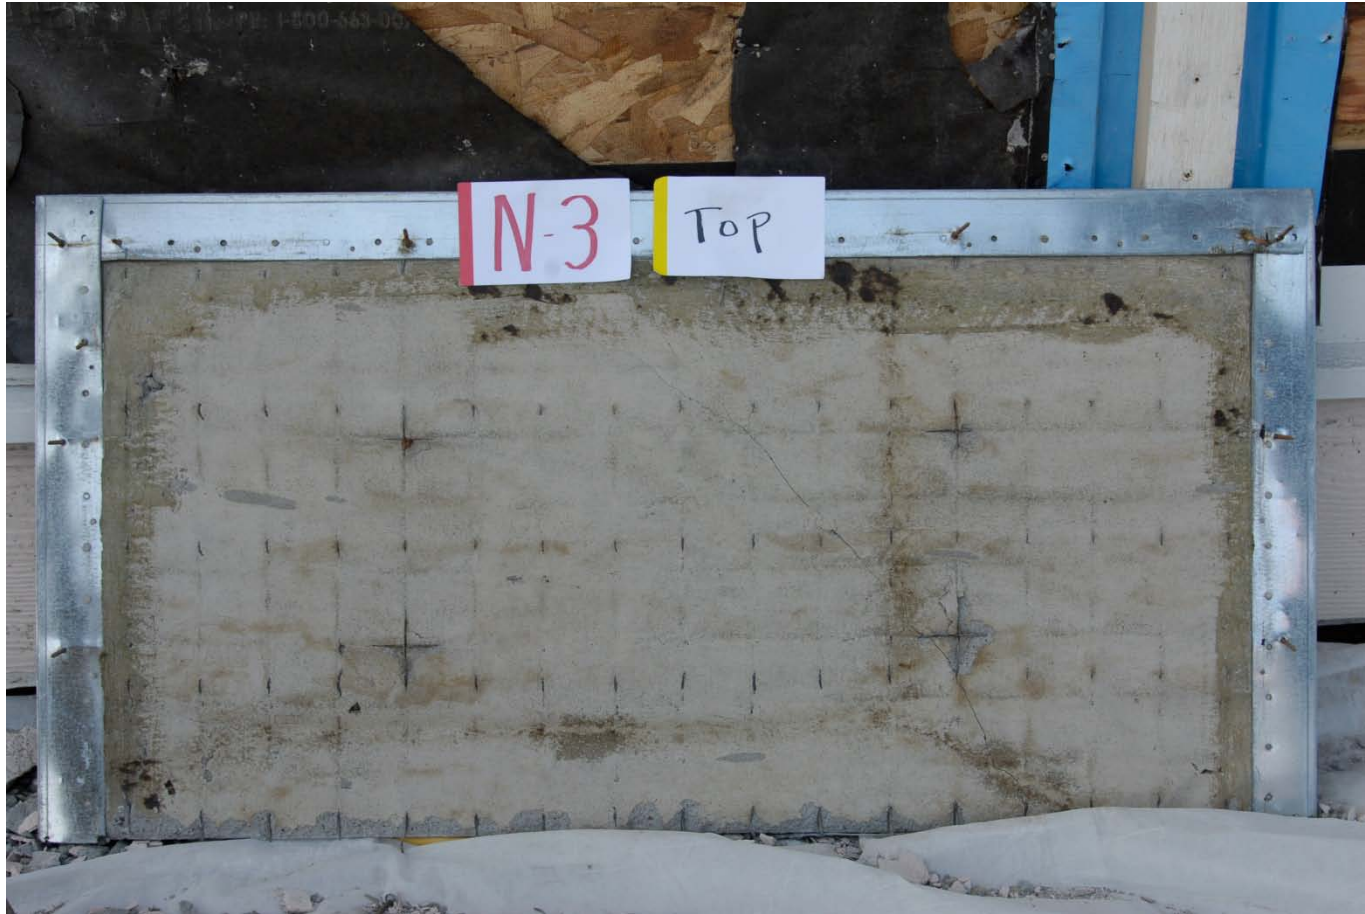
Less bonding on no poly wall

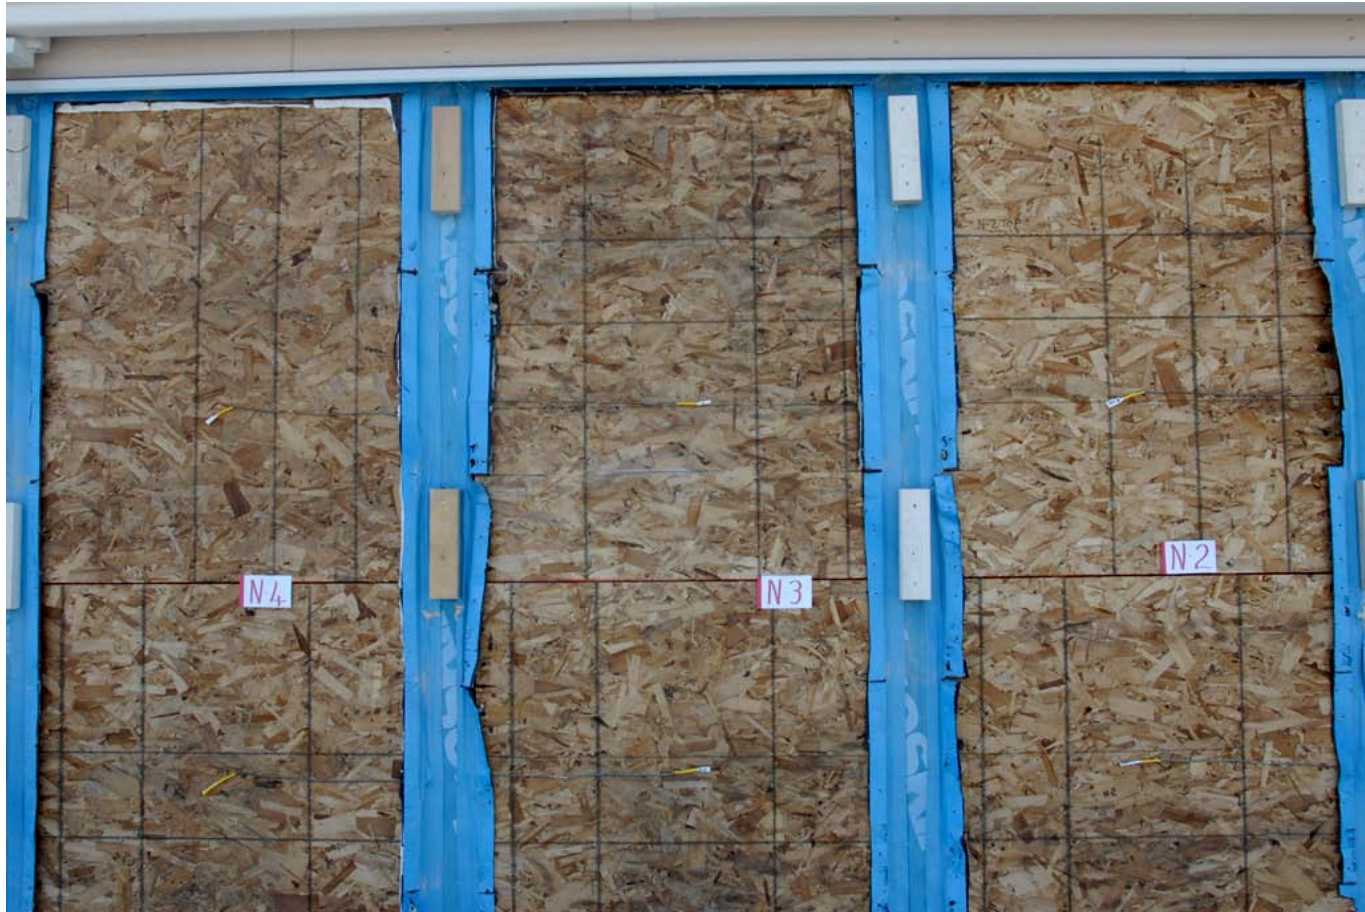
N3 (no poly) vs N2 (poly)

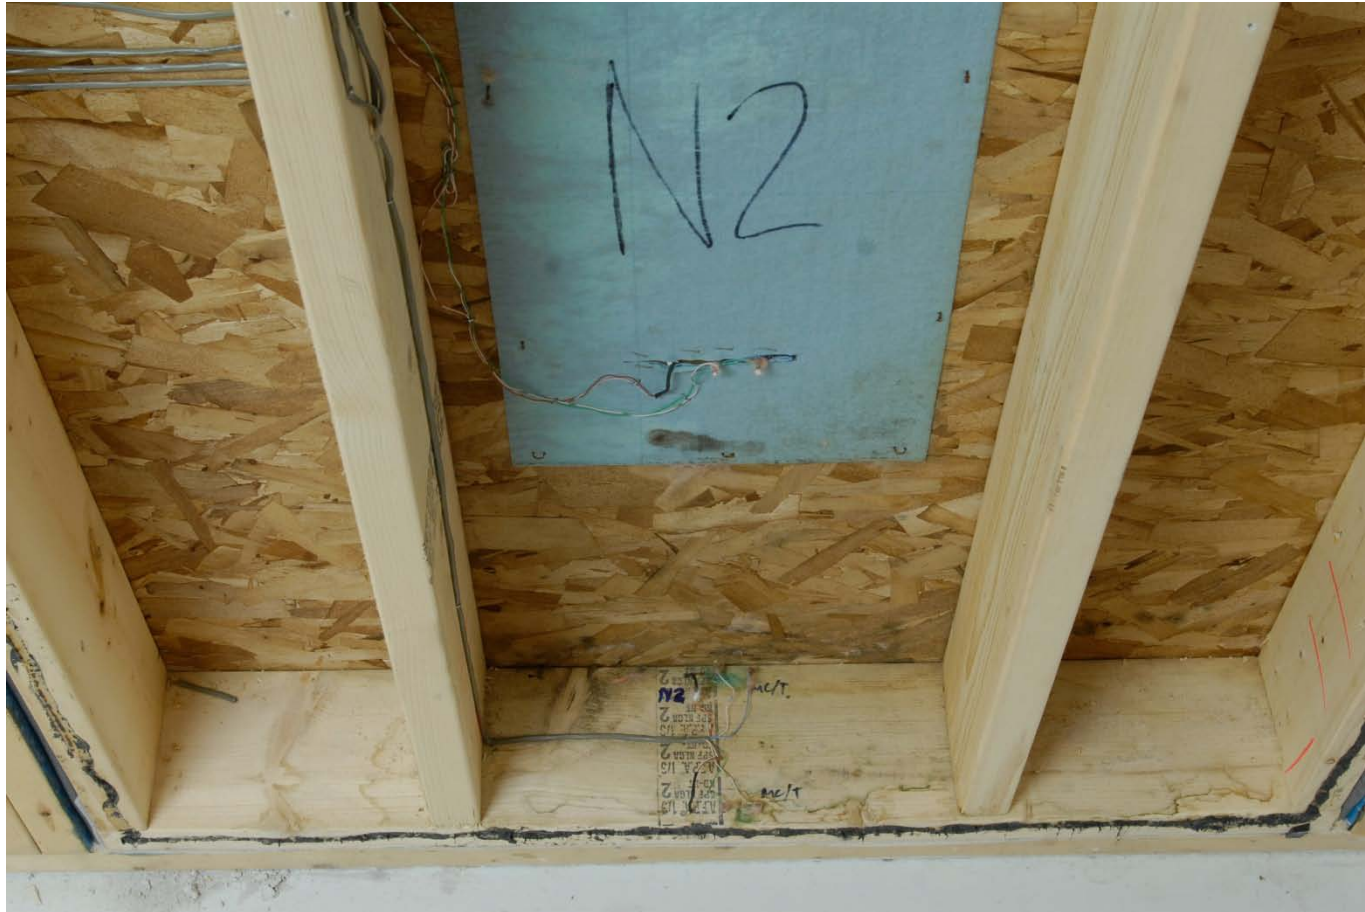
Interior of 1980s wall w/ poly

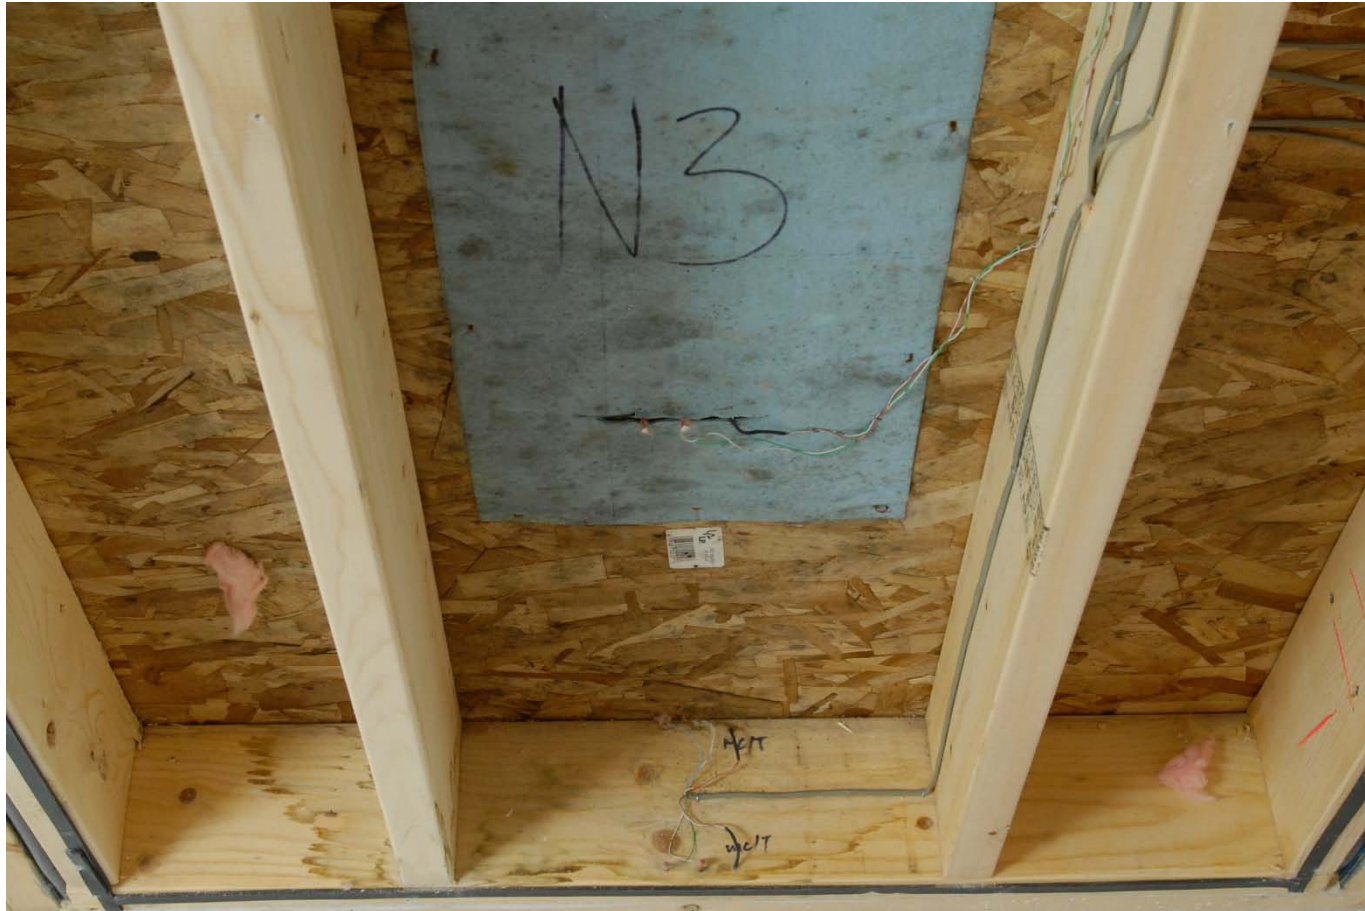
Interior of 1980s wall no poly

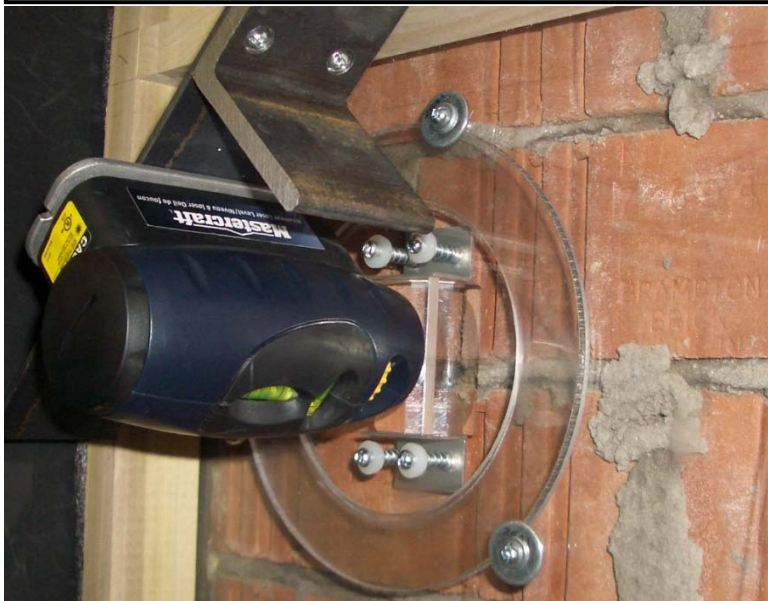
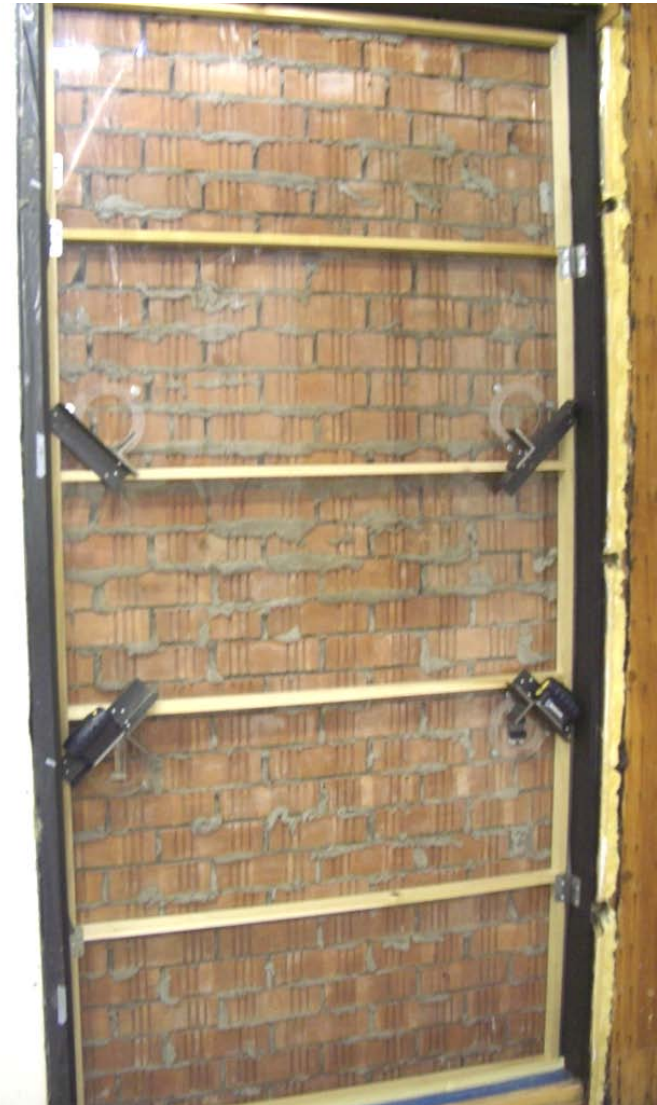
Flow Visualization (U of W 2004)

- East-facing Brick Veneer
 - 1.2x2.4 m, Two 10x65 mm vents Top & Bottom

- Conditions
 - Wind speed 1.5-2.5 m/s
 - Wind dir NNW
 - Outdoor temp -2.5°C
 - Airspace temp ~10°C

- Characterization of Flow
 - Uniform
 - Unsteady
 - Highly influenced by obstructions

- Measurement
 - Velocity on the order of 0.12 m/s
 - Flow rate of 3.6 lps/panel or 1.25 lps/m²

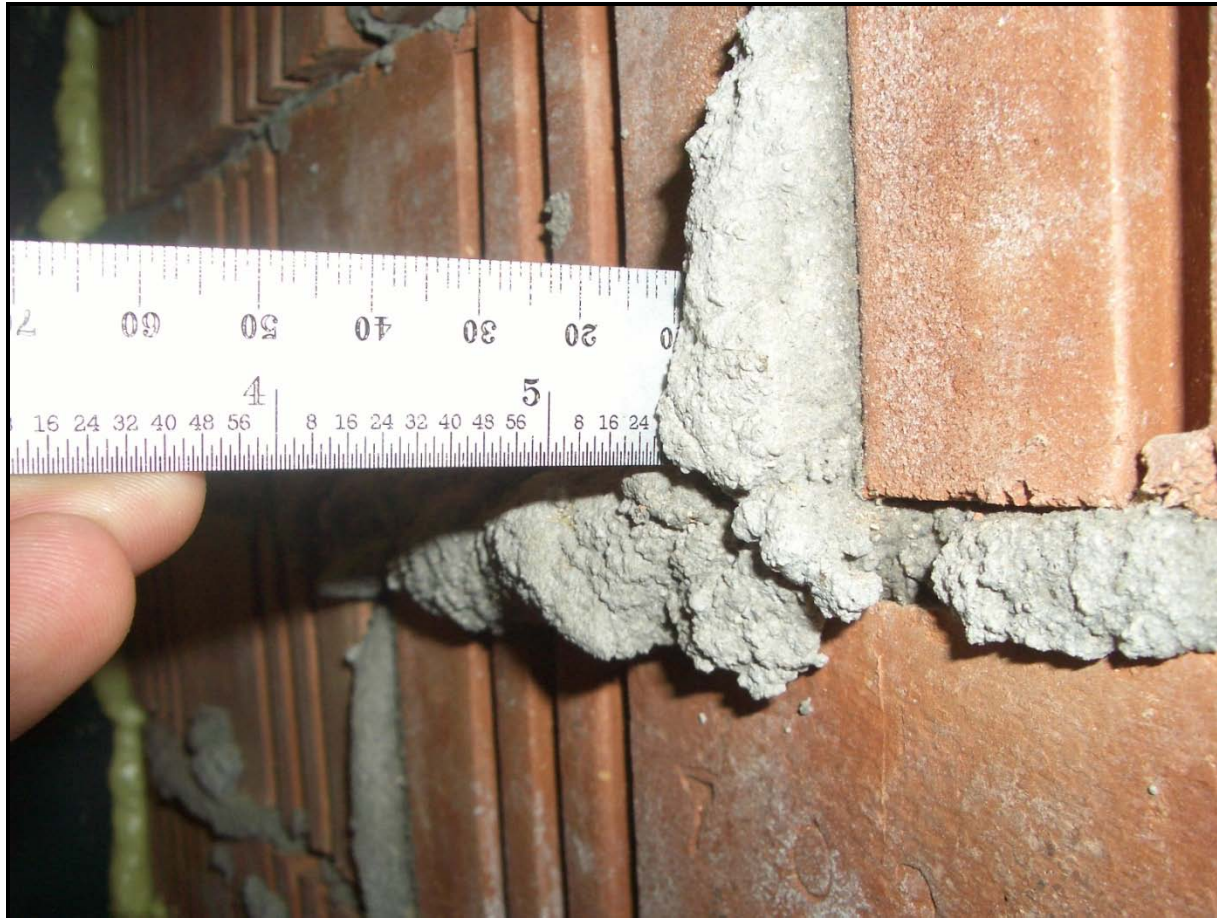
Close-up at a mortar bridge

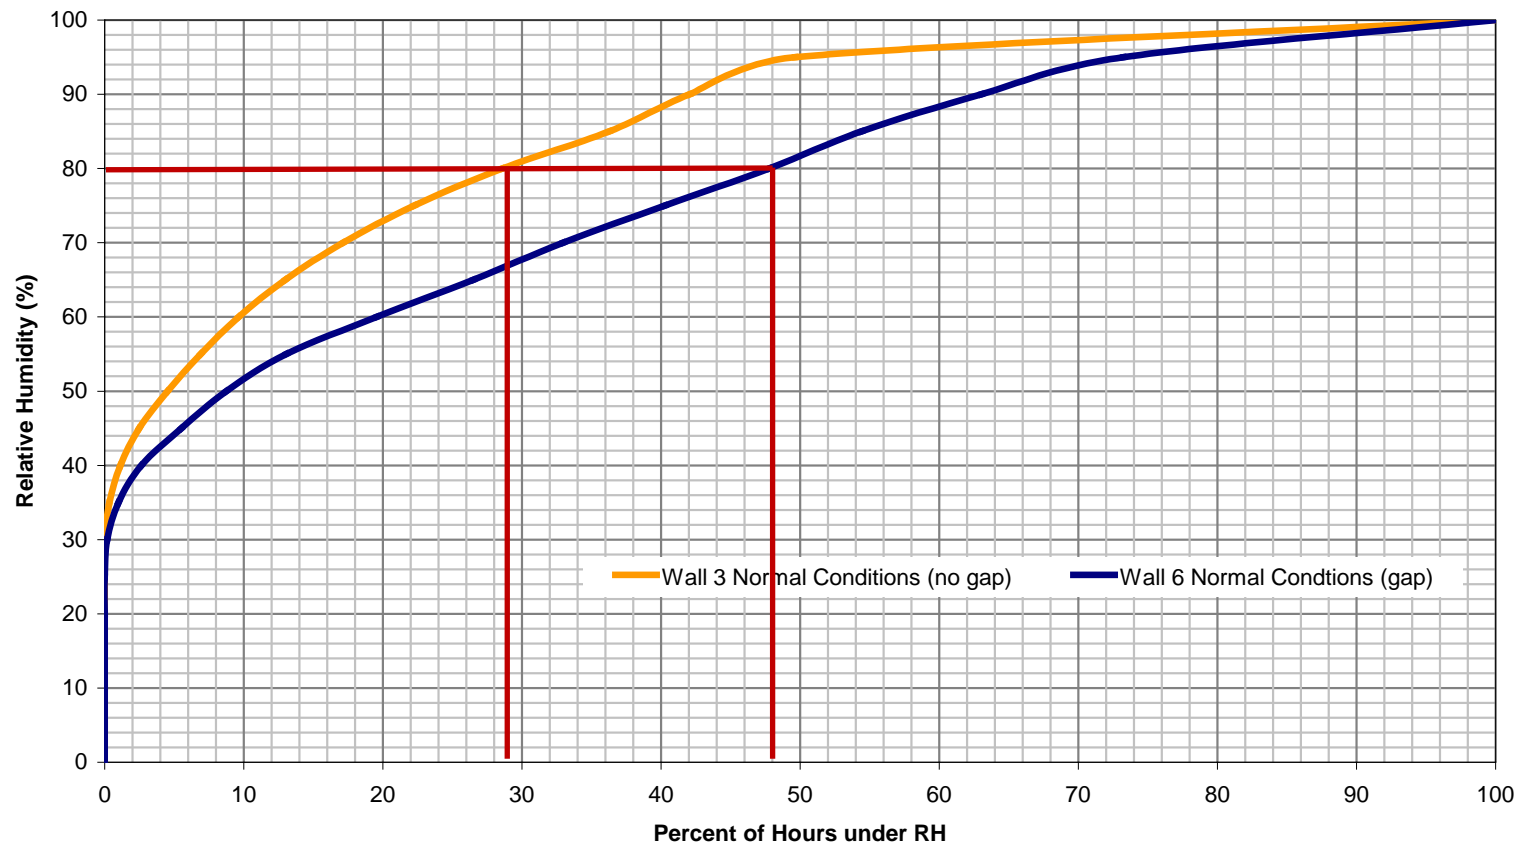
RH behind stucco cladding 1980s vs 2000s no poly (west)

- Drained Ventilated Gaps were shown to
 - Reduce hours of high RH behind the cladding
 - Reduce the OSB drying time
 - Potential to reduce average MC of the OSB
- Ventilation may not be sufficient for high exterior moisture loadings & cases where there is little drive (e.g. north-facing walls)

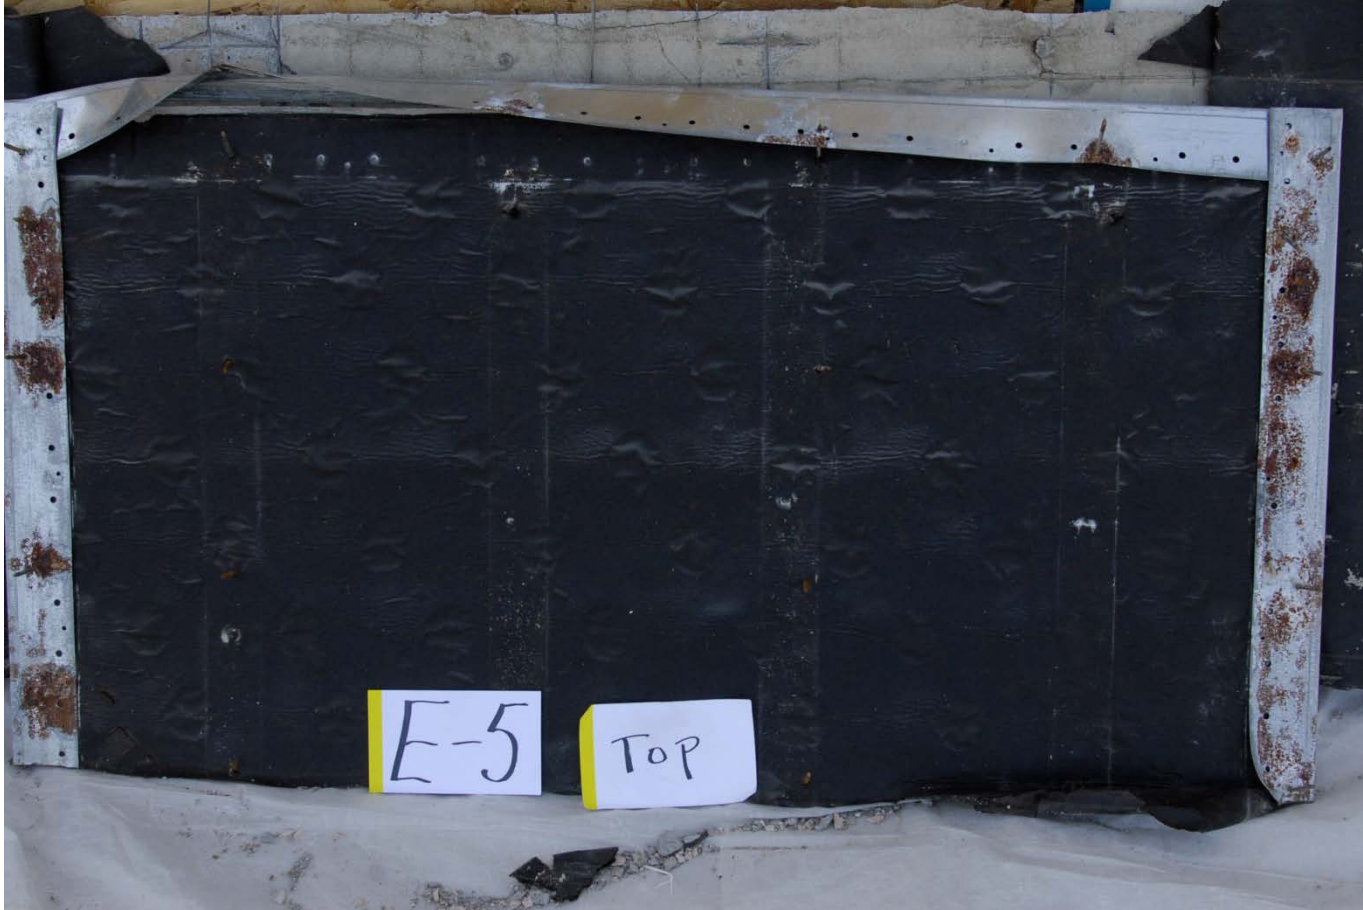
2000s wall, ventilated w poly

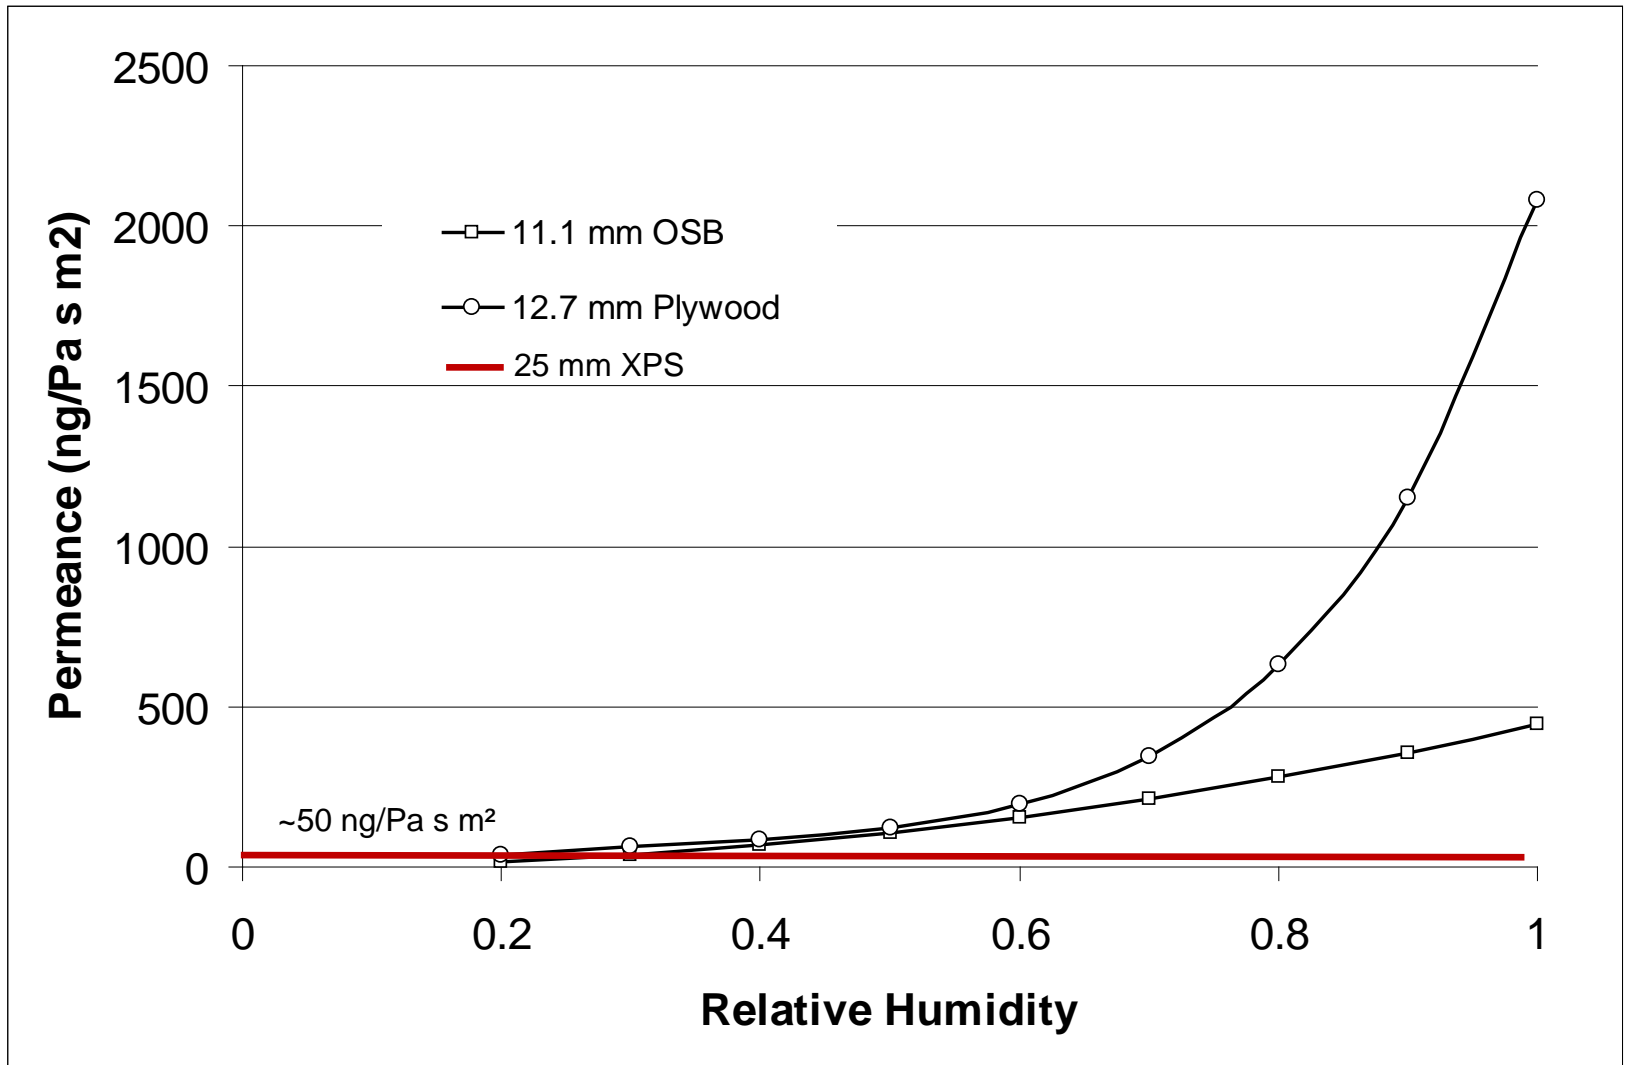
Permeance of XPS

- Throttles vapor diffusion
 - Disconnects sensitive interior materials from wet, absorptive claddings but..
 - Also limits the amount of drying that can occur from the OSB to the outside

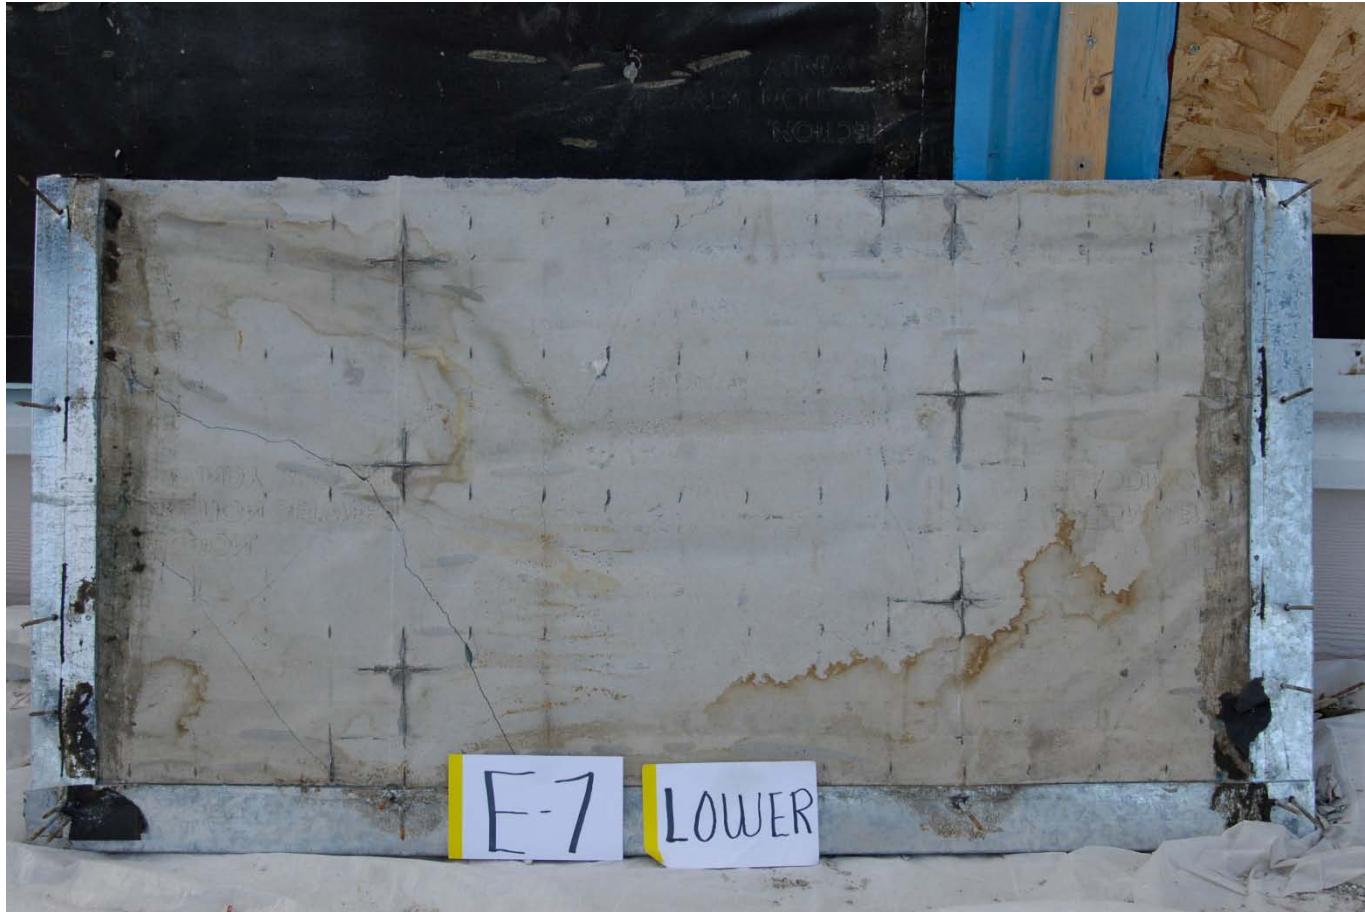
2005+ Wall, drained, ext insulated, no poly

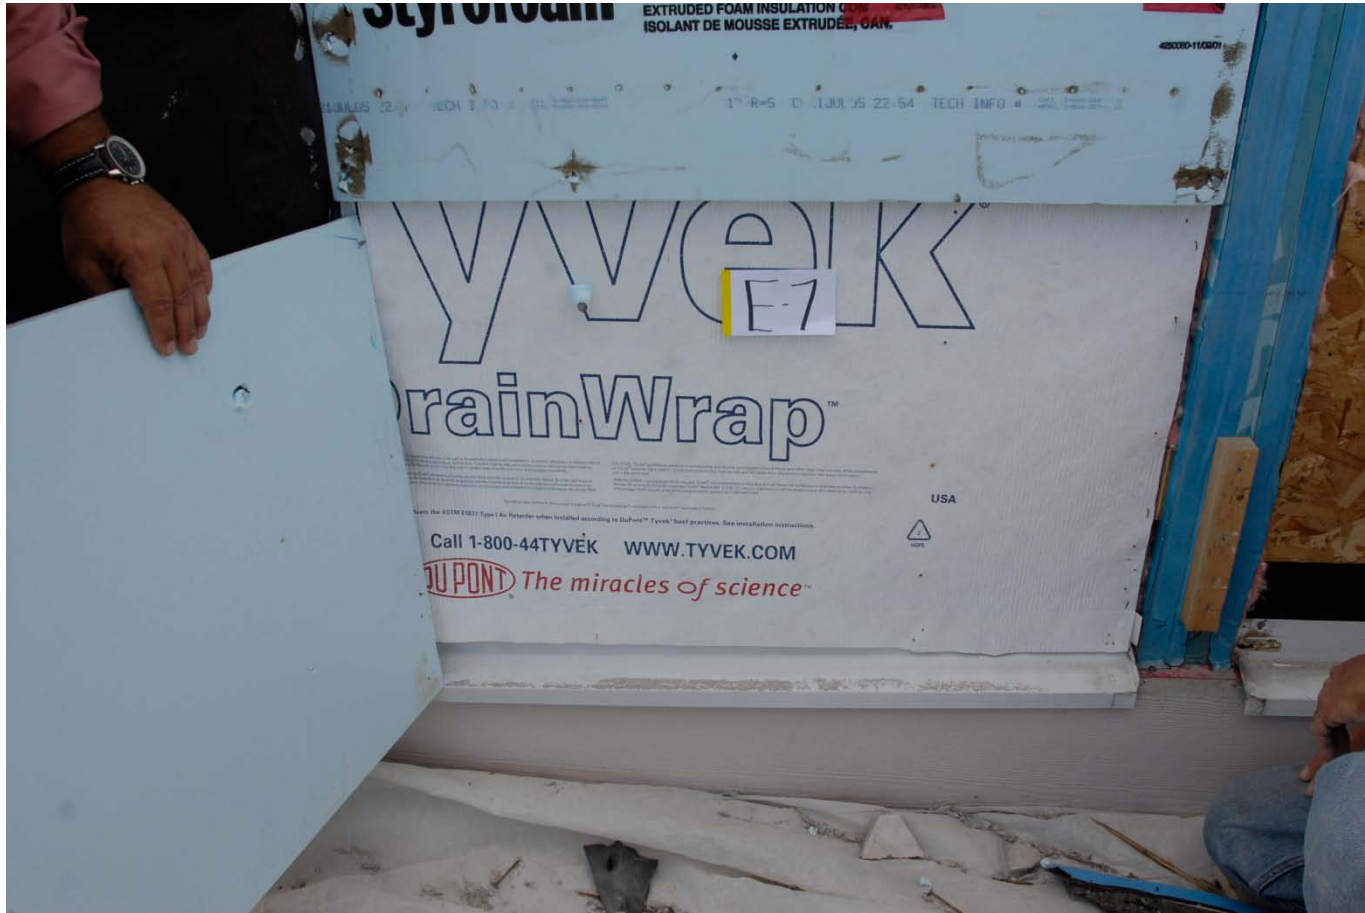
Drainwrap looks new

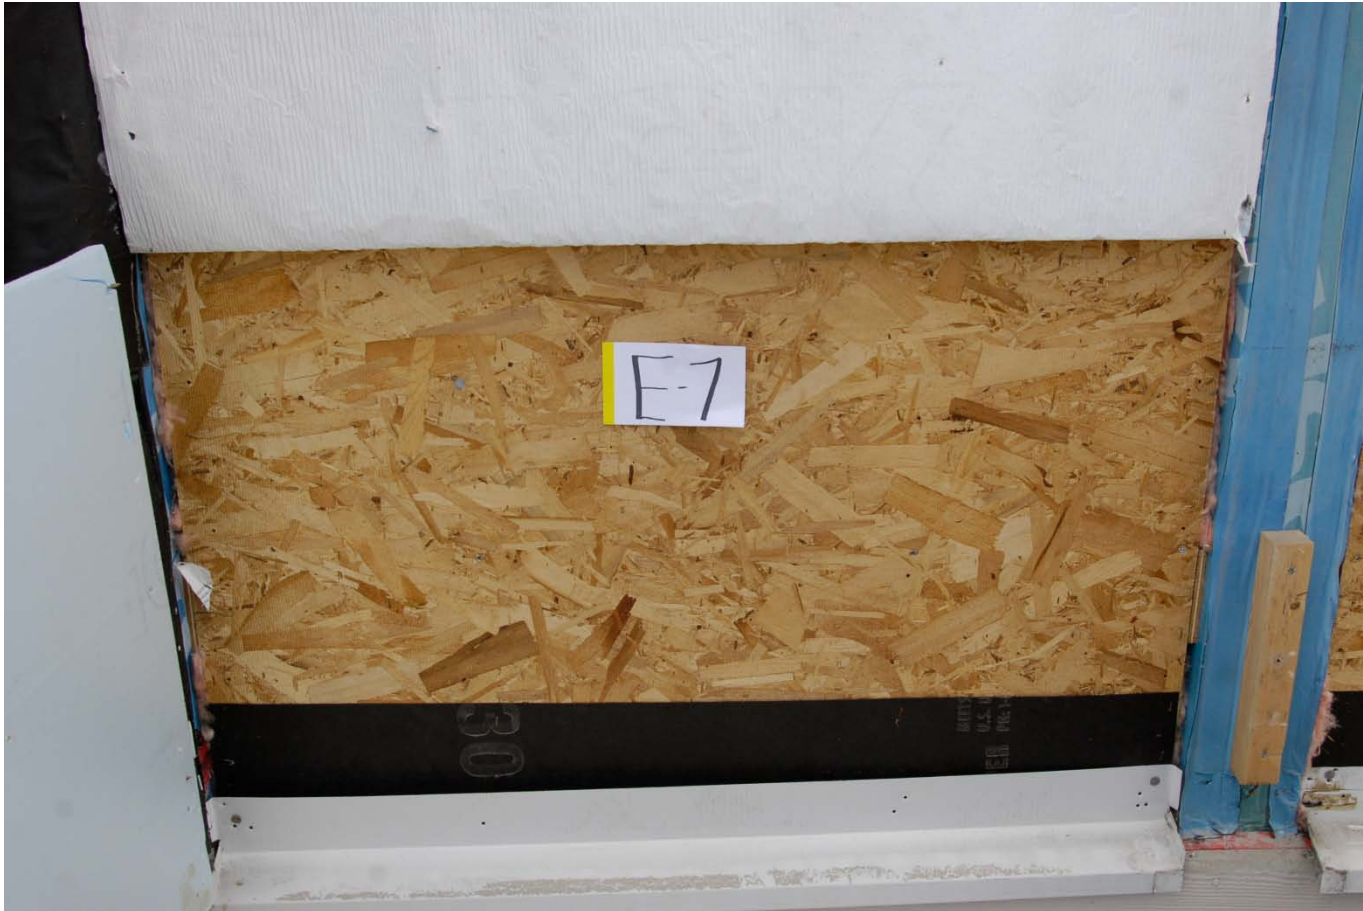
OSB is pristine
