Building Science Research Highlights

BCBEC
Annual General Meeting & Conference
2009.09.22

Chris Schumacher
Building Science Corp. | Somerville MA
Building Science Consulting Inc. | Waterloo ON

Coquitlam Test Hut

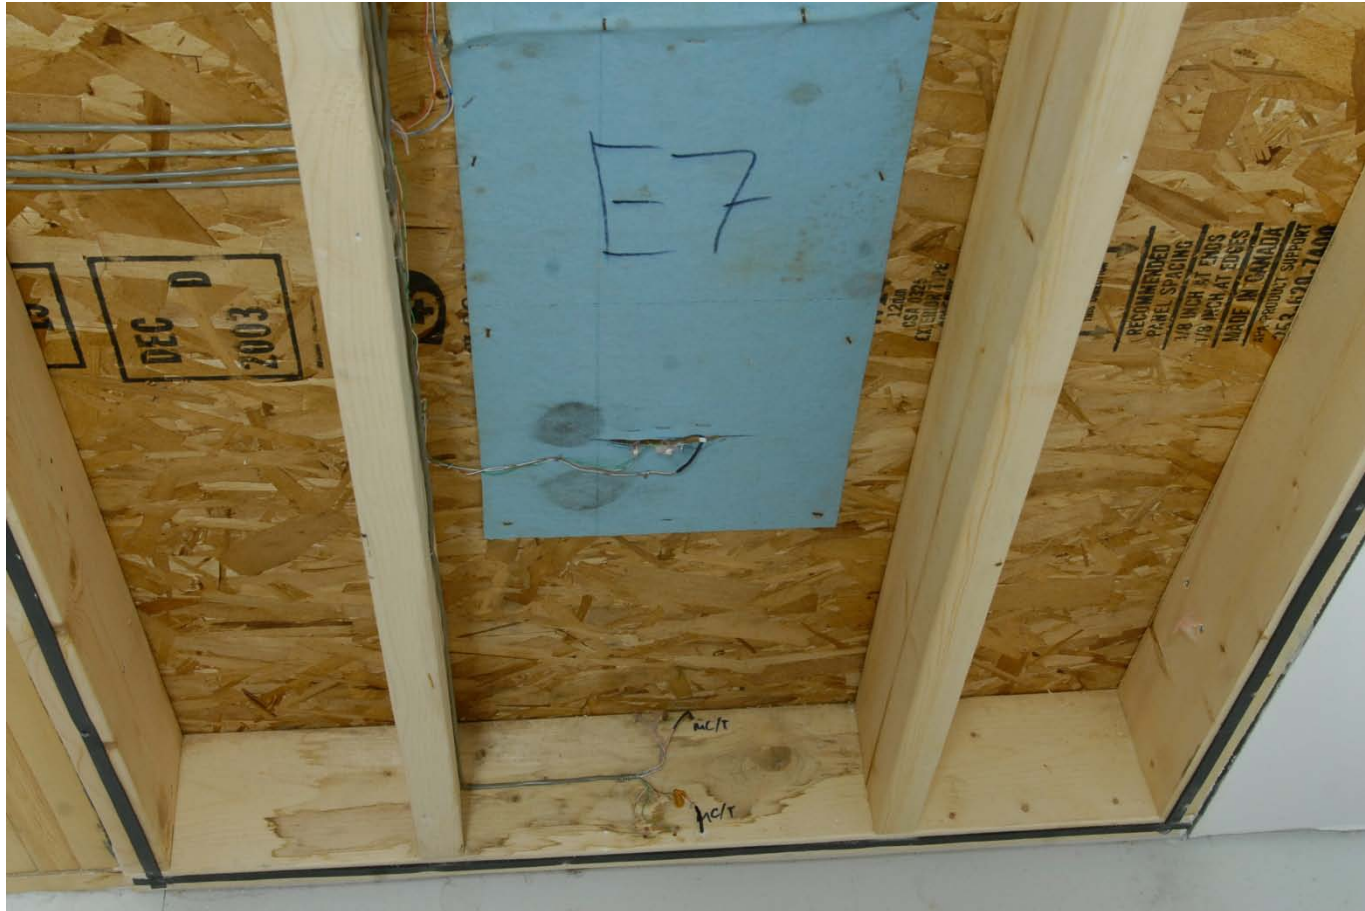
Only moderate staining from leaks
