## *Air Barrier Commissioning of Large Buildings*

September 2011

Martin Houston, AIA, LEED AP

Walsh Construction Co.

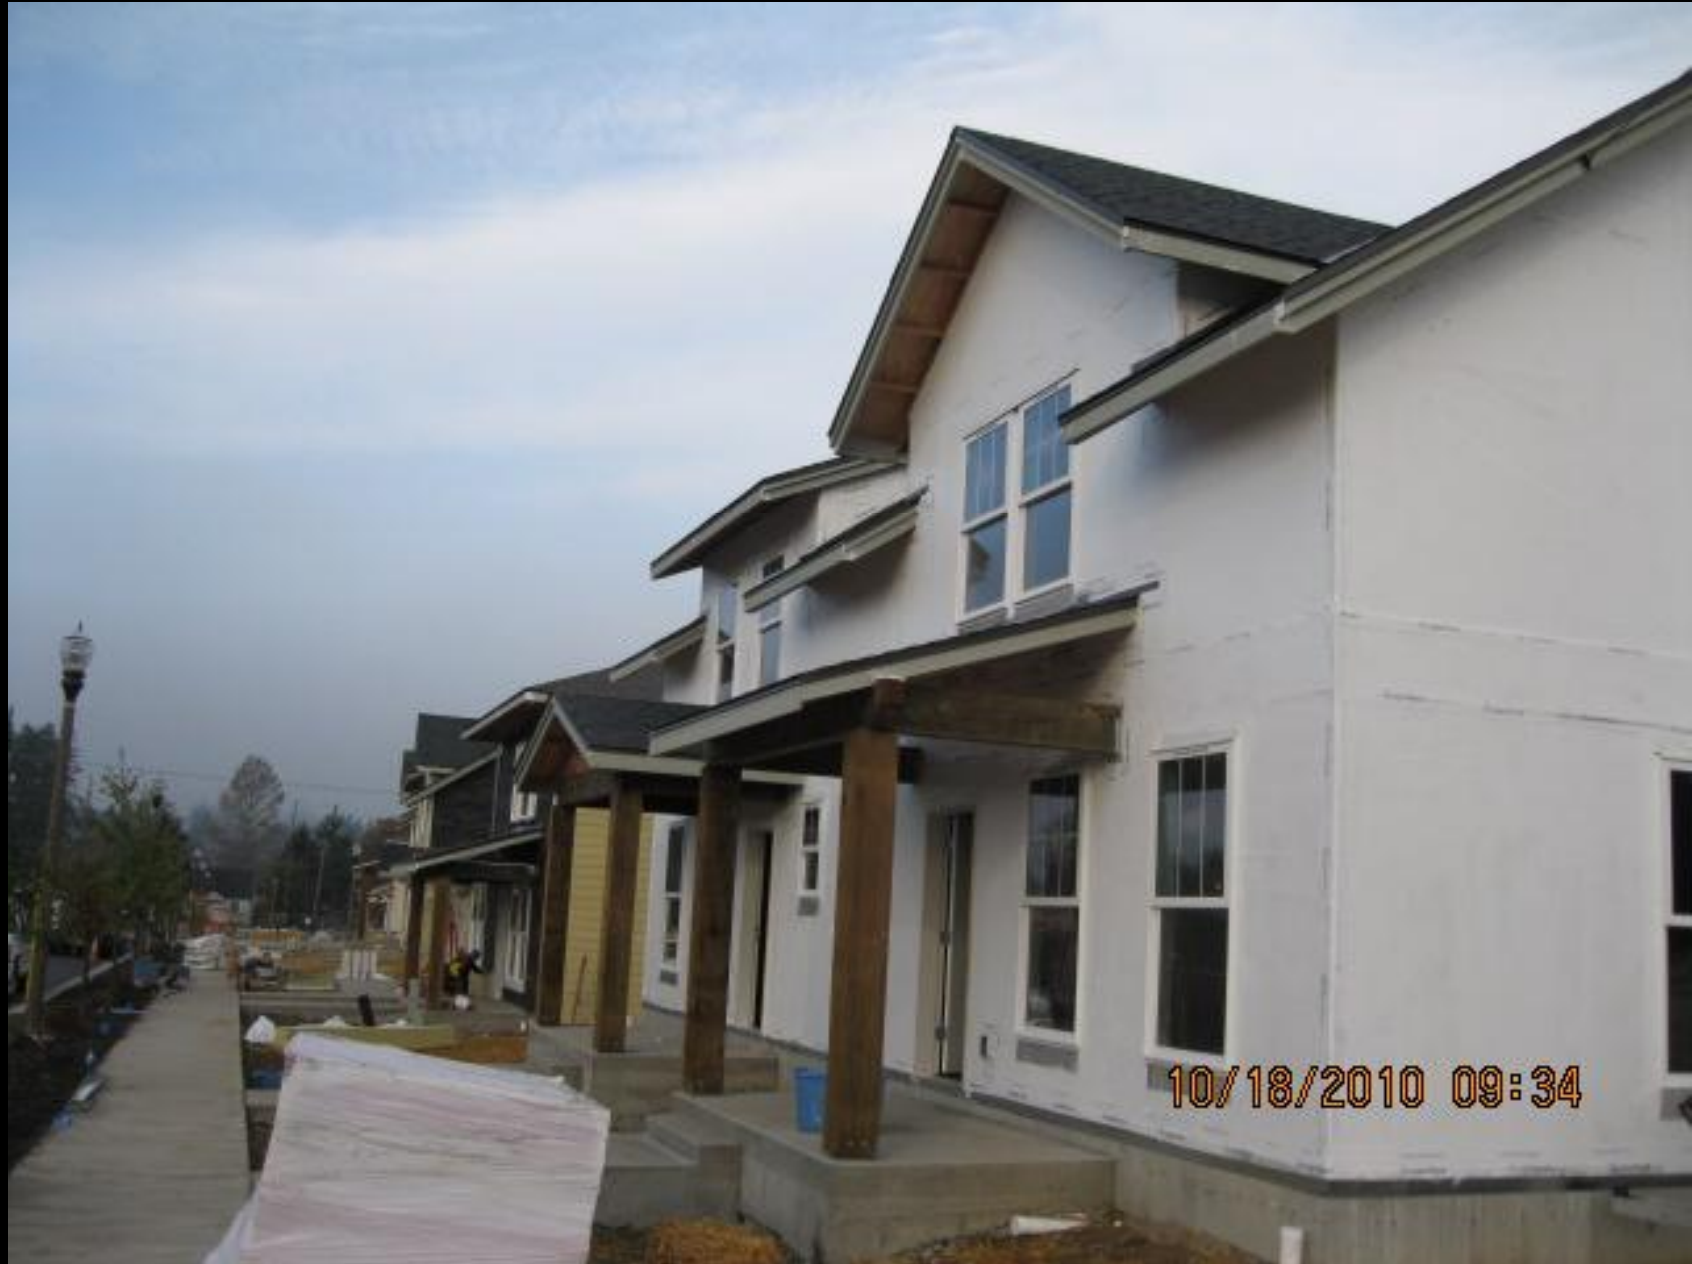
- 1.8 ACH 50
- 33% of air leakage was attributable to windows
